# Geotechnical Engineering Pavement Thickness Design Report

Centennial Boulevard Reconstruction  
West Fillmore Street to Garden of the Gods Road  
Colorado Springs, Colorado

Terracon Project No. 23155014

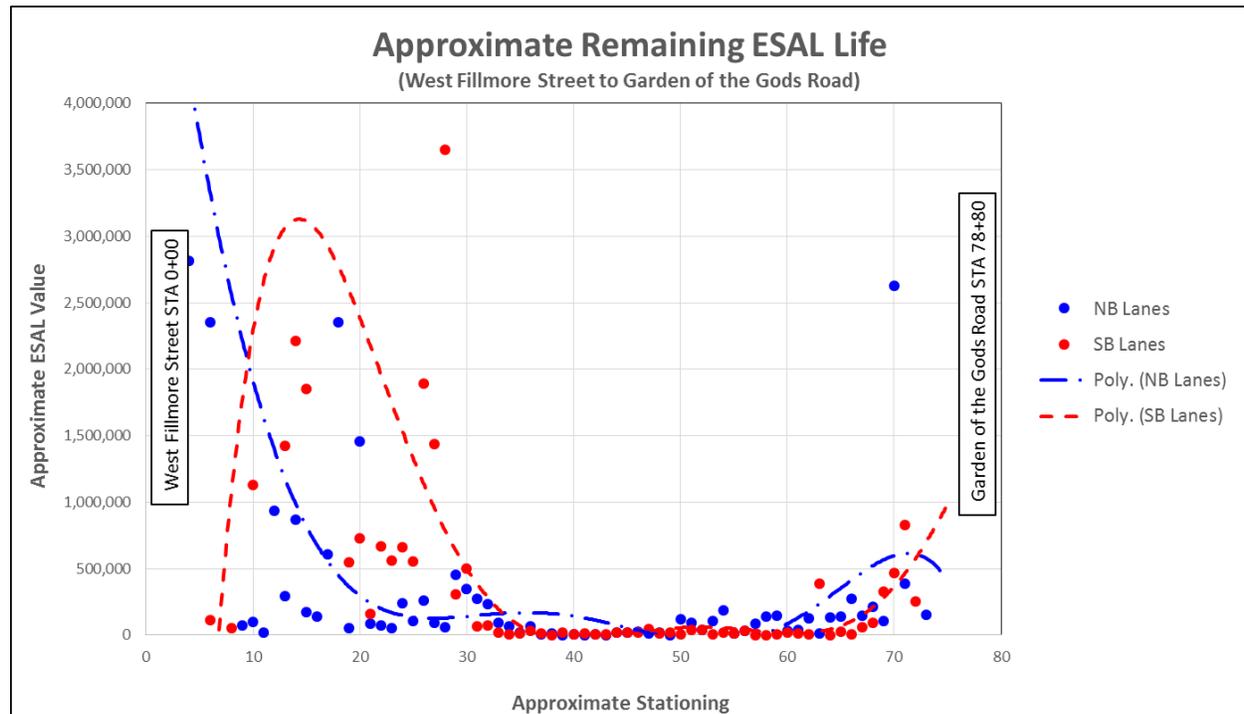
The remaining ESAL life of the roadway is shown in the following graph. Based on the results, the remaining ESALs varied significantly, but tended to be greater from approximate Station 0+00 to 30+00. The ESAL values were then consistently lower than the previous values to approximate Station 70+00. The results of the FWD testing are presented in Appendix F.

Arbitrary stationing was assigned to the roadway section by Terracon, with STA 0+00 beginning at the intersection of West Fillmore Street to STA 78+80 at the intersection of Garden of the Gods Road. The following graph indicates the remaining ESAL life of the roadway based on structural numbers.

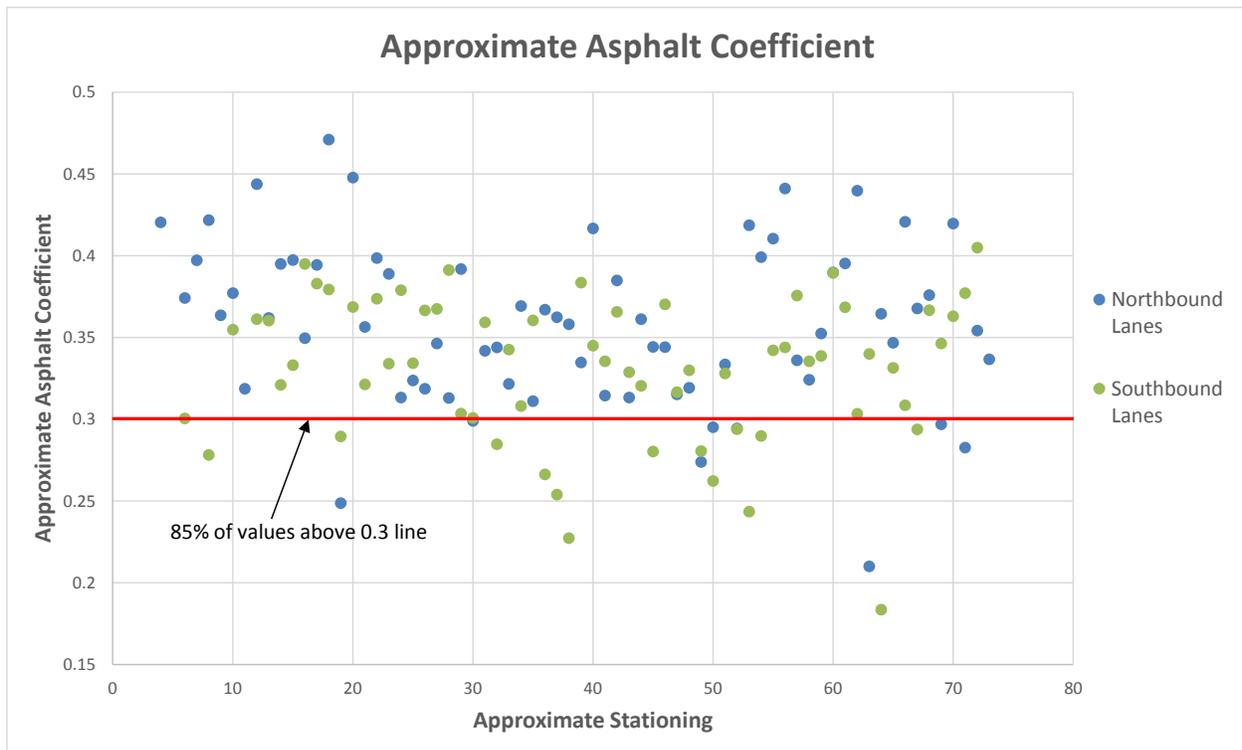
The Standards indicate that a maximum asphalt coefficient of 0.24 should be used for existing asphalt pavements, unless a higher value is supported by testing. An asphalt coefficient was calculated by others for the existing asphalt using the FWD data. The following graph outlines the approximate calculated asphalt coefficient data.

Approximately 85 percent of the coefficient data from the FWD testing indicated coefficient values of 0.3. This asphalt coefficient of 0.3 was selected to represent the existing asphalt pavement for design of the mill and inlay.

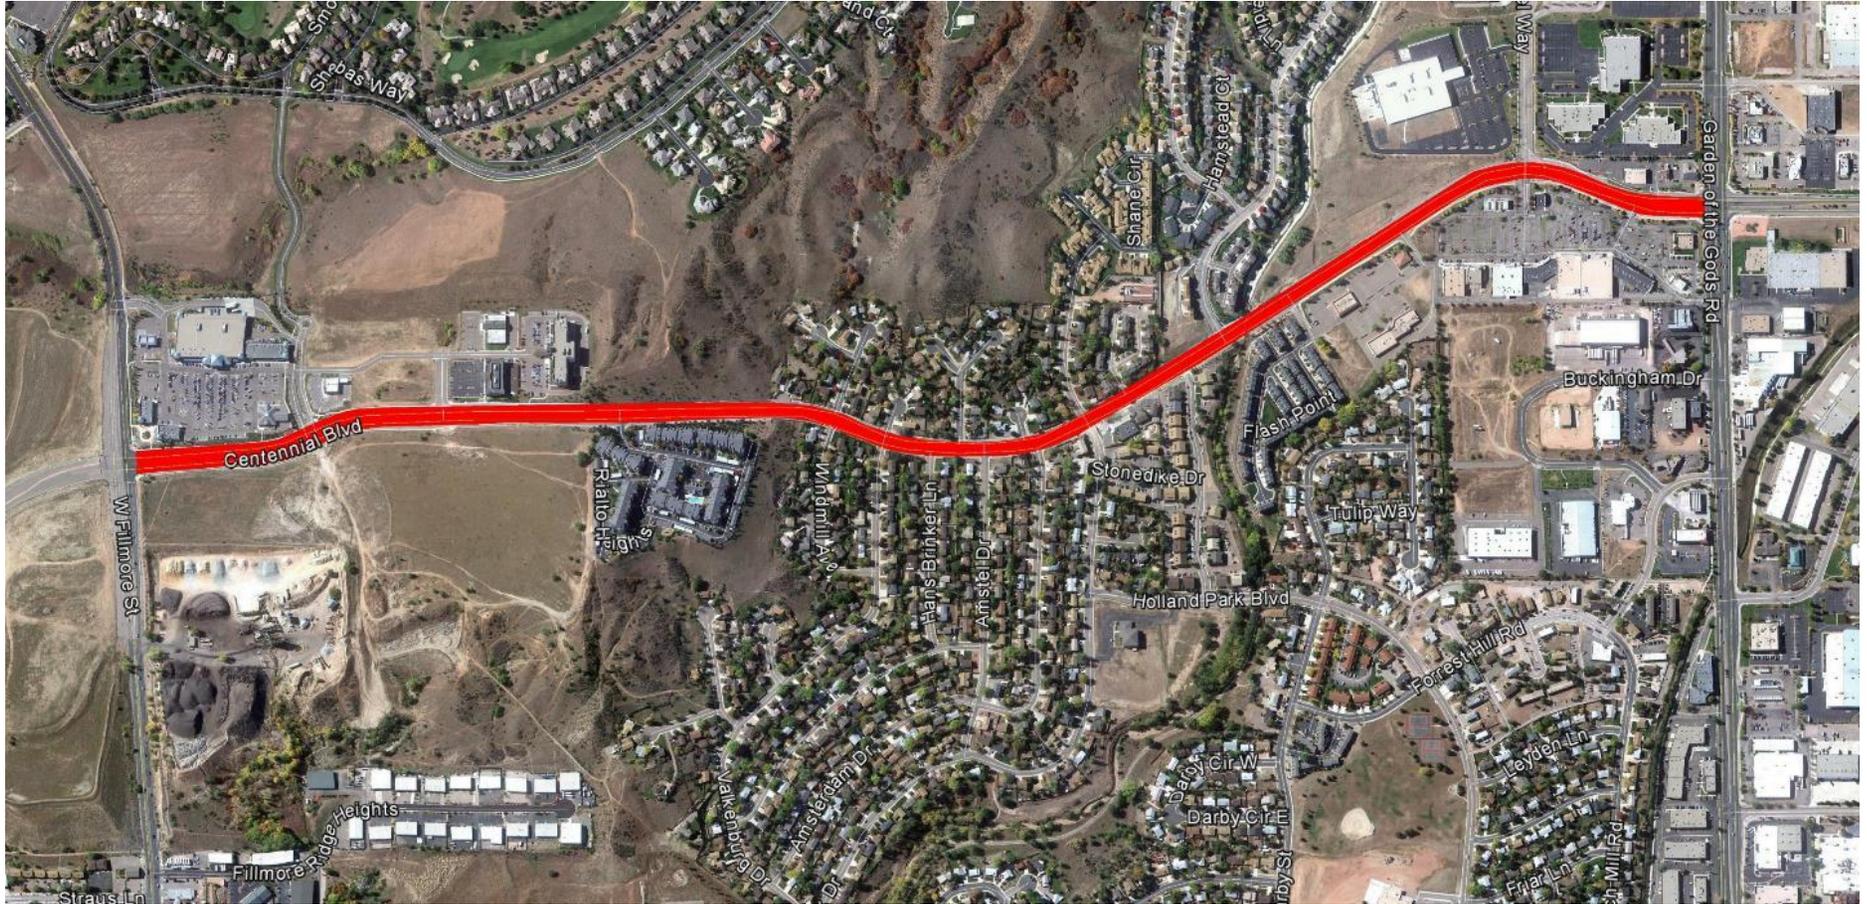
Exhibit
<b>A-2</b>

<b>SITE PLAN</b>
<b>CENTENNIAL BOULEVARD RECONSTRUCTION</b> WEST FILLMORE STREET TO GARDEN OF THE GODS ROAD COLORADO SPRINGS, COLORADO

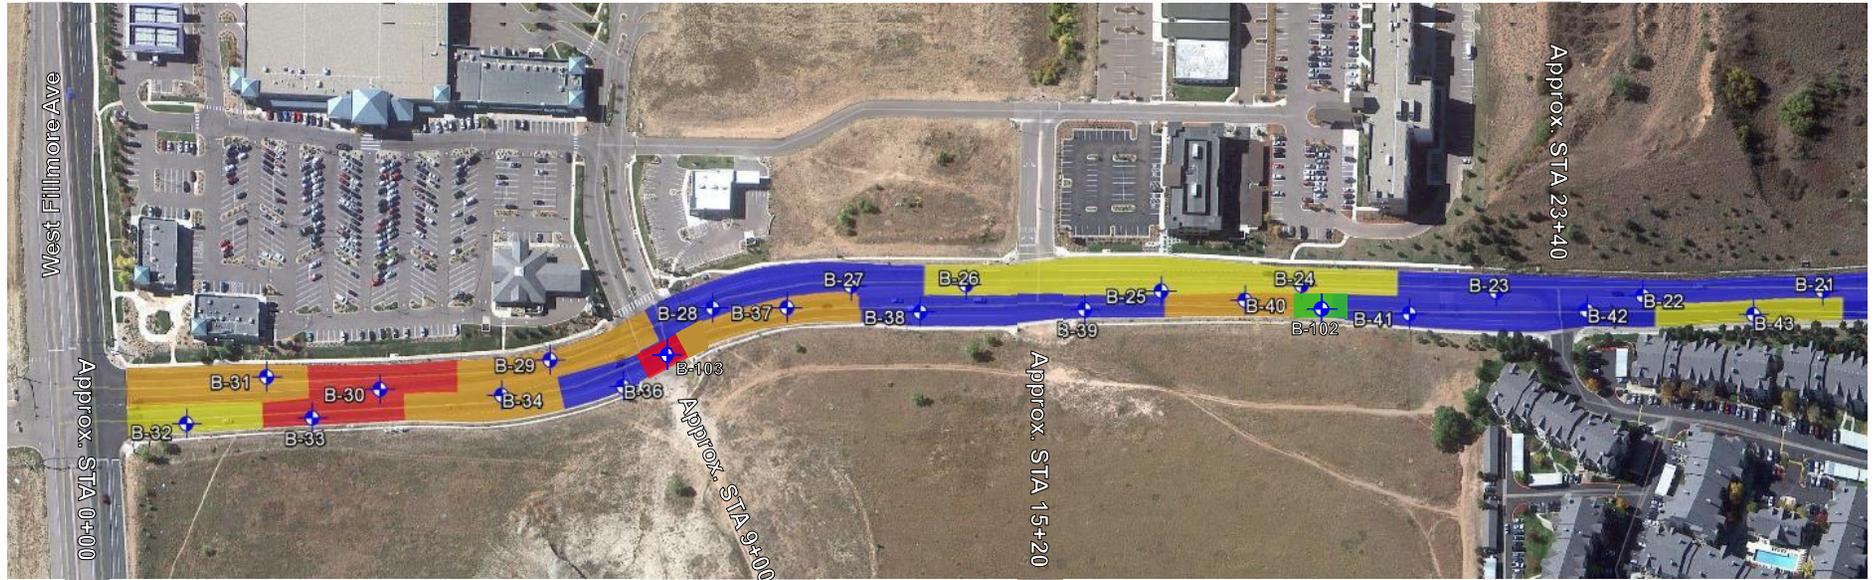
Exhibit
<b>A-5</b>

<b>SOIL TYPE AND TRAFFIC LOADING</b>
<b>CENTENNIAL BOULEVARD RECONSTRUCTION WEST FILLMORE STREET TO GARDEN OF THE GODS ROAD COLORADO SPRINGS, COLORADO</b>

- The subgrade soils varying along the alignment from A-1-a, A-2-4, A-4, A-2-6, A-6, A-7-5 and A-7-6 according to the AASHTO classification system. The weaker subgrade soils (A-6 and A-7-6) are generally at the southern and central portions of the alignment. We have provided several pavement thickness designs and subgrade mitigation as part of our recommendations.

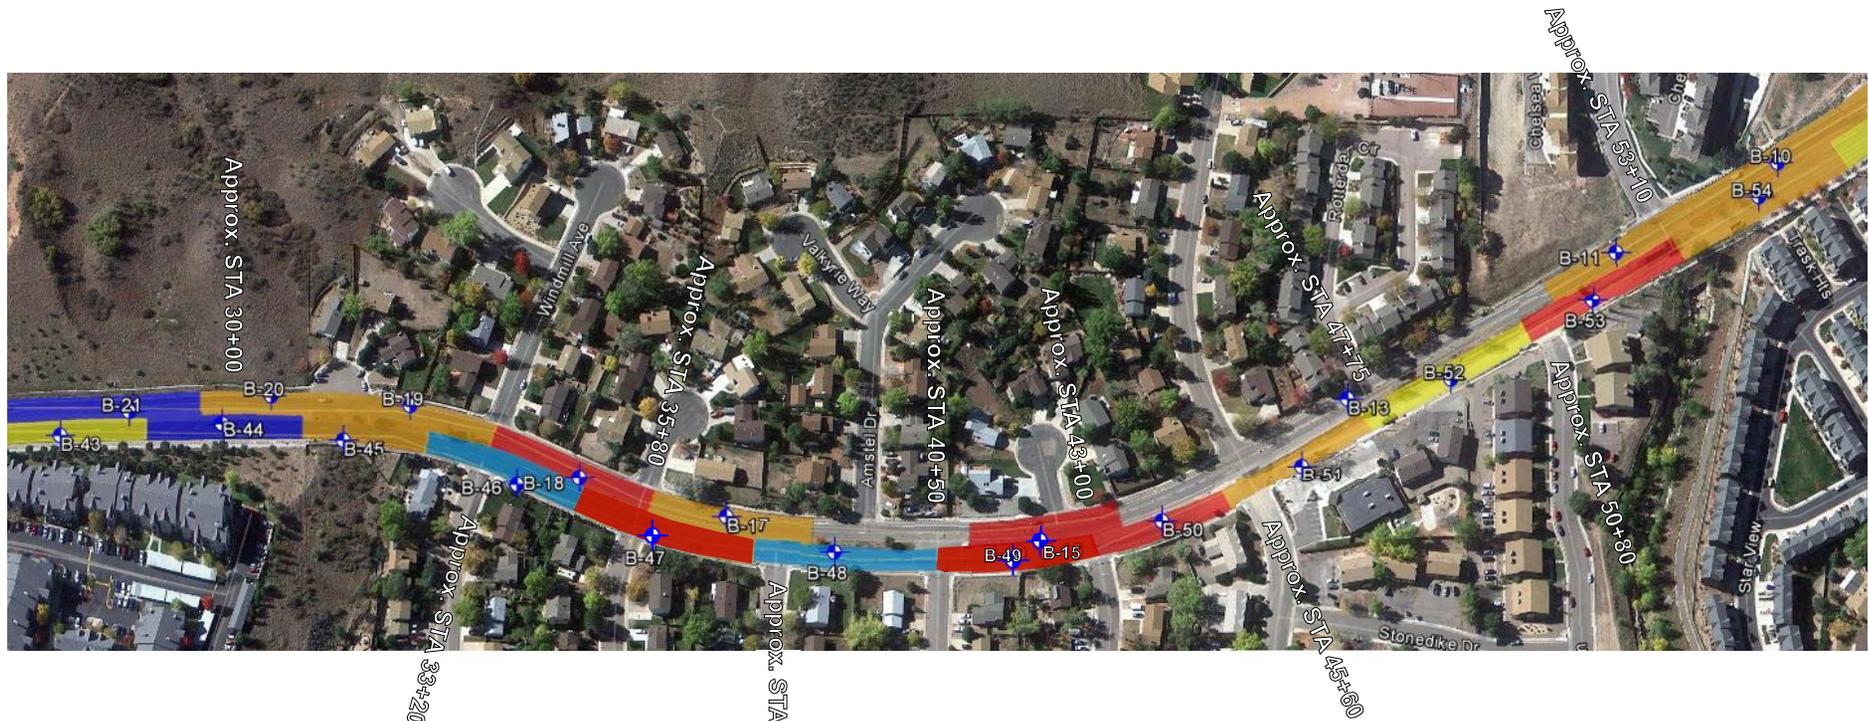
Exhibit
<b>A-6</b>

<b>SOIL TYPE AND TRAFFIC LOADING</b>
<b>CENTENNIAL BOULEVARD RECONSTRUCTION WEST FILLMORE STREET TO GARDEN OF THE GODS ROAD COLORADO SPRINGS, COLORADO</b>

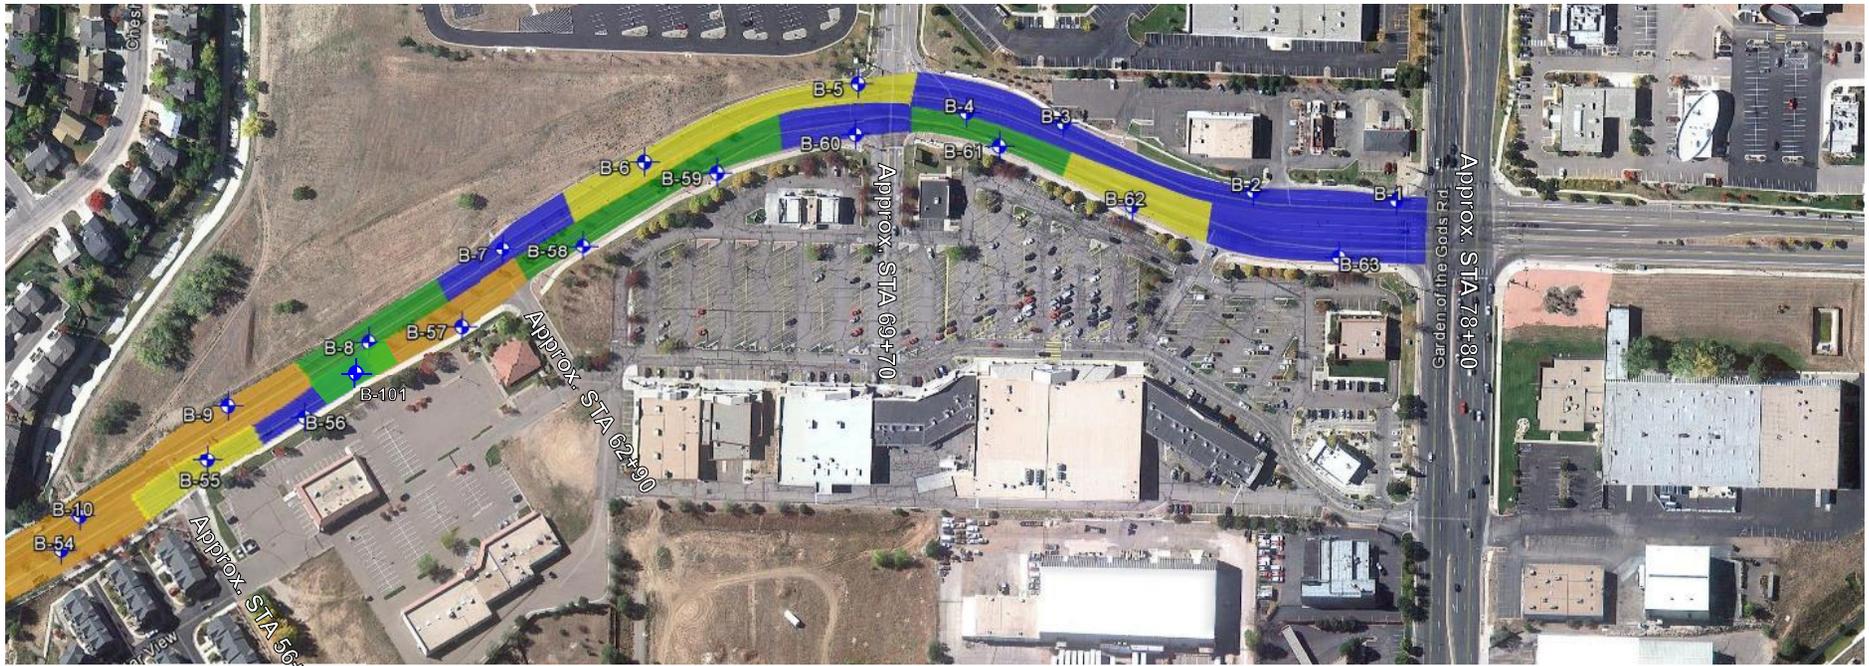
Exhibit
<b>A-7</b>

<b>SOIL TYPE AND TRAFFIC LOADING</b>
<b>CENTENNIAL BOULEVARD RECONSTRUCTION WEST FILLMORE STREET TO GARDEN OF THE GODS ROAD COLORADO SPRINGS, COLORADO</b>

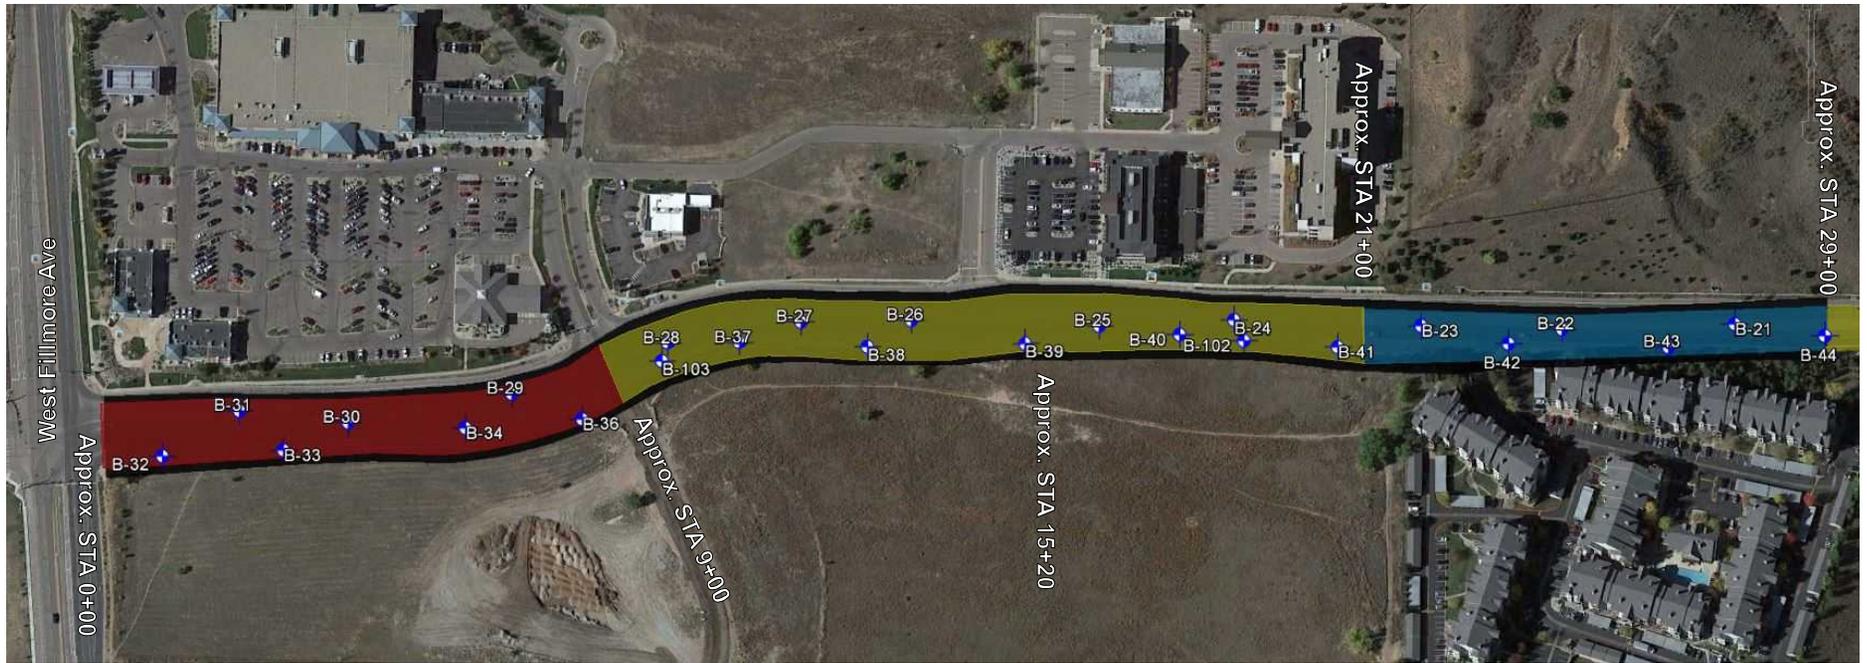
Exhibit
<b>A-8</b>

<b>SUBGRADE STABILIZATION PLAN</b>
<b>CENTENNIAL BOULEVARD RECONSTRUCTION</b> WEST FILLMORE STREET TO GARDEN OF THE GODS ROAD COLORADO SPRINGS, COLORADO

- Expansive and potentially low strength clay soils were encountered within the influence of the pavement section in portions of the Centennial Boulevard alignment. These areas will potentially require mitigation by removal and replacement, moisture conditioning, and/or chemical stabilization.

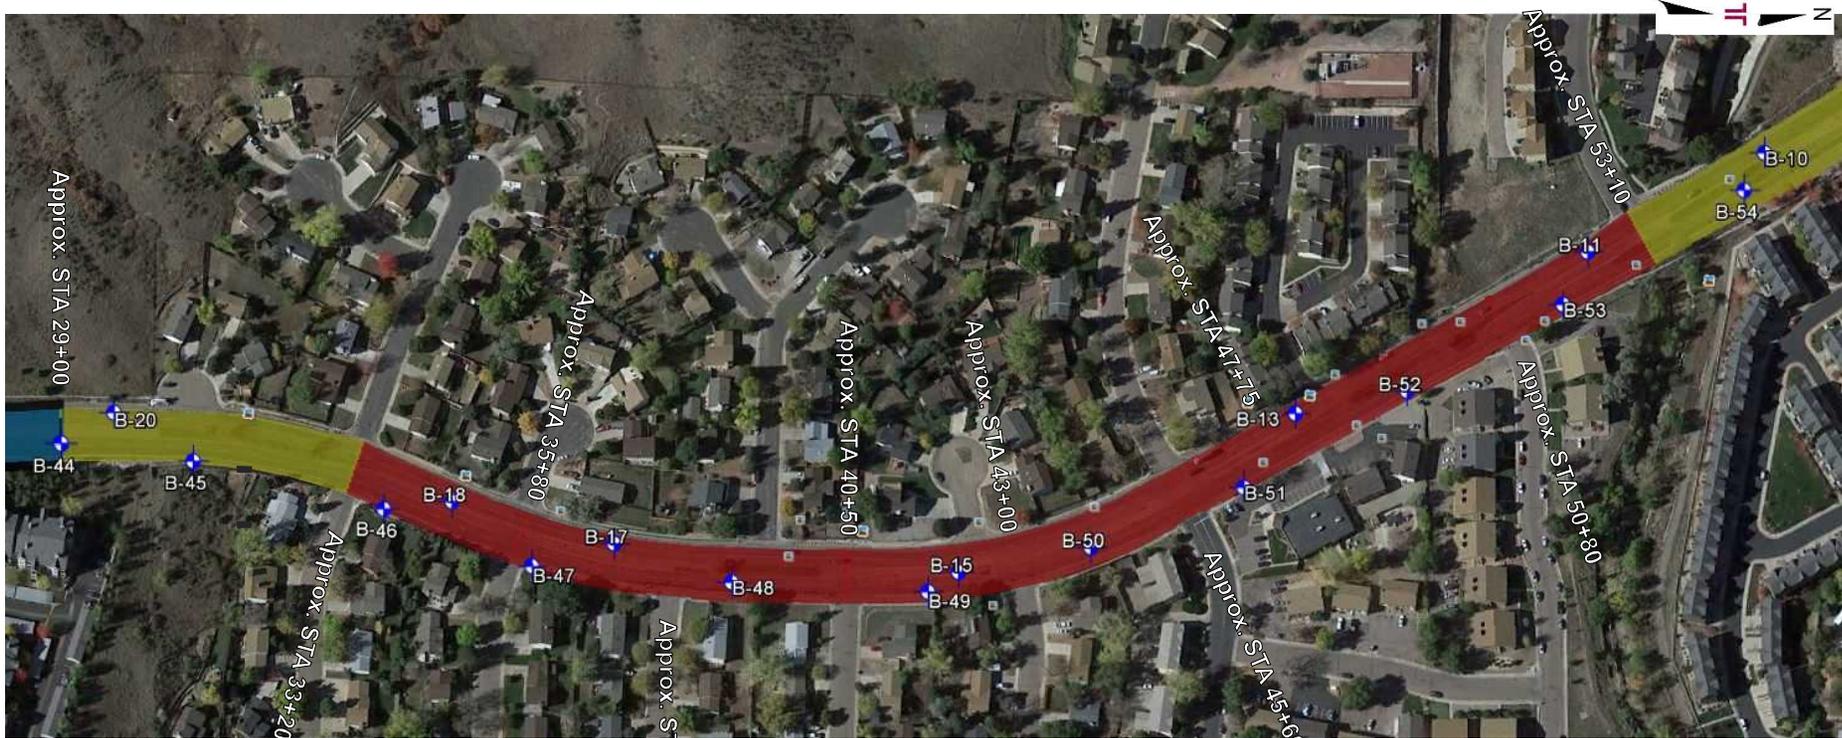
Exhibit
<b>A-9</b>

<b>SUBGRADE STABILIZATION PLAN</b>
<b>CENTENNIAL BOULEVARD RECONSTRUCTION</b> WEST FILLMORE STREET TO GARDEN OF THE GODS ROAD COLORADO SPRINGS, COLORADO

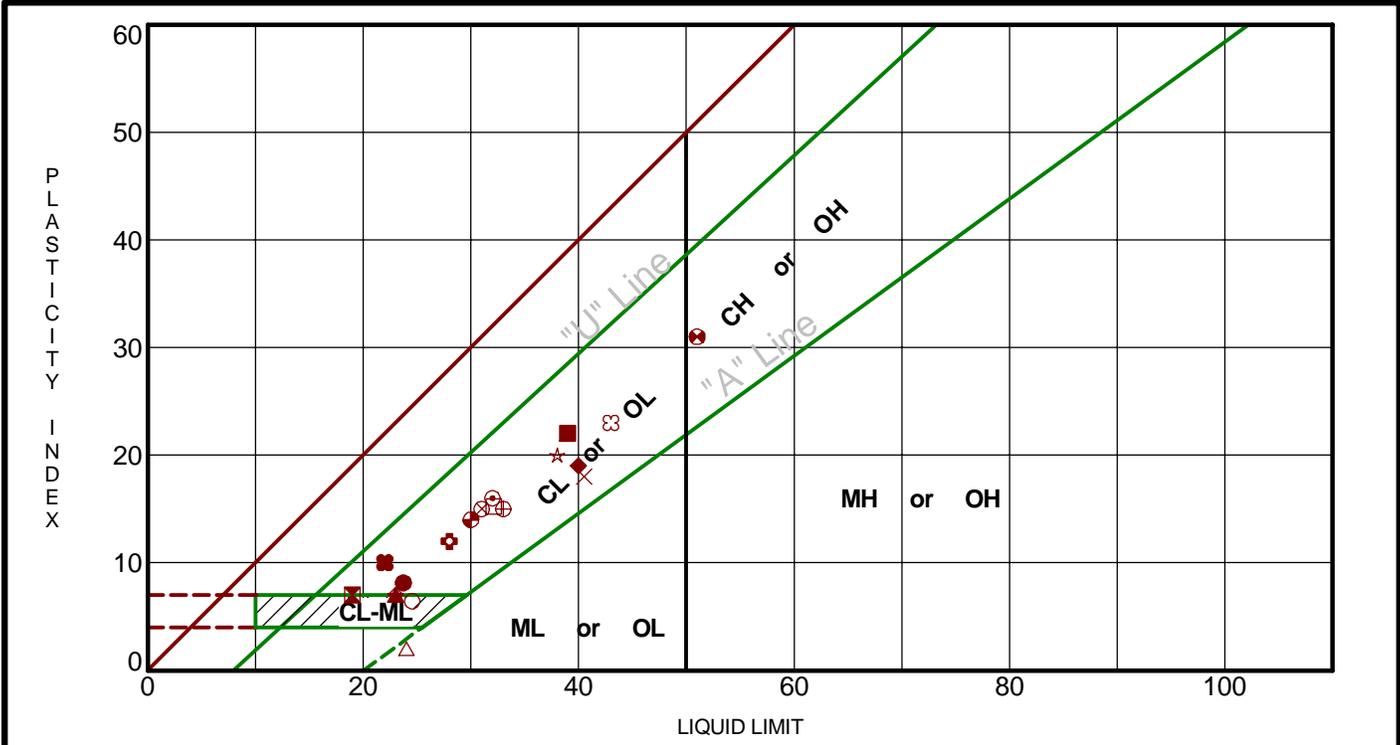
ASTM D4318

# ATTERBERG LIMITS RESULTS

Boring ID	Depth	LL	PL	PI	Fines	USCS	Description
● B-01	0.15 - 1.2	24	16	8	14	SC	CLAYEY SAND with GRAVEL
⊠ B-02	1.5 - 2.5	19	12	7	24	SC-SM	SILTY, CLAYEY SAND with GRAVEL
▲ B-03	1.5 - 2.5	23	16	7	8	SW-SC	WELL-GRADED SAND with SILTY CLAY and GRAVEL
★ B-04	1.5 - 2.5	23	16	7	16	SC-SM	SILTY, CLAYEY SAND with GRAVEL
⊙ B-05	1 - 2	32	16	16	23	SC	CLAYEY SAND with GRAVEL
⊕ B-06	0.5 - 1.5	28	16	12	25	SC	CLAYEY SAND with GRAVEL
○ B-07	0.42 - 1.4	25	18	7	21	SC-SM	SILTY, CLAYEY SAND with GRAVEL
△ B-08	1.5 - 2.5	24	22	2	9	SW-SM	WELL-GRADED SAND with SILT and GRAVEL
⊗ B-09	1 - 2	31	16	15	35	SC	CLAYEY SAND
⊕ B-10	1 - 2	33	18	15	51	CL	SANDY LEAN CLAY
□ B-11	0.5 - 1.5	32	17	15	49	SC	CLAYEY SAND
⊕ B-15	1 - 2	51	20	31	65	CH	SANDY FAT CLAY
⊕ B-17	0 - 5	30	16	14	47	SC	CLAYEY SAND
★ B-17	0.8 - 1.8	38	18	20	68	CL	SANDY LEAN CLAY
⊗ B-18	1 - 2	43	20	23	43	---	WEATHERED CLAYEY SANDSTONE
■ B-19	1 - 2	39	17	22	53	CL	SANDY LEAN CLAY
◆ B-20	1 - 2	40	21	19	56	CL	SANDY LEAN CLAY

◇ B-21	1.7 - 2.7	23	16	7	13	SC-SM	SILTY, CLAYEY SAND with GRAVEL
× B-21	4 - 5	40	22	18	80	---	WEATHERED SANDY CLAYSTONE
■ B-22	1.5 - 2.5	22	12	10	10	SW-SC	WELL-GRADED SAND with CLAY and GRAVEL

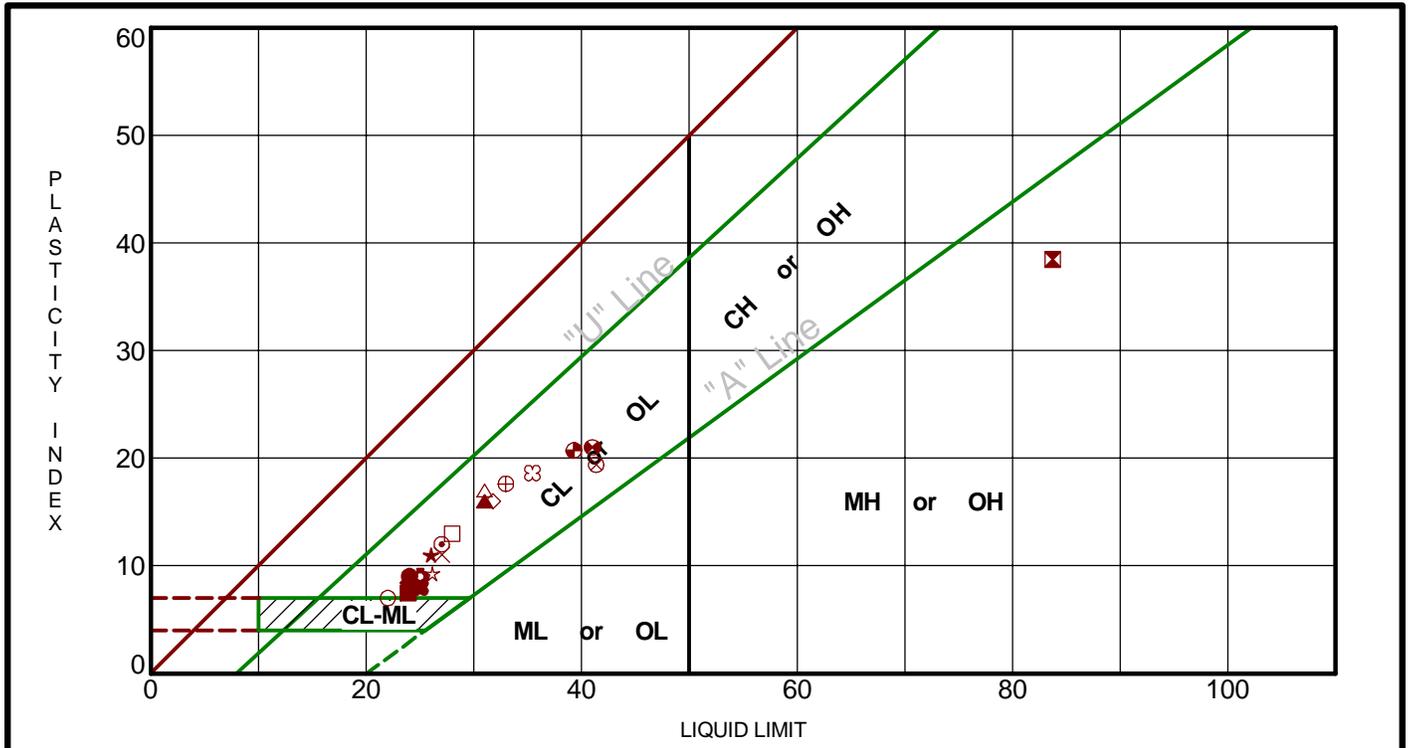
ASTM D4318

# ATTERBERG LIMITS RESULTS

Boring ID	Depth	LL	PL	PI	Fines	USCS	Description
● B-23	1.5 - 2.5	24	15	9	15	SC	CLAYEY SAND with GRAVEL
⊠ B-23	4 - 5	84	45	39	84	---	SANDY SILTSTONE
▲ B-24	1.5 - 2.5	31	15	16	24	SC	CLAYEY SAND with GRAVEL
★ B-25	1.5 - 2.5	26	15	11	16	SC	CLAYEY SAND with GRAVEL
⊙ B-26	2 - 3	27	15	12	12	SW-SC	WELL-GRADED SAND with CLAY and GRAVEL
⊕ B-27	1.5 - 2.5	25	16	9	13	SC	CLAYEY SAND with GRAVEL
○ B-28	2 - 3	22	15	7	15	SC-SM	SILTY, CLAYEY SAND with GRAVEL
△ B-29	2 - 3	31	14	17	37	SC	CLAYEY SAND with GRAVEL
⊗ B-30	4 - 5	41	22	19	48	SC	CLAYEY SAND
⊕ B-31	4 - 5	33	15	18	57	CL	SANDY LEAN CLAY
□ B-32	2 - 3	28	15	13	32	SC	CLAYEY SAND
⊕ B-33	2 - 3	41	20	21	54	CL	SANDY LEAN CLAY
⊕ B-34	4 - 5	39	19	20	59	CL	SANDY LEAN CLAY
★ B-36	0.67 - 1.7	26	17	9	10	SW-SC	WELL-GRADED SAND with CLAY and GRAVEL
⊗ B-37	0.5 - 1.5	35	17	18	42	SC	CLAYEY SAND with GRAVEL
■ B-38	0.67 - 1.7	24	16	8	14	GC	CLAYEY GRAVEL with SAND
◆ B-39	0.67 - 1.7	24	15	9	10	SW-SC	WELL-GRADED SAND with CLAY and GRAVEL

◇ B-40	0.5 - 1.5	32	16	16	38	SC	CLAYEY SAND with GRAVEL
× B-41	0 - 5	27	16	11	21	SC	CLAYEY SAND with GRAVEL
■ B-41	0.67 - 1.7	25	17	8	15	SC	CLAYEY SAND with GRAVEL

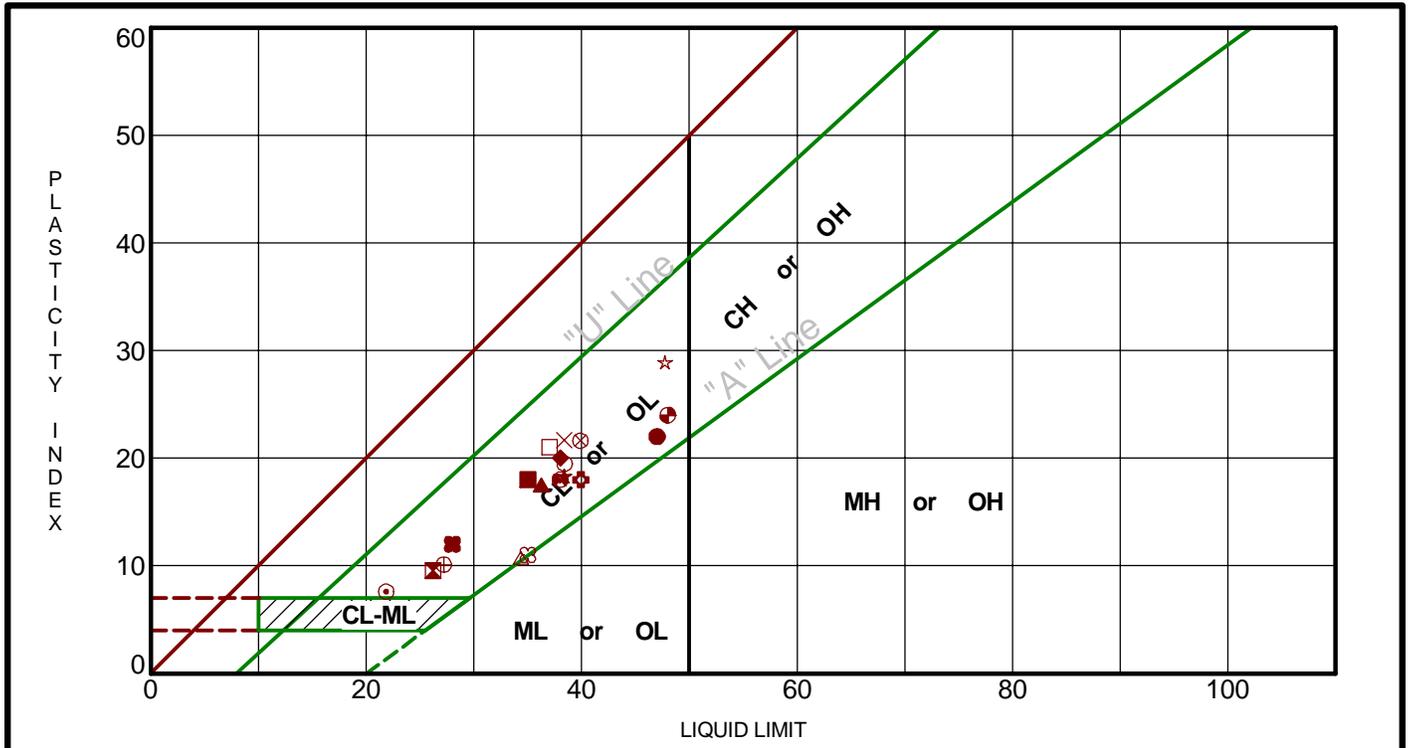
ASTM D4318

# ATTERBERG LIMITS RESULTS

Boring ID	Depth	LL	PL	PI	Fines	USCS	Description
● B-41	4 - 5	47	25	22	50	CL	SANDY LEAN CLAY
⊠ B-42	0.5 - 1.5	26	17	9	22	SC	CLAYEY SAND with GRAVEL
▲ B-43	0.75 - 1.8	36	19	17	35	SC	CLAYEY SAND with GRAVEL
★ B-43	4 - 5	38	20	18	58	---	SANDY CLAYSTONE
⊕ B-44	0.75 - 1.8	22	14	8	17	SC	CLAYEY SAND with GRAVEL
⊕ B-44	4 - 5	40	22	18	66	---	SANDY CLAYSTONE
○ B-45	0.58 - 1.6	38	19	19	48	SC	CLAYEY SAND
△ B-46	0.44 - 1.4	34	24	10	59	ML	SANDY SILT
⊗ B-47	0.33 - 1.3	40	18	22	76	CL	LEAN CLAY with SAND
⊕ B-48	0.33 - 1.3	27	17	10	48	SC	CLAYEY SAND
□ B-49	0 - 5	37	16	21	59	---	SANDY CLAYSTONE
⊕ B-49	0.5 - 1.5	38	20	18	56	---	WEATHERED CLAYSTONE
⊕ B-49	4 - 5	48	24	24	52	---	SANDY CLAYSTONE
★ B-50	0.5 - 1.5	48	19	29	61	CL	SANDY LEAN CLAY
⊗ B-51	1.3 - 2.3	35	24	11	55	CL	SANDY LEAN CLAY
■ B-52	1 - 2	35	17	18	17	SC	CLAYEY SAND with GRAVEL
◆ B-53	0 - 5	38	18	20	73	---	WEATHERED SANDY CLAYSTONE
◇ B-53	1 - 2	38	18	20	36	---	WEATHERED CLAYEY SANDSTONE

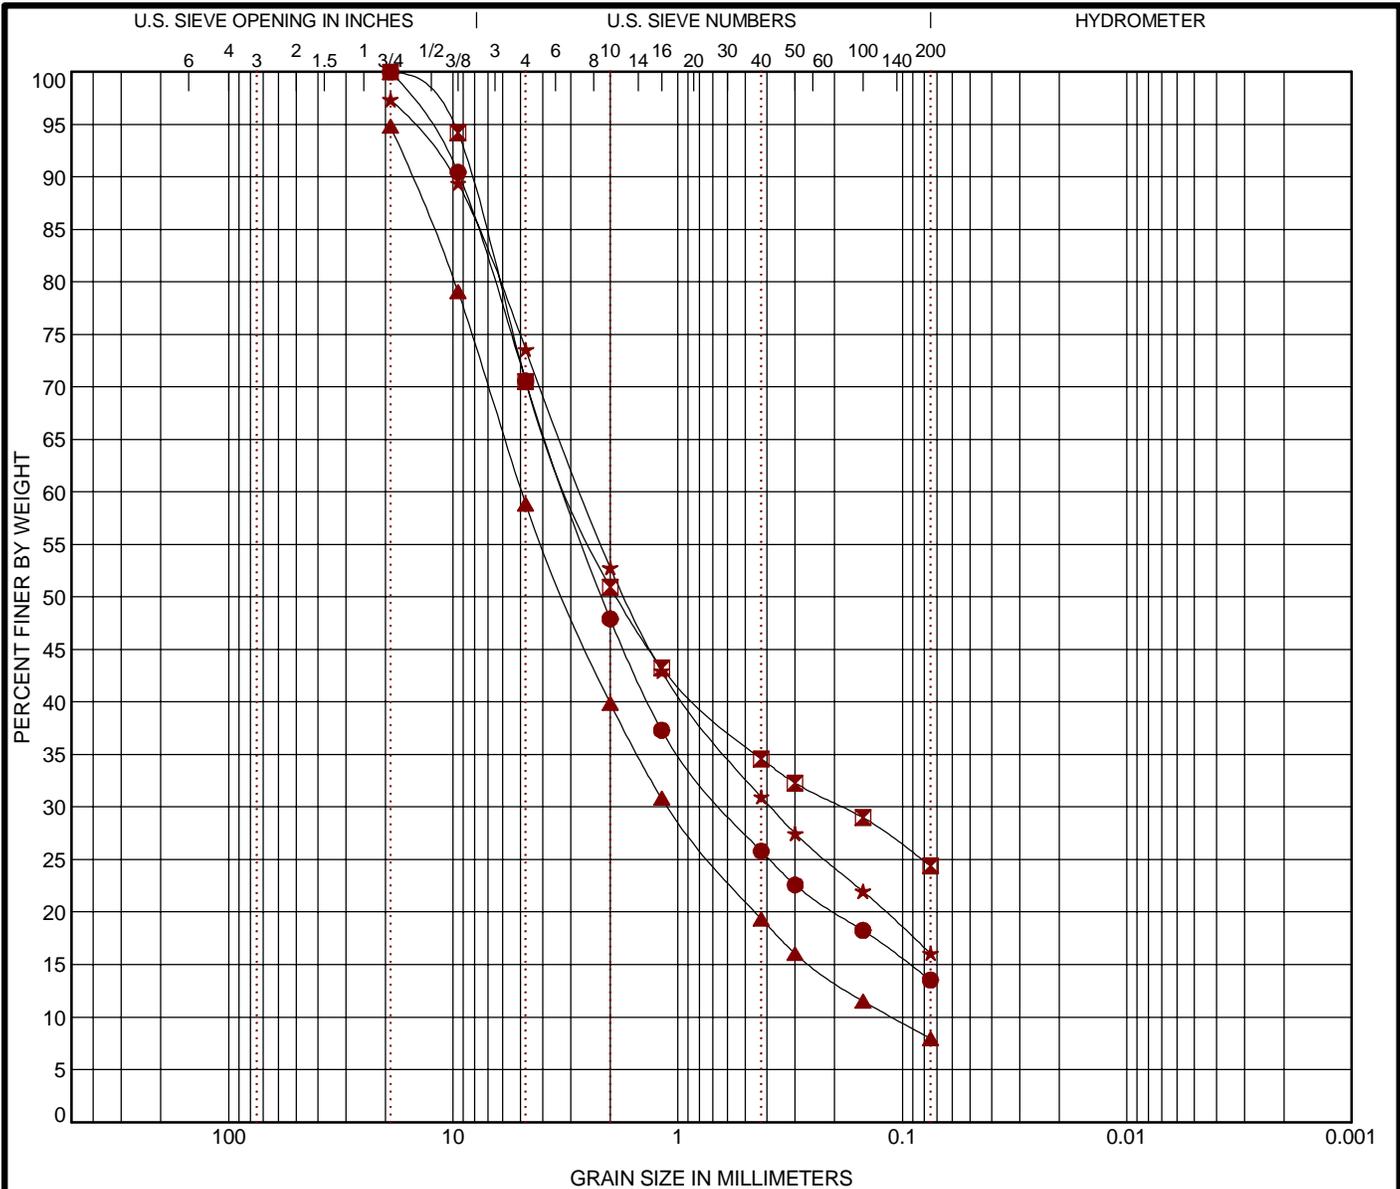
ASTM D422

# GRAIN SIZE DISTRIBUTION

Boring ID	Depth	USCS Classification	AASHTO Classification	LL	PL	PI	Cc	Cu	
●	B-01	0.15 - 1.2	CLAYEY SAND with GRAVEL (SC)	A-2-4(0)	24	16	8			
■	B-02	1.5 - 2.5	SILTY, CLAYEY SAND with GRAVEL (SC-SM)	A-2-4(0)	19	12	7			
▲	B-03	1.5 - 2.5	WELL-GRADED SAND with SILTY CLAY and GRAVEL (SW-SC)	A-2-4(0)	23	16	7	2.18	44.20	
★	B-04	1.5 - 2.5	SILTY, CLAYEY SAND with GRAVEL (SC-SM)	A-2-4(0)	23	16	7			
	Boring ID	Depth	D <sub>100</sub>	D <sub>60</sub>	D <sub>30</sub>	D <sub>10</sub>	%Gravel	%Sand	%Silt	%Clay
●	B-01	0.15 - 1.2	19	3.173	0.617		29.4	57.0	13.5	
■	B-02	1.5 - 2.5	19	2.983	0.185		29.5	46.2	24.4	
▲	B-03	1.5 - 2.5	19	4.939	1.096	0.112	36.0	50.9	8.0	
★	B-04	1.5 - 2.5	19	2.7	0.386		23.8	57.5	16.1

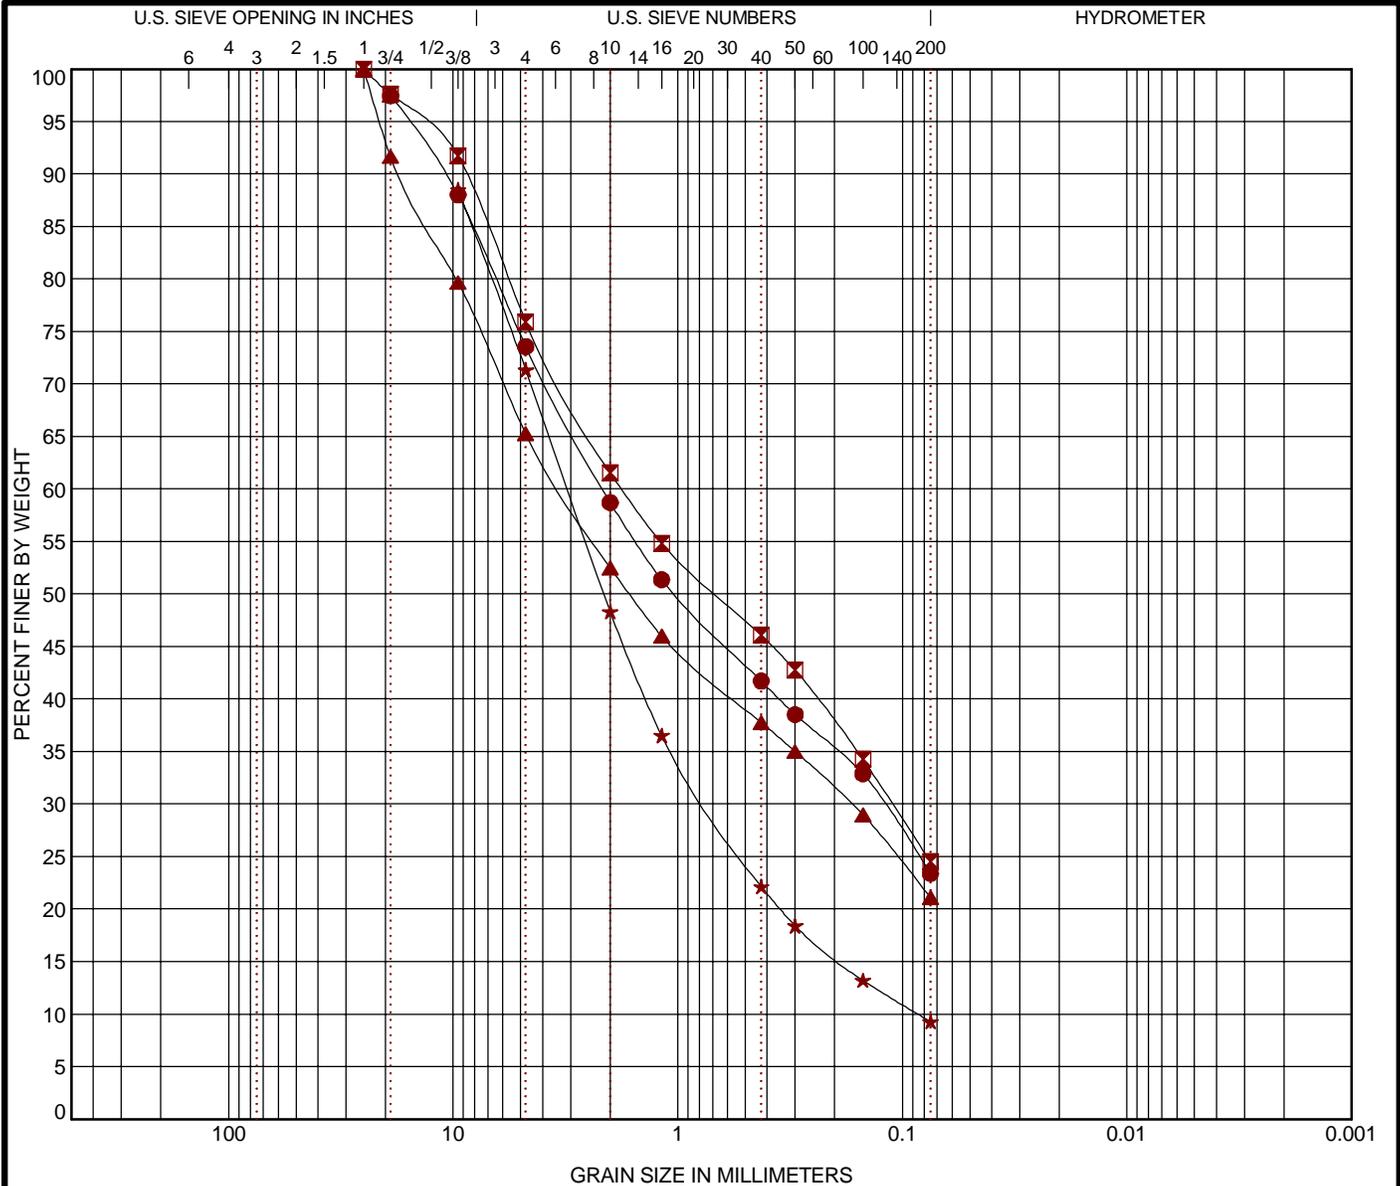
ASTM D422

# GRAIN SIZE DISTRIBUTION

Boring ID	Depth	USCS Classification	AASHTO Classification		LL	PL	PI	Cc	Cu
● B-05	1 - 2	CLAYEY SAND with GRAVEL (SC)	A-2-6(0)		32	16	16		
■ B-06	0.5 - 1.5	CLAYEY SAND with GRAVEL (SC)	A-2-6(0)		28	16	12		
▲ B-07	0.42 - 1.4	SILTY, CLAYEY SAND with GRAVEL (SC-SM)	A-2-4(0)		25	18	7		
★ B-08	1.5 - 2.5	WELL-GRADED SAND with SILT and GRAVEL (SW-SM)	A-1-a(0)		24	22	2	2.09	36.44
Boring ID	Depth	D <sub>100</sub>	D <sub>60</sub>	D <sub>30</sub>	D <sub>10</sub>	%Gravel	%Sand	%Silt	%Clay
● B-05	1 - 2	19	2.156	0.122		23.9	50.2	23.4	
■ B-06	0.5 - 1.5	25	1.773	0.111		24.1	51.4	24.5	
▲ B-07	0.42 - 1.4	25	3.326	0.169		34.7	44.2	21.1	
★ B-08	1.5 - 2.5	9.5	3.101	0.743	0.085	17.1	62.1	9.3

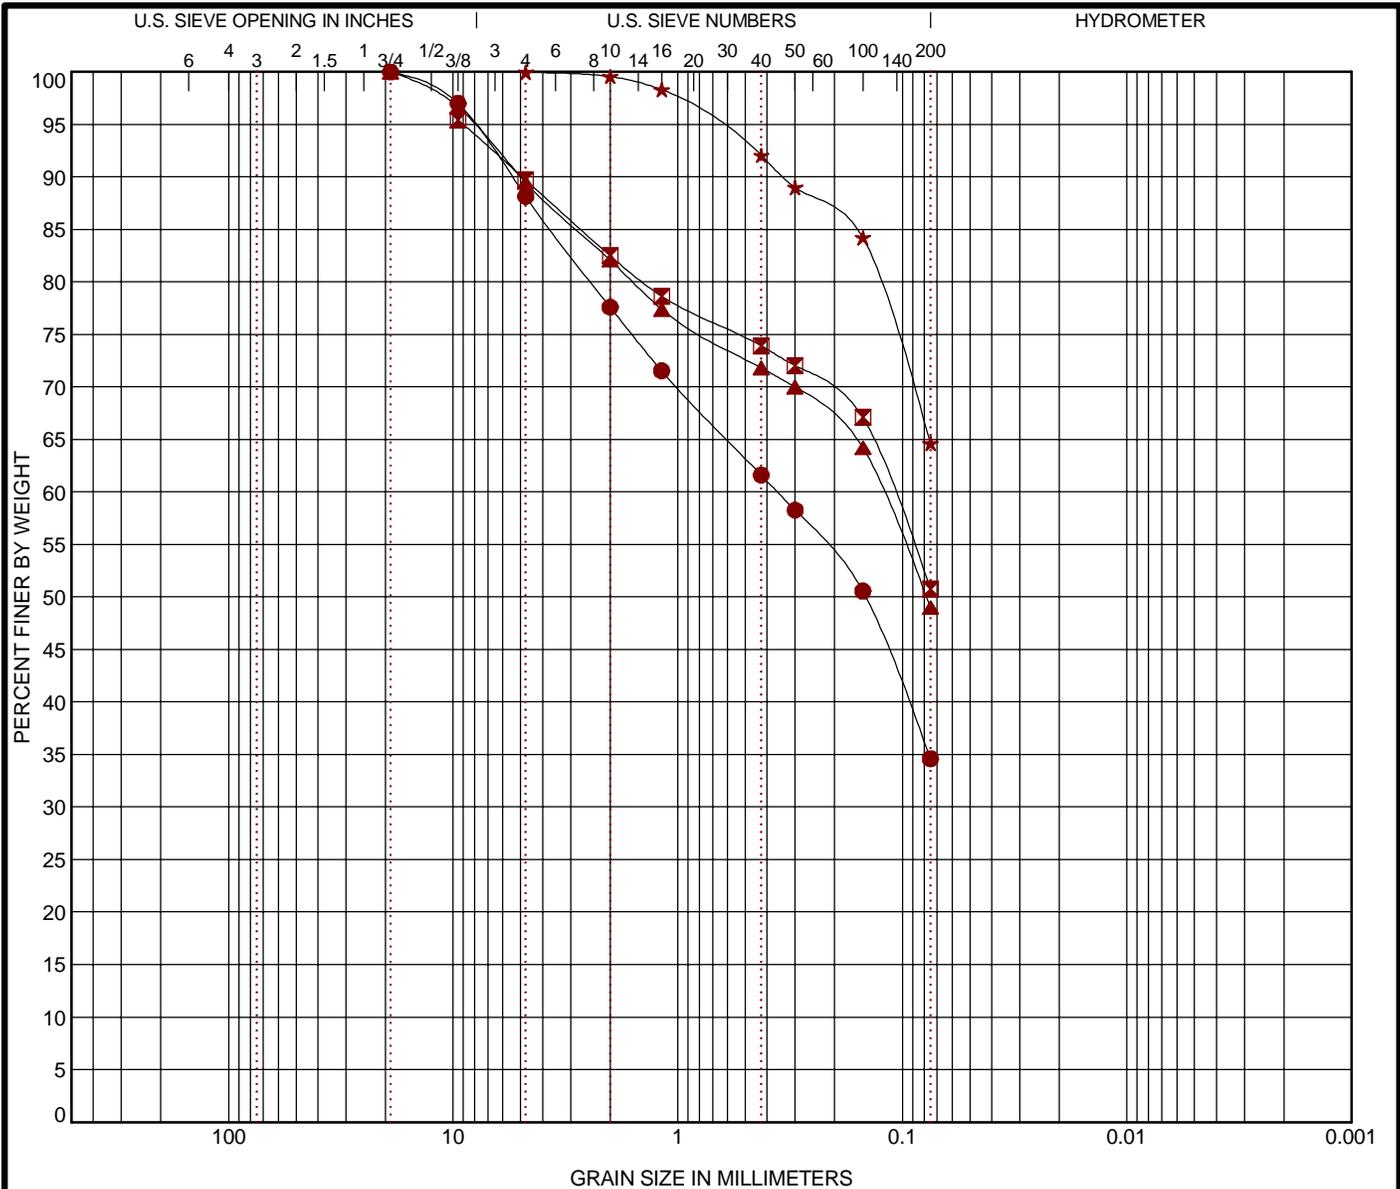
ASTM D422

# GRAIN SIZE DISTRIBUTION

Boring ID	Depth	USCS Classification		AASHTO Classification		LL	PL	PI	Cc	Cu
● B-09	1 - 2	CLAYEY SAND (SC)		A-2-6(1)		31	16	15		
■ B-10	1 - 2	SANDY LEAN CLAY (CL)		A-6(4)		33	18	15		
▲ B-11	0.5 - 1.5	CLAYEY SAND (SC)		A-6(4)		32	17	15		
★ B-15	1 - 2	SANDY FAT CLAY (CH)		A-7-6(18)		51	20	31		
Boring ID	Depth	D <sub>100</sub>	D <sub>60</sub>	D <sub>30</sub>	D <sub>10</sub>	%Gravel	%Sand	%Silt	%Clay	
● B-09	1 - 2	19	0.359			11.8	53.6	34.6		
■ B-10	1 - 2	9.5	0.111			5.7	39.0	50.8		
▲ B-11	0.5 - 1.5	19	0.124			10.5	40.5	49.0		
★ B-15	1 - 2	4.75				0.0	35.3	64.6

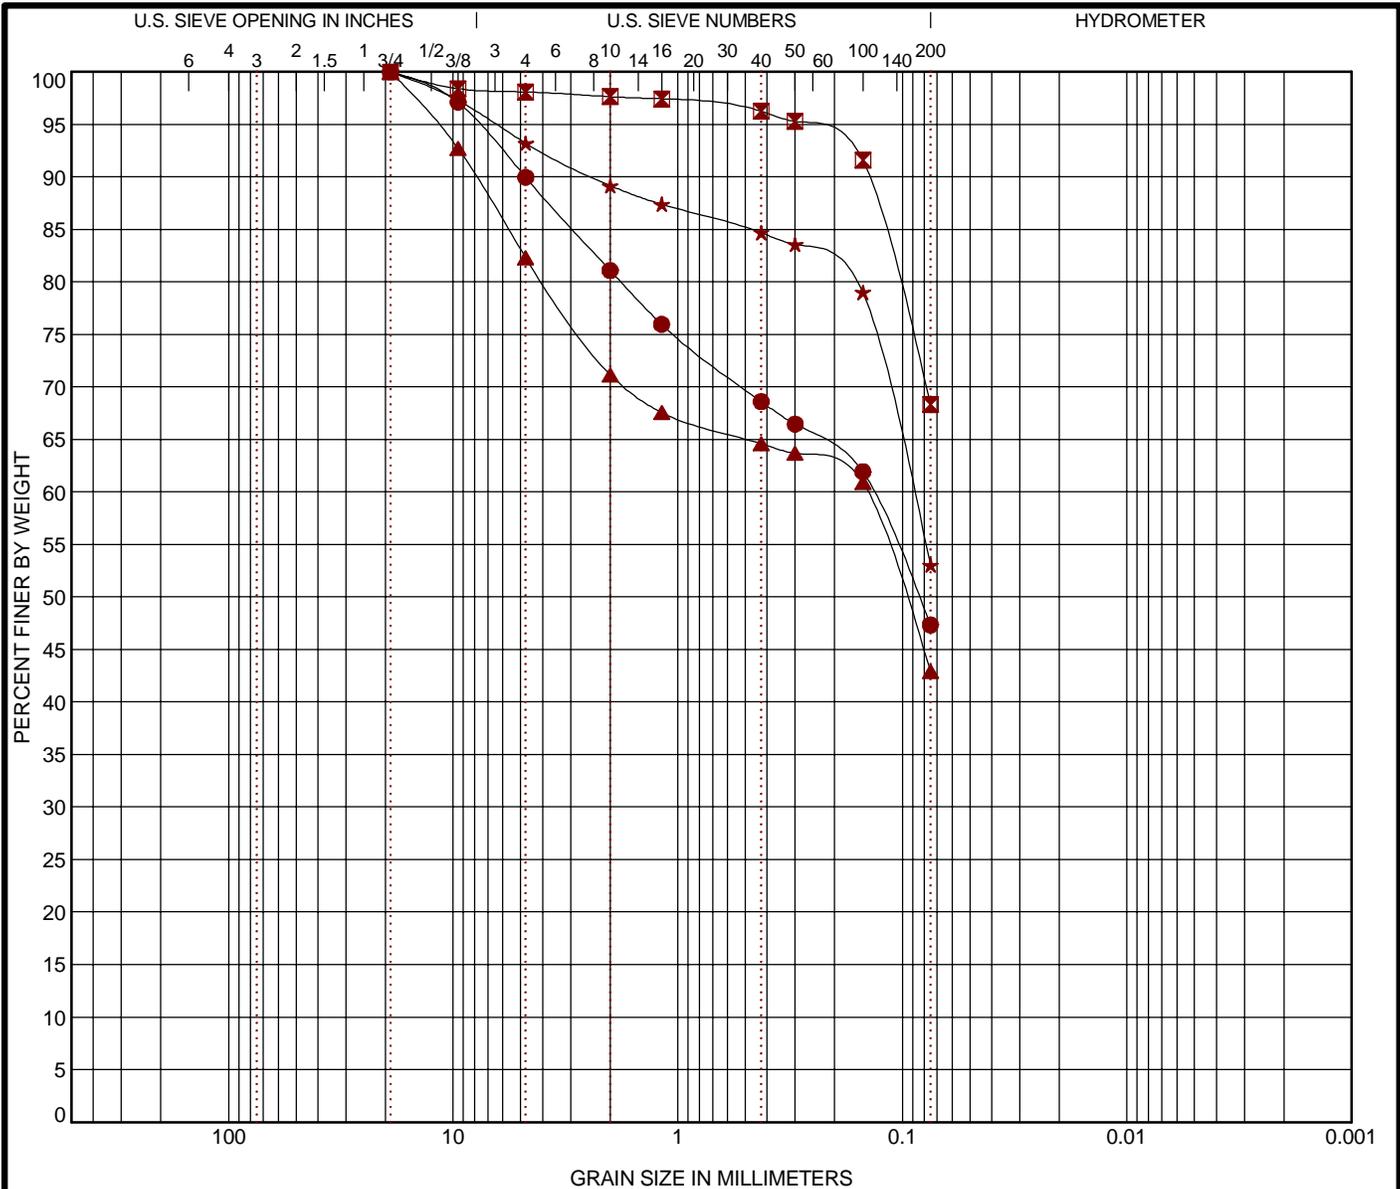
ASTM D422

# GRAIN SIZE DISTRIBUTION

Boring ID	Depth	USCS Classification	AASHTO Classification	LL	PL	PI	Cc	Cu	
●	B-17	0 - 5	CLAYEY SAND (SC)	A-6(3)	30	16	14			
☒	B-17	0.8 - 1.8	SANDY LEAN CLAY (CL)	A-6(12)	38	18	20			
▲	B-18	1 - 2	WEATHERED CLAYEY SANDSTONE	---	43	20	23			
★	B-19	1 - 2	SANDY LEAN CLAY (CL)	A-6(8)	39	17	22			
	Boring ID	Depth	D <sub>100</sub>	D <sub>60</sub>	D <sub>30</sub>	D <sub>10</sub>	%Gravel	%Sand	%Silt	%Clay
●	B-17	0 - 5	19	0.137			10.0	42.6	47.3	
☒	B-17	0.8 - 1.8	19				1.9	29.8	68.3	
▲	B-18	1 - 2	19	0.145			17.7	39.4	42.9	
★	B-19	1 - 2	19	0.09			6.8	40.2	53.0
