# Geotechnical Engineering Pavement Thickness Design Report

Centennial Boulevard Reconstruction  
West Fillmore Street to Garden of the Gods Road  
Colorado Springs, Colorado

Terracon Project No. 23155014

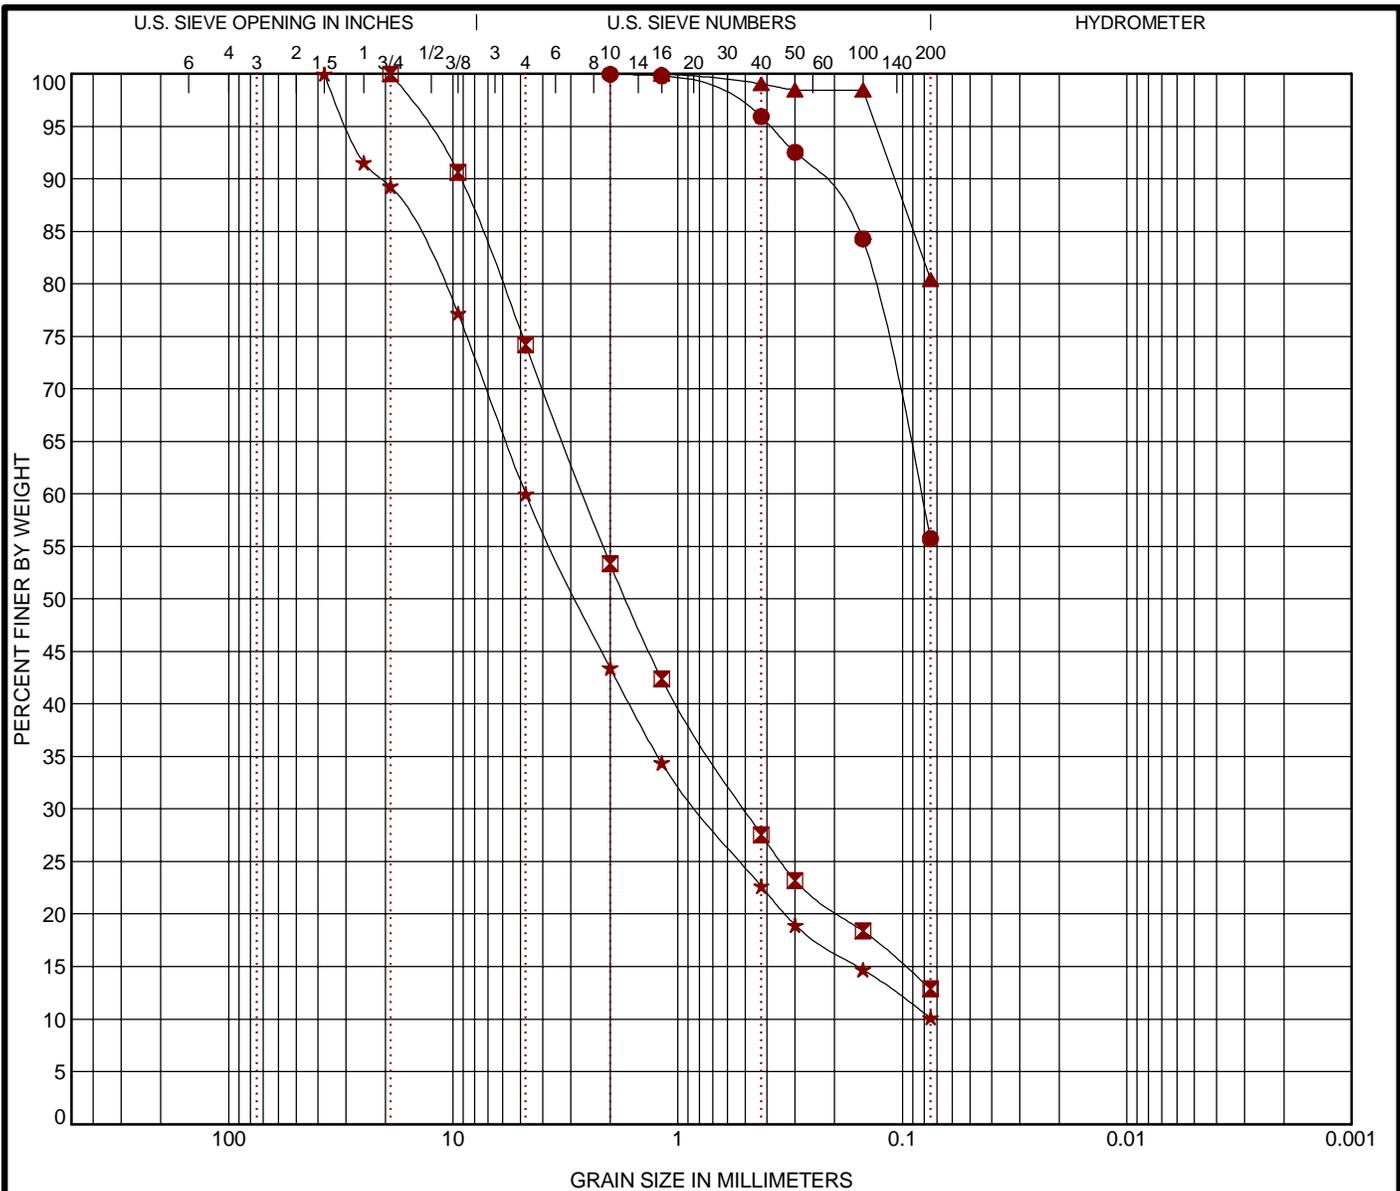
ASTM D422

# GRAIN SIZE DISTRIBUTION

Boring ID	Depth	USCS Classification	AASHTO Classification	LL	PL	PI	Cc	Cu	
●	B-20	1 - 2	SANDY LEAN CLAY (CL)	A-6(8)	40	21	19			
☒	B-21	1.7 - 2.7	SILTY, CLAYEY SAND with GRAVEL (SC-SM)	A-2-4(0)	23	16	7			
▲	B-21	4 - 5	WEATHERED SANDY CLAYSTONE	---	40	22	18			
★	B-22	1.5 - 2.5	WELL-GRADED SAND with CLAY and GRAVEL (SW-SC)	A-2-4(0)	22	12	10	1.85	64.38	
	Boring ID	Depth	D <sub>100</sub>	D <sub>60</sub>	D <sub>30</sub>	D <sub>10</sub>	%Gravel	%Sand	%Silt	%Clay
●	B-20	1 - 2	2	0.083			0.0	44.2	55.7	
☒	B-21	1.7 - 2.7	19	2.635	0.503		25.8	61.4	12.9	
▲	B-21	4 - 5	1.18				0.0	19.6	80.4	
★	B-22	1.5 - 2.5	37.5	4.747	0.805		40.0	49.9	10.1

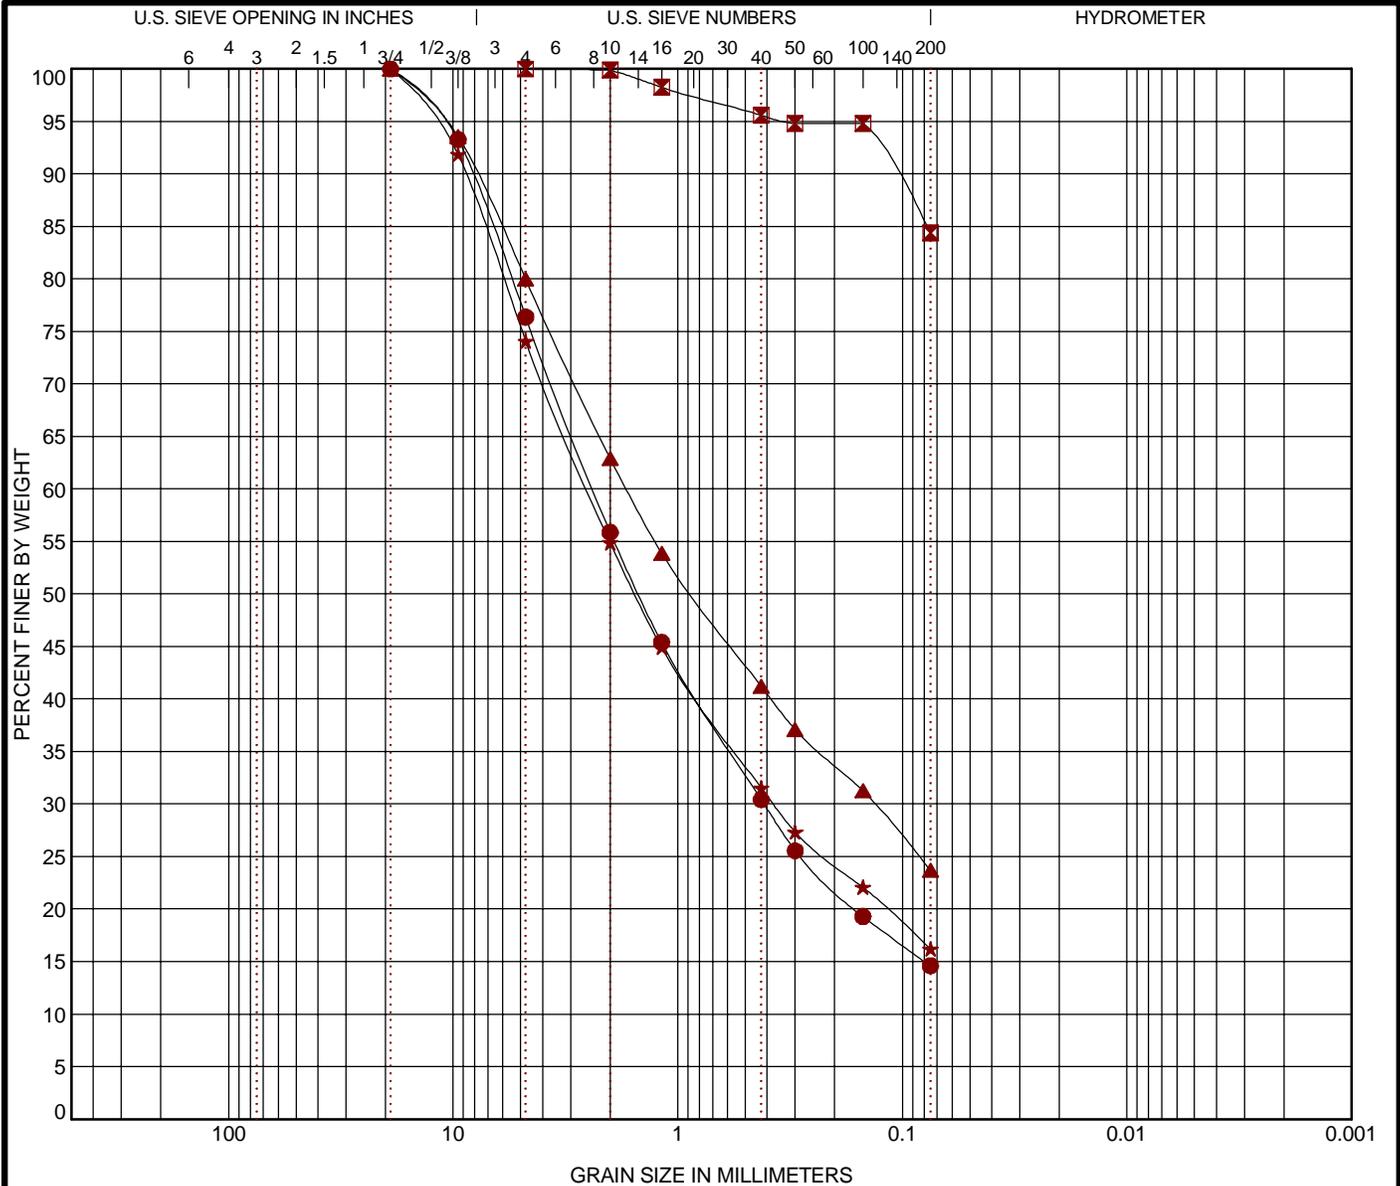
ASTM D422

# GRAIN SIZE DISTRIBUTION

Boring ID	Depth	USCS Classification	AASHTO Classification	LL	PL	PI	Cc	Cu	
●	B-23	1.5 - 2.5	CLAYEY SAND with GRAVEL (SC)	A-2-4(0)	24	15	9			
☒	B-23	4 - 5	SANDY SILTSTONE	---	84	45	39			
▲	B-24	1.5 - 2.5	CLAYEY SAND with GRAVEL (SC)	---	31	15	16			
★	B-25	1.5 - 2.5	CLAYEY SAND with GRAVEL (SC)	A-2-6(0)	26	15	11			
	Boring ID	Depth	D <sub>100</sub>	D <sub>60</sub>	D <sub>30</sub>	D <sub>10</sub>	%Gravel	%Sand	%Silt	%Clay
●	B-23	1.5 - 2.5	19	2.381	0.412		23.6	61.8		14.6
☒	B-23	4 - 5	4.75				0.0	15.6		84.4
▲	B-24	1.5 - 2.5	19	1.687	0.134		20.0	56.3		23.7
★	B-25	1.5 - 2.5	19	2.519	0.374		25.9	57.9		16.2

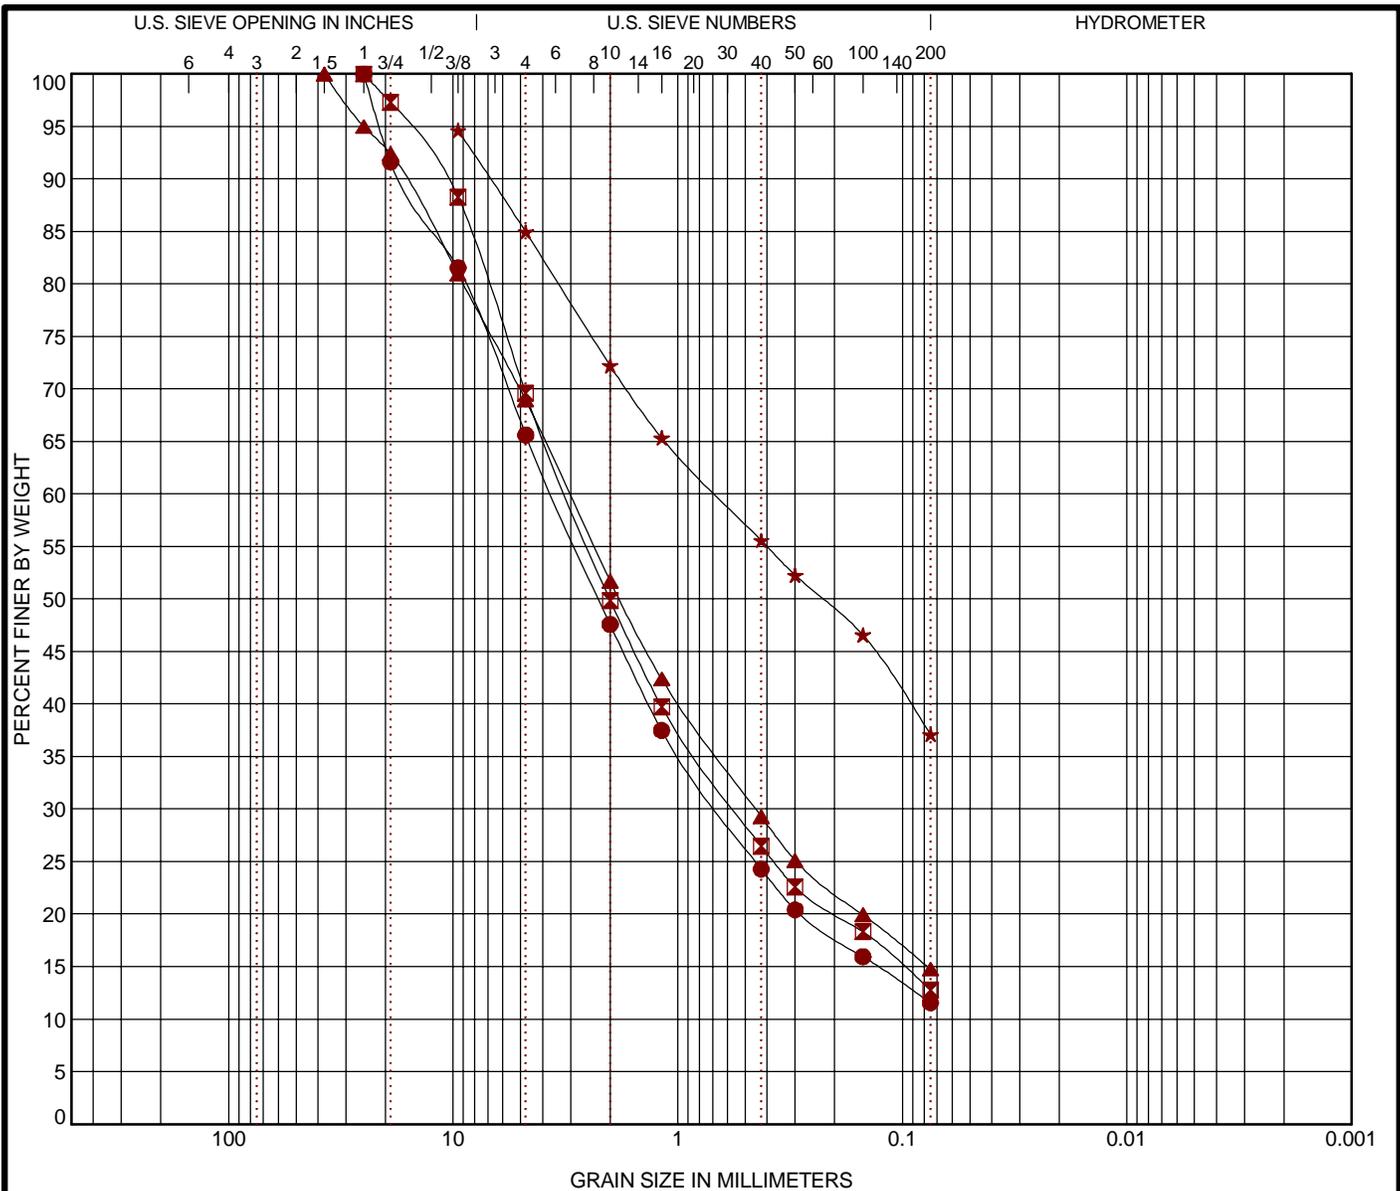
ASTM D422

# GRAIN SIZE DISTRIBUTION

Boring ID	Depth	USCS Classification	AASHTO Classification	LL	PL	PI	Cc	Cu	
●	B-26	2 - 3	WELL-GRADED SAND with CLAY and GRAVEL (SW-SC)	A-2-6(0)	27	15	12	2.06	61.96	
☒	B-27	1.5 - 2.5	CLAYEY SAND with GRAVEL (SC)	A-2-4(0)	25	16	9			
▲	B-28	2 - 3	SILTY, CLAYEY SAND with GRAVEL (SC-SM)	A-2-4(0)	22	15	7			
★	B-29	2 - 3	CLAYEY SAND with GRAVEL (SC)	A-6(2)	31	14	17			
	Boring ID	Depth	D <sub>100</sub>	D <sub>60</sub>	D <sub>30</sub>	D <sub>10</sub>	%Gravel	%Sand	%Silt	%Clay
●	B-26	2 - 3	25	3.627	0.662		34.4	54.1		11.6
☒	B-27	1.5 - 2.5	25	3.119	0.558		30.4	56.8		12.7
▲	B-28	2 - 3	37.5	3.033	0.45		31.1	54.2		14.8
★	B-29	2 - 3	9.5	0.675			9.7	47.9		37.1

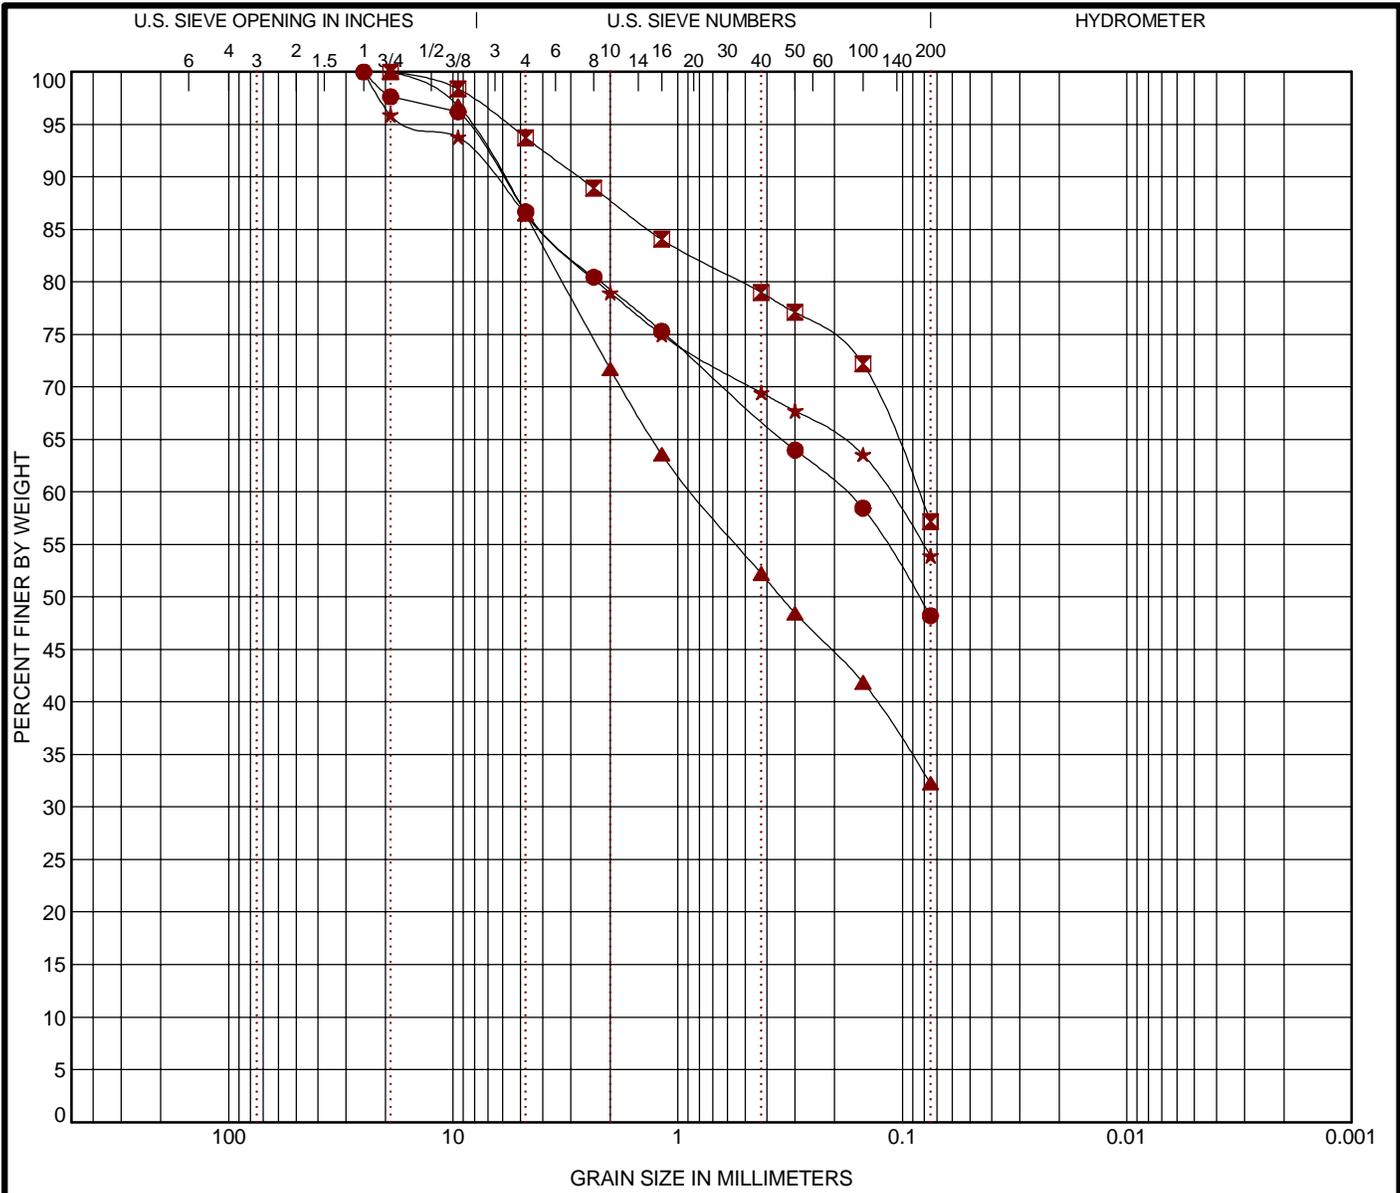
ASTM D422

# GRAIN SIZE DISTRIBUTION

Boring ID	Depth	USCS Classification	AASHTO Classification	LL	PL	PI	Cc	Cu	
●	B-30	4 - 5	CLAYEY SAND (SC)	A-7-6(6)	41	22	19			
☒	B-31	4 - 5	SANDY LEAN CLAY (CL)	A-6(7)	33	15	18			
▲	B-32	2 - 3	CLAYEY SAND (SC)	A-2-6(1)	28	15	13			
★	B-33	2 - 3	SANDY LEAN CLAY (CL)	A-7-6(8)	41	20	21			
	Boring ID	Depth	D <sub>100</sub>	D <sub>60</sub>	D <sub>30</sub>	D <sub>10</sub>	%Gravel	%Sand	%Silt	%Clay
●	B-30	4 - 5	25	0.182			13.3	38.5	48.2	
☒	B-31	4 - 5	19	0.085			6.3	36.5	57.2	
▲	B-32	2 - 3	19	0.853			13.5	54.2	32.3	
★	B-33	2 - 3	25	0.116			13.6	32.5	53.9

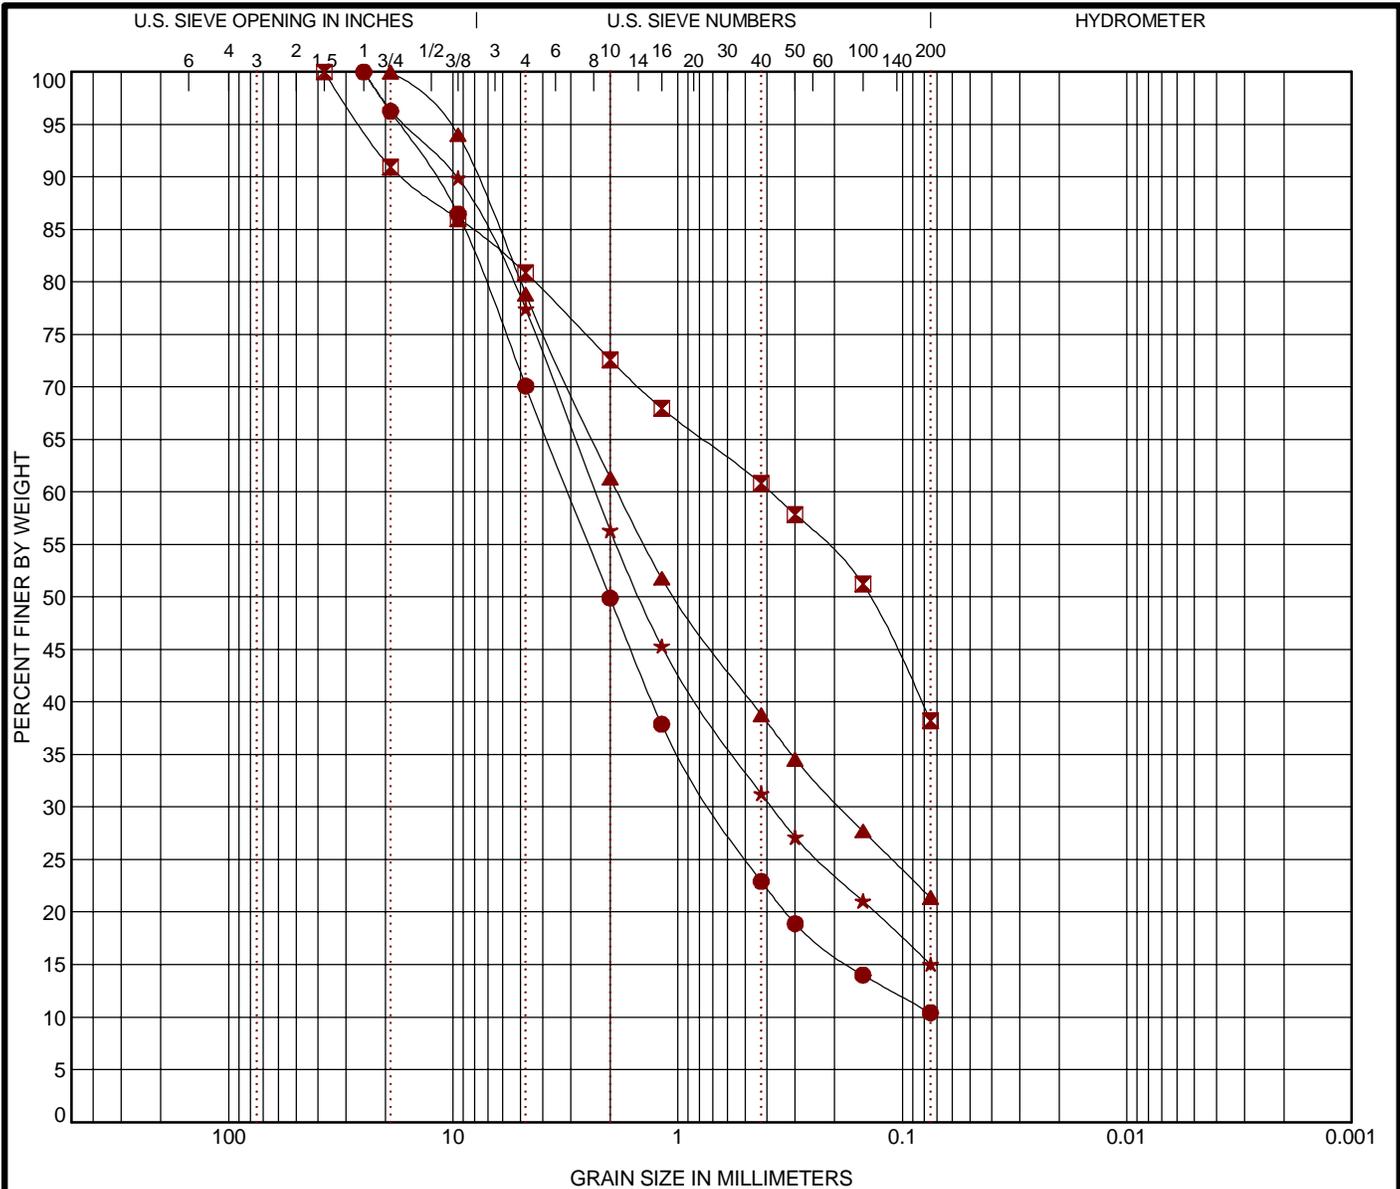
ASTM D422

# GRAIN SIZE DISTRIBUTION

Boring ID	Depth	USCS Classification	AASHTO Classification			LL	PL	PI	Cc	Cu	
●	B-39	0.67 - 1.7	WELL-GRADED SAND with CLAY and GRAVEL (SW-SC)			A-2-4(0)	24	15	9	2.22	44.51
☒	B-40	0.5 - 1.5	CLAYEY SAND with GRAVEL (SC)			A-6(2)	32	16	16		
▲	B-41	0 - 5	CLAYEY SAND with GRAVEL (SC)			A-2-6(0)	27	16	11		
★	B-41	0.67 - 1.7	CLAYEY SAND with GRAVEL (SC)			A-2-4(0)	25	17	8		
Boring ID	Depth	D <sub>100</sub>	D <sub>60</sub>	D <sub>30</sub>	D <sub>10</sub>	%Gravel	%Sand	%Silt	%Clay		
●	B-39	0.67 - 1.7	25	3.083	0.689	29.9	59.7	10.4			
☒	B-40	0.5 - 1.5	37.5	0.386		19.1	42.7	38.2			
▲	B-41	0 - 5	19	1.856	0.189	21.1	57.5	21.4			
★	B-41	0.67 - 1.7	25	2.323	0.382	22.6	62.4	15.0

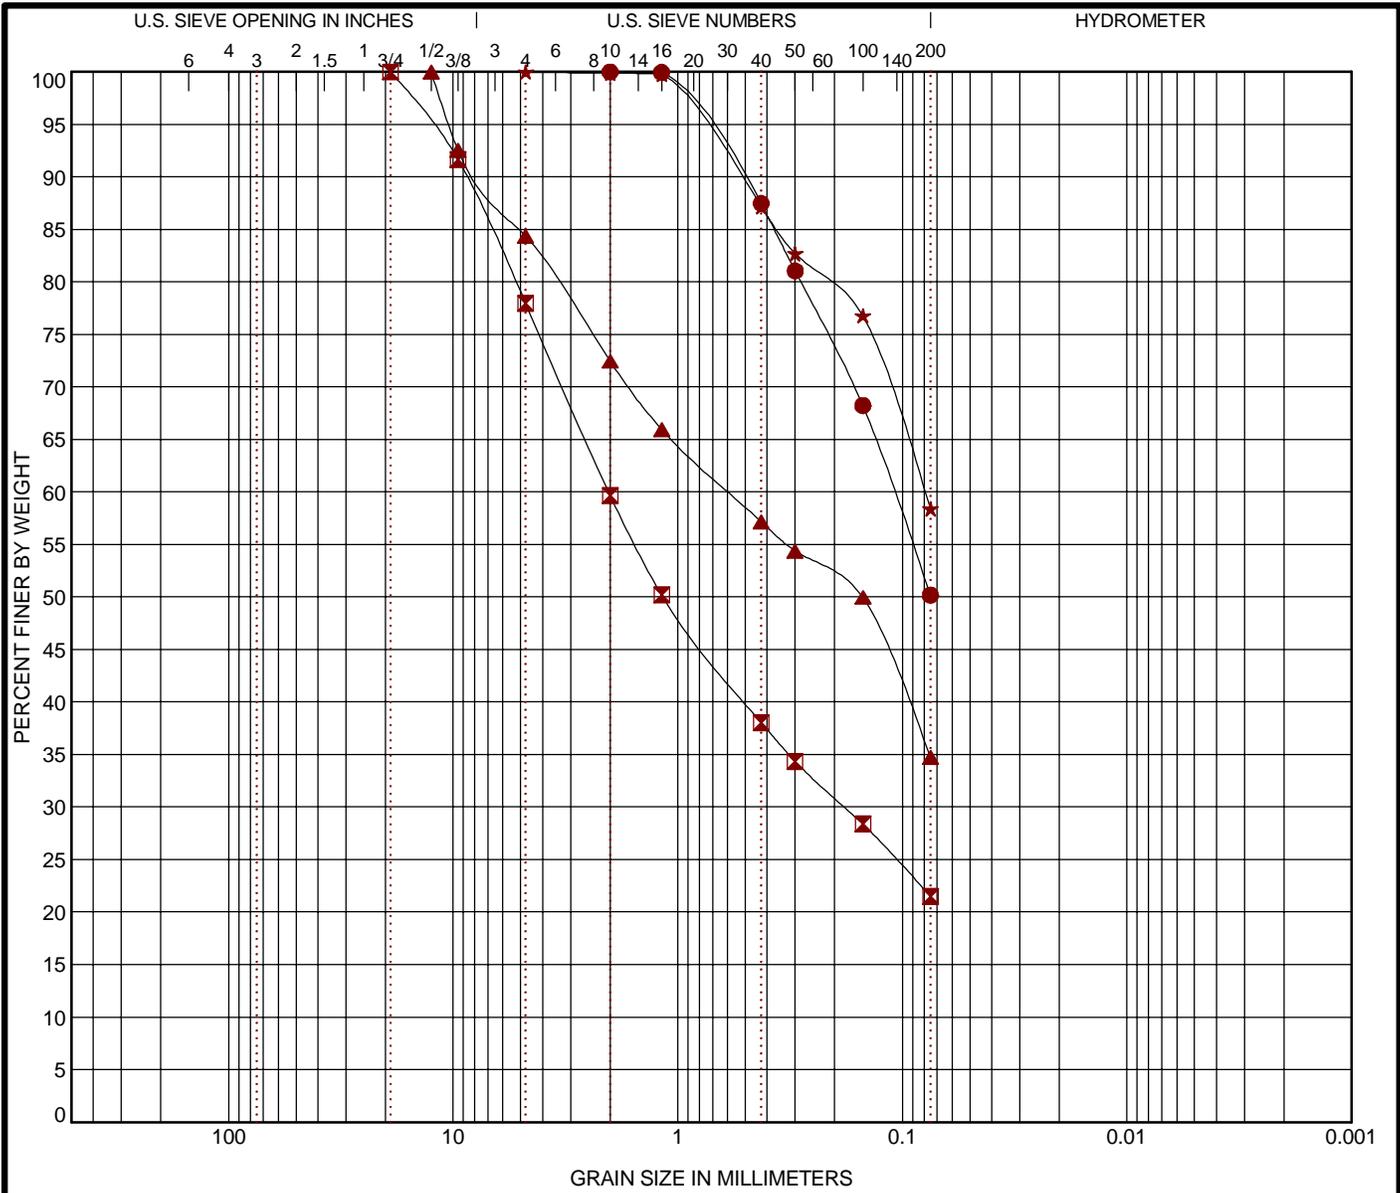
ASTM D422

# GRAIN SIZE DISTRIBUTION

Boring ID	Depth	USCS Classification	AASHTO Classification	LL	PL	PI	Cc	Cu	
●	B-41	4 - 5	SANDY LEAN CLAY (CL)	A-7-6(8)	47	25	22			
☒	B-42	0.5 - 1.5	CLAYEY SAND with GRAVEL (SC)	A-2-4(0)	26	17	9			
▲	B-43	0.75 - 1.8	CLAYEY SAND with GRAVEL (SC)	A-2-6(1)	36	19	17			
★	B-43	4 - 5	SANDY CLAYSTONE	---	38	20	18			
●	Boring ID	Depth	D <sub>100</sub>	D <sub>60</sub>	D <sub>30</sub>	D <sub>10</sub>	%Gravel	%Sand	%Silt	%Clay
●	B-41	4 - 5	2	0.109			0.0	49.8	50.2	
☒	B-42	0.5 - 1.5	19	2.032	0.181		22.1	56.4	21.5	
▲	B-43	0.75 - 1.8	12.5	0.591			15.6	49.6	34.7	
★	B-43	4 - 5	4.75	0.08			0.0	41.6	58.4

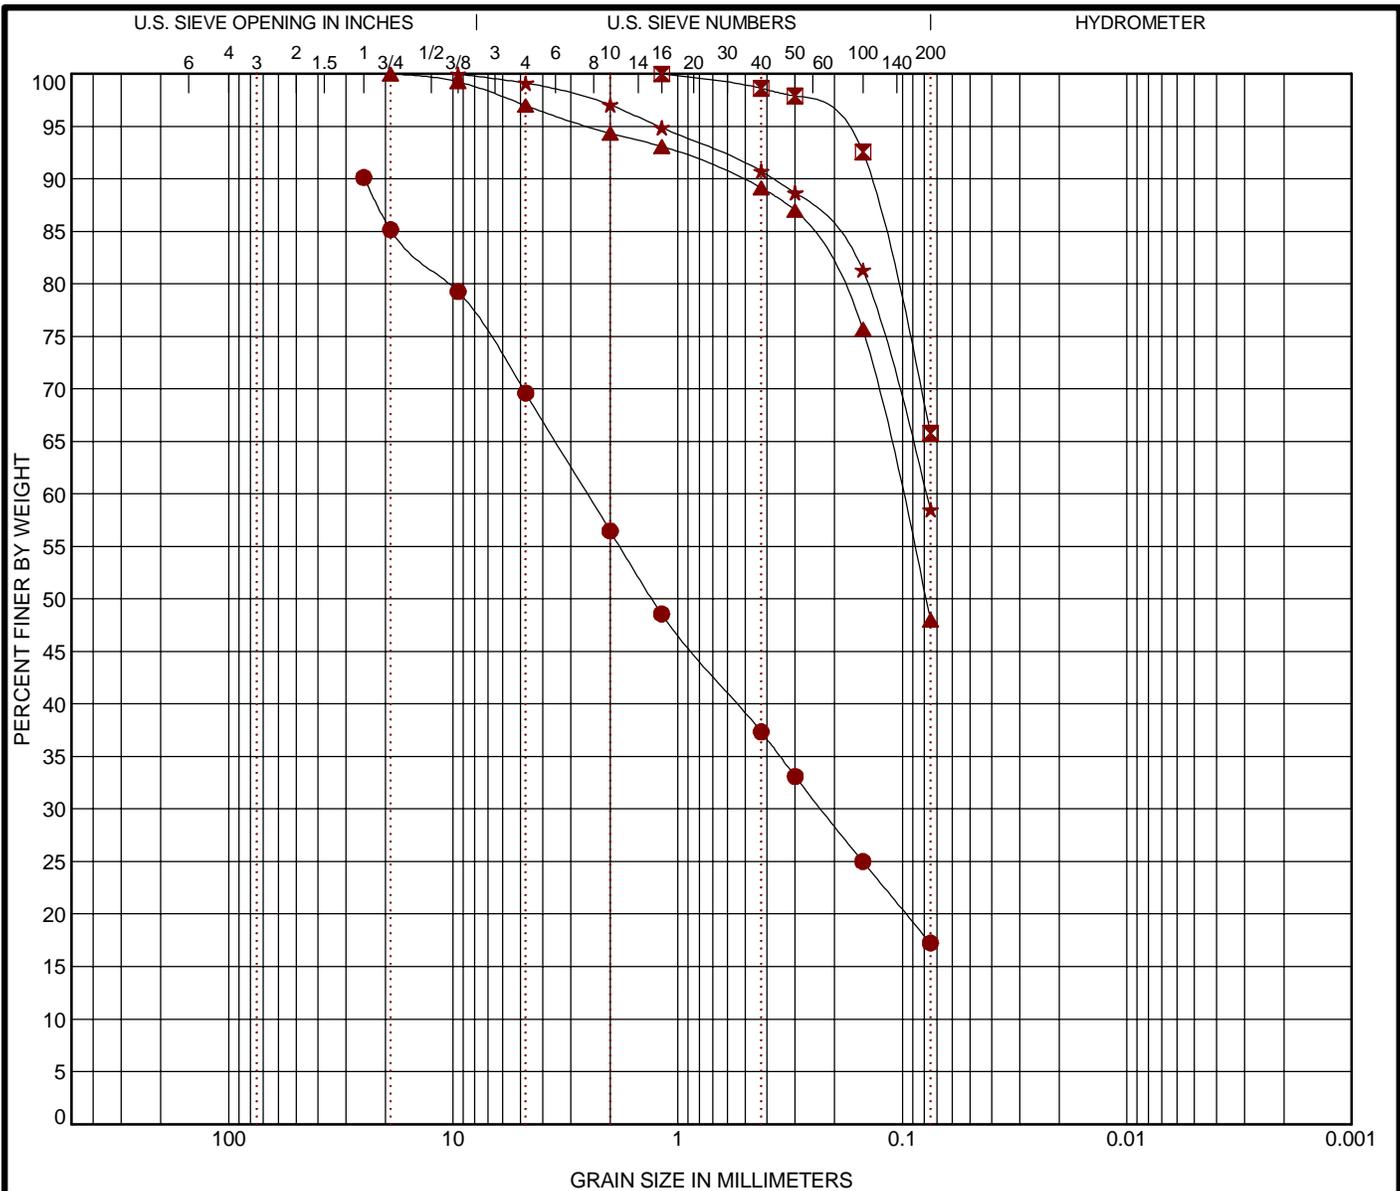
ASTM D422

# GRAIN SIZE DISTRIBUTION

Boring ID	Depth	USCS Classification	AASHTO Classification			LL	PL	PI	Cc	Cu
● B-44	0.75 - 1.8	CLAYEY SAND with GRAVEL (SC)	A-2-4(0)			22	14	8		
☒ B-44	4 - 5	SANDY CLAYSTONE	---			40	22	18		
▲ B-45	0.58 - 1.6	CLAYEY SAND (SC)	---			38	19	19		
★ B-46	0.44 - 1.4	SANDY SILT (ML)	A-4(4)			34	24	10		
Boring ID	Depth	D <sub>100</sub>	D <sub>60</sub>	D <sub>30</sub>	D <sub>10</sub>	%Gravel	%Sand	%Silt	%Clay	
● B-44	0.75 - 1.8	25	2.521	0.23		20.5	52.4	17.2		
☒ B-44	4 - 5	1.18				0.0	34.2	65.8		
▲ B-45	0.58 - 1.6	19	0.101			3.0	49.0	48.0		
★ B-46	0.44 - 1.4	9.5	0.078			0.9	40.6	58.5

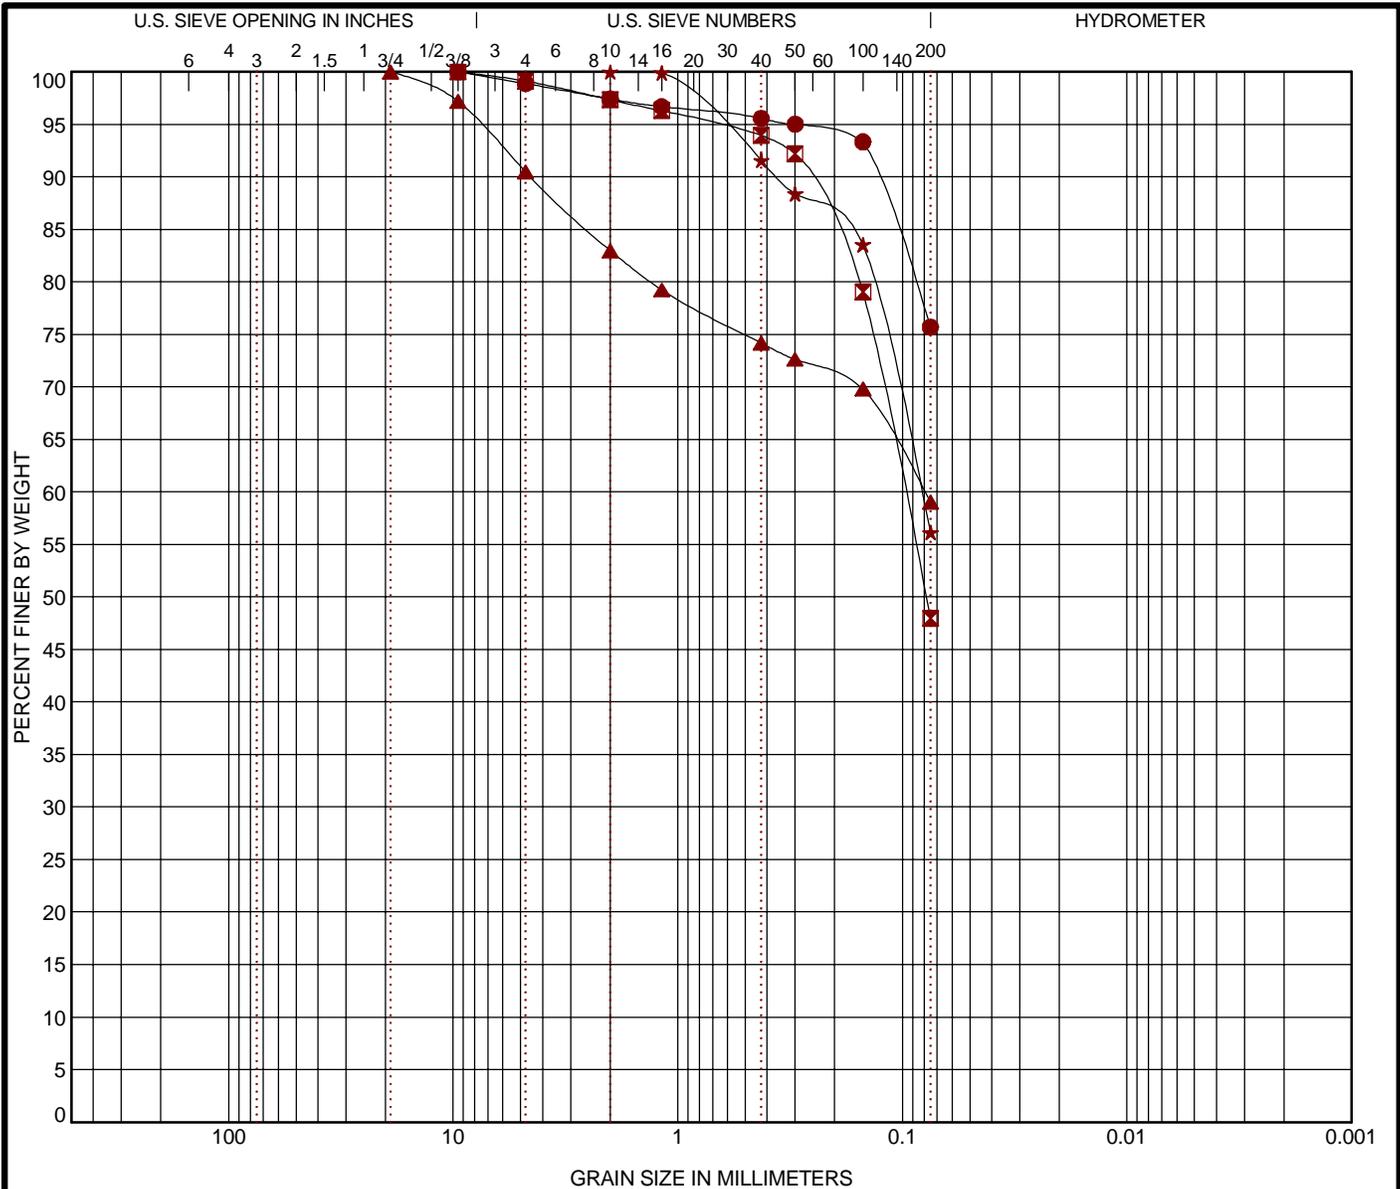
ASTM D422

# GRAIN SIZE DISTRIBUTION

Boring ID	Depth	USCS Classification	AASHTO Classification	LL	PL	PI	Cc	Cu	
●	B-47	0.33 - 1.3	LEAN CLAY with SAND (CL)	A-6(16)	40	18	22			
☒	B-48	0.33 - 1.3	CLAYEY SAND (SC)	A-4(2)	27	17	10			
▲	B-49	0 - 5	SANDY CLAYSTONE	---	37	16	21			
★	B-49	0.5 - 1.5	WEATHERED CLAYSTONE	---	38	20	18			
	Boring ID	Depth	D <sub>100</sub>	D <sub>60</sub>	D <sub>30</sub>	D <sub>10</sub>	%Gravel	%Sand	%Silt	%Clay
●	B-47	0.33 - 1.3	9.5				1.1	23.2	75.7	
☒	B-48	0.33 - 1.3	9.5	0.098			0.9	51.2	48.0	
▲	B-49	0 - 5	19	0.08			9.5	31.5	59.0	
★	B-49	0.5 - 1.5	2	0.083			0.0	43.9	56.1

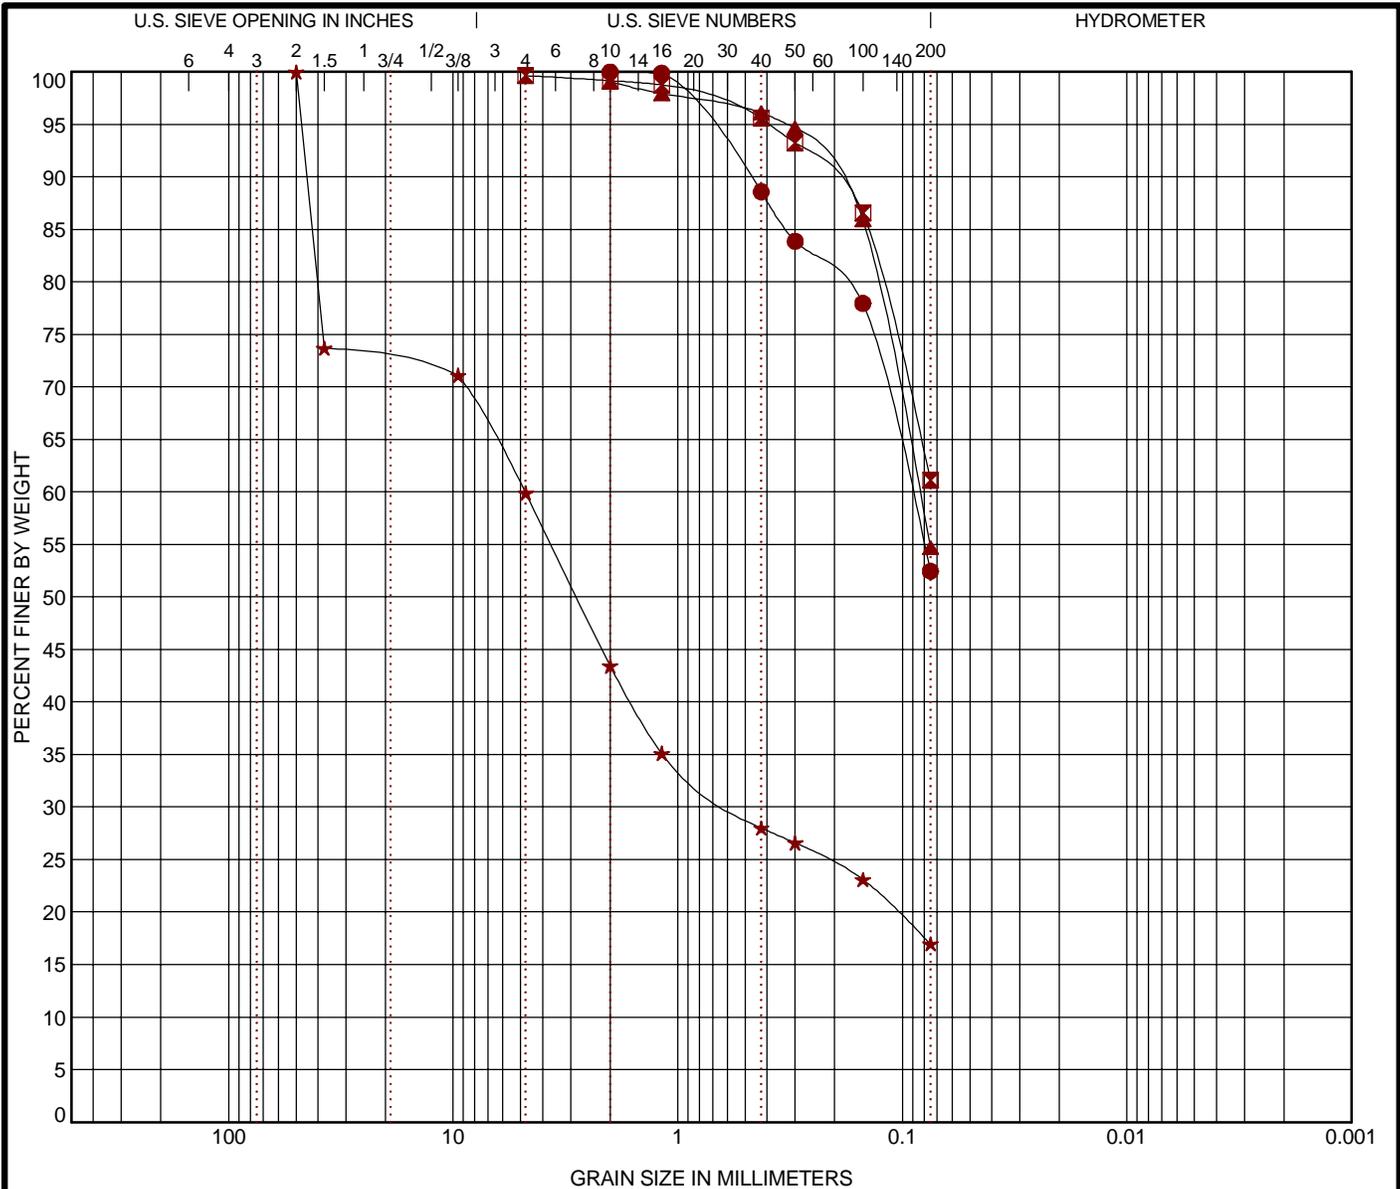
ASTM D422

# GRAIN SIZE DISTRIBUTION

Boring ID	Depth	USCS Classification	AASHTO Classification			LL	PL	PI	Cc	Cu
● B-49	4 - 5	SANDY CLAYSTONE	---			48	24	24		
◻ B-50	0.5 - 1.5	SANDY LEAN CLAY (CL)	A-7-6(15)			48	19	29		
▲ B-51	1.3 - 2.3	SANDY LEAN CLAY (CL)	A-6(4)			35	24	11		
★ B-52	1 - 2	CLAYEY SAND with GRAVEL (SC)	A-2-6(0)			35	17	18		
Boring ID	Depth	D <sub>100</sub>	D <sub>60</sub>	D <sub>30</sub>	D <sub>10</sub>	%Gravel	%Sand	%Silt	%Clay	
● B-49	4 - 5	2	0.092			0.0	47.5	52.5		
◻ B-50	0.5 - 1.5	4.75				0.0	38.5	61.1		
▲ B-51	1.3 - 2.3	2	0.084			0.0	44.4	54.7		
★ B-52	1 - 2	50	4.779	0.567		40.1	42.9	17.0

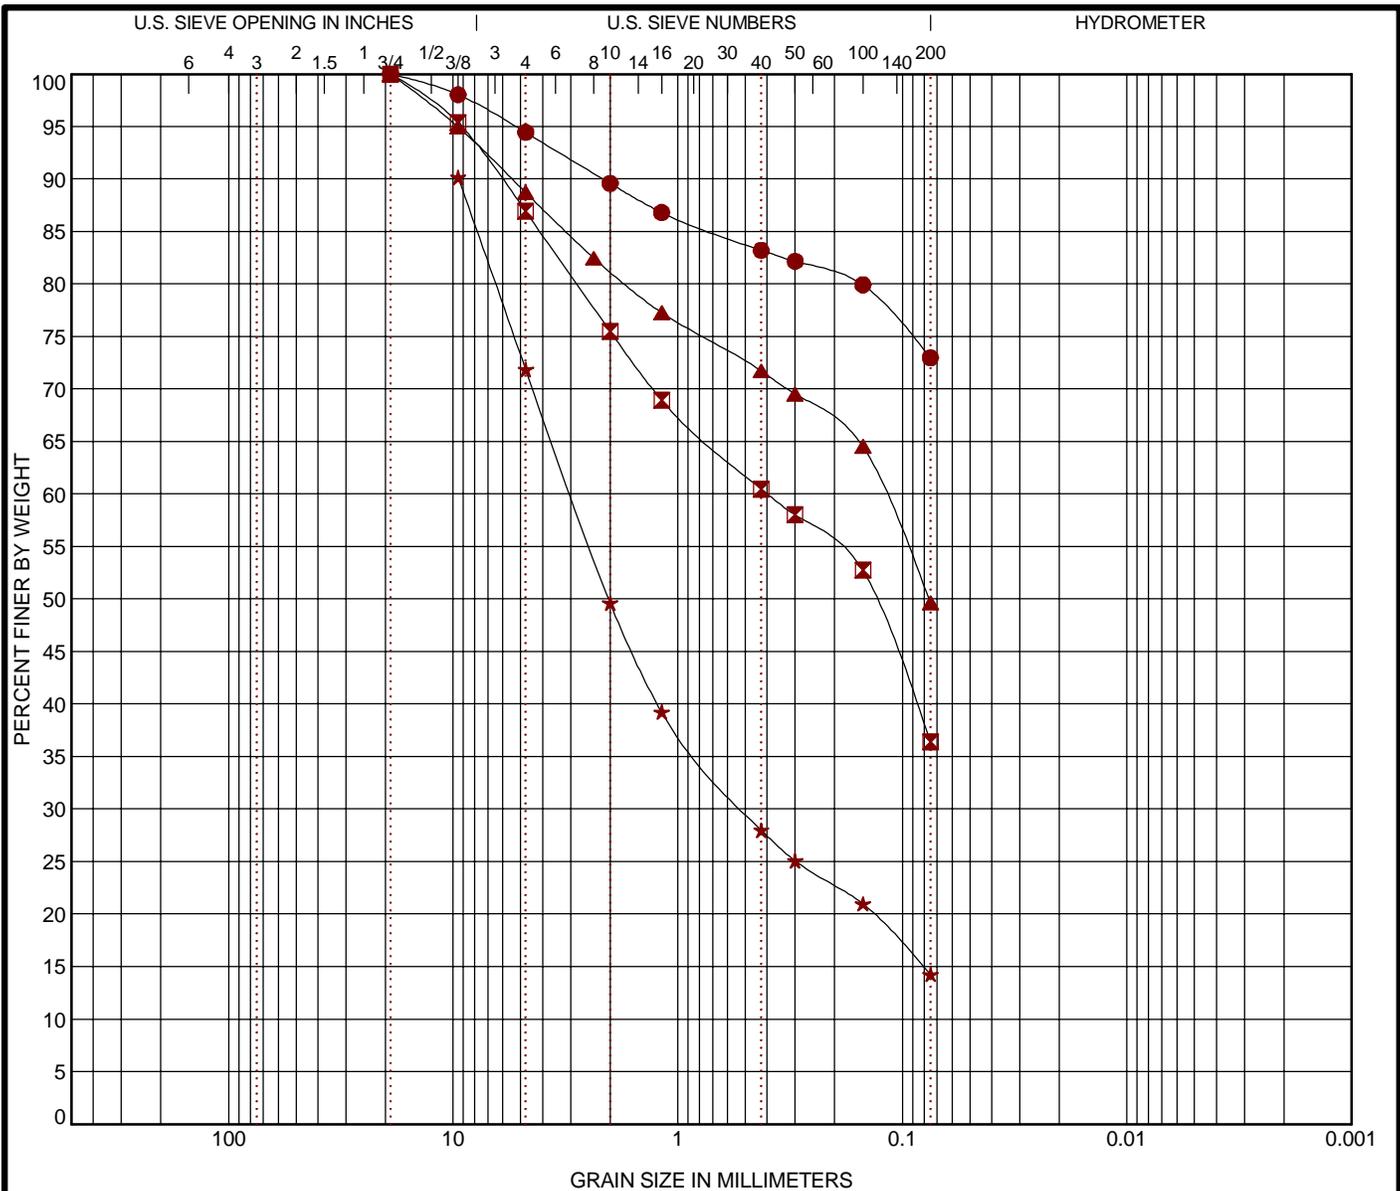
# GRAIN SIZE DISTRIBUTION

Boring ID	Depth	USCS Classification	AASHTO Classification	LL	PL	PI	Cc	Cu	
●	B-53	0 - 5	WEATHERED SANDY CLAYSTONE	---	38	18	20			
☒	B-53	1 - 2	WEATHERED CLAYEY SANDSTONE	---	38	18	20			
▲	B-54	4 - 5	CLAYEY SAND (SC)	A-6(7)	38	17	21			
★	B-55	1 - 2	CLAYEY SAND with GRAVEL (SC)	A-2-6(0)	28	16	12			
	Boring ID	Depth	D <sub>100</sub>	D <sub>60</sub>	D <sub>30</sub>	D <sub>10</sub>	%Gravel	%Sand	%Silt	%Clay
●	B-53	0 - 5	19				5.6	21.5	73.0	
☒	B-53	1 - 2	19	0.398			13.1	50.5	36.4	
▲	B-54	4 - 5	19	0.121			11.3	39.1	49.6	
★	B-55	1 - 2	9.5	2.996	0.511		18.3	57.6	14.3

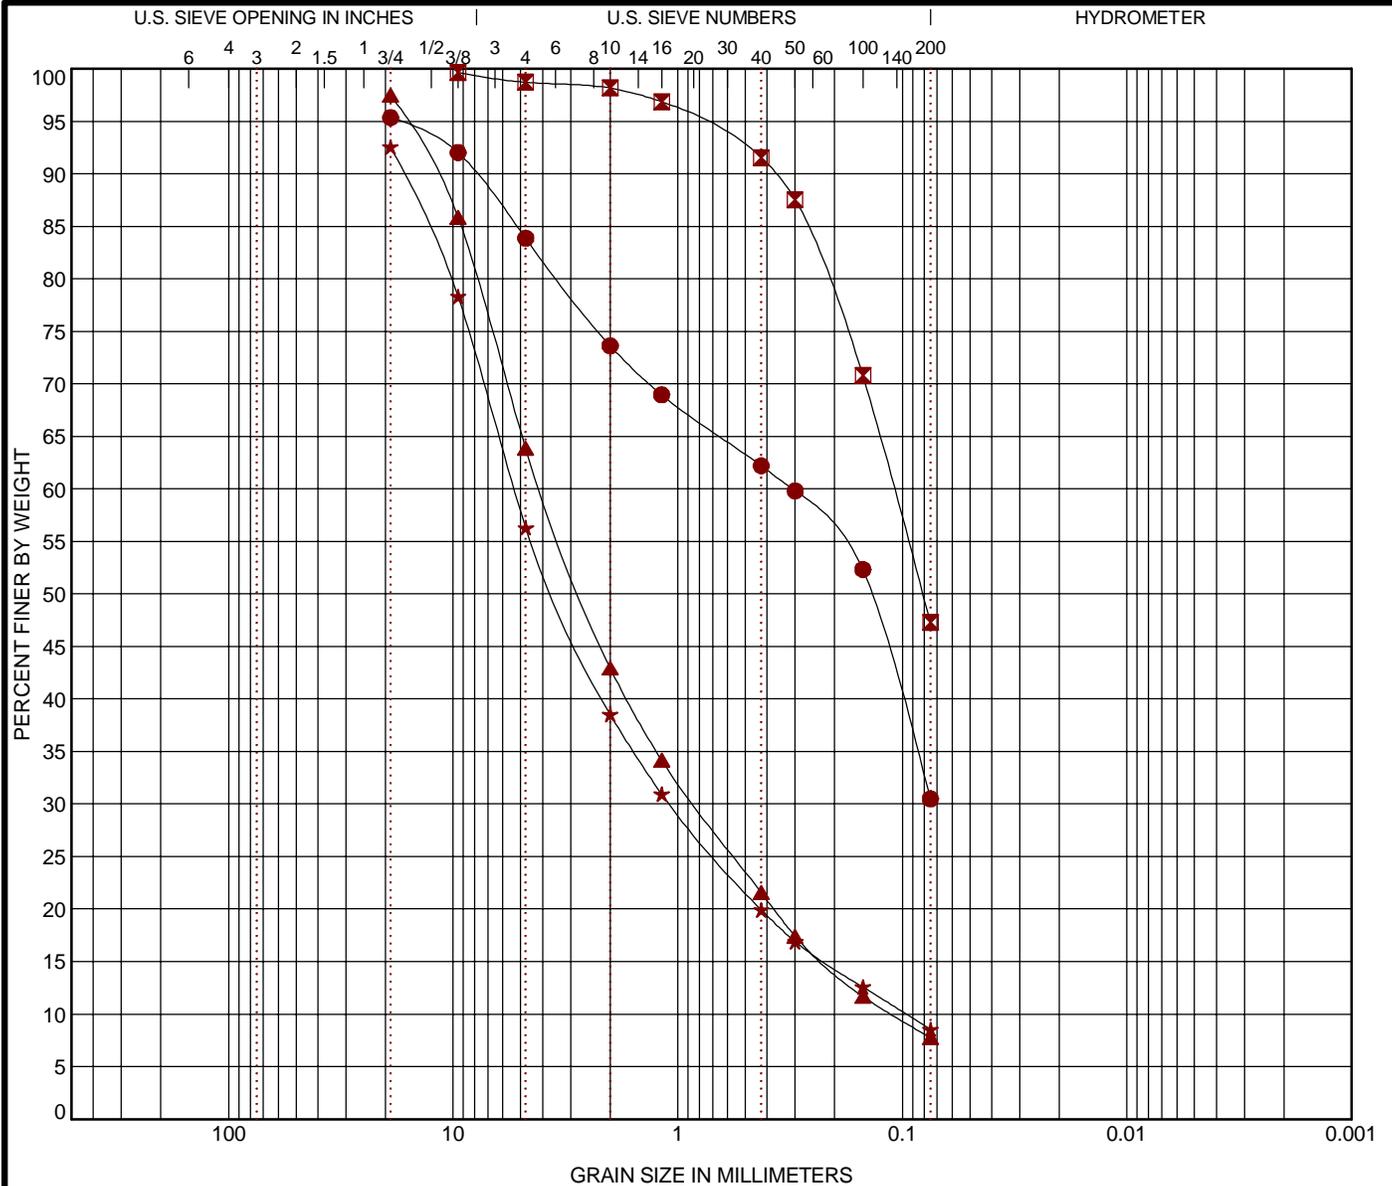
# GRAIN SIZE DISTRIBUTION

Boring ID	Depth	USCS Classification	AASHTO Classification	LL	PL	PI	Cc	Cu	
●	B-56	1 - 2	CLAYEY SAND with GRAVEL (SC)	A-2-4(0)	24	15	9			
☒	B-57	4 - 5	CLAYEY SAND (SC)	A-6(2)	26	15	11			
▲	B-58	1.2 - 2.2	WELL-GRADED SAND with SILT and GRAVEL (SW-SM)	A-1-a(0)	NP	NP	NP	1.57	36.34	
★	B-59	1.2 - 2.2	WELL-GRADED SAND with SILTY CLAY and GRAVEL (SW-SC)	A-1-a(0)	25	19	6	2.28	55.39	
	Boring ID	Depth	D <sub>100</sub>	D <sub>60</sub>	D <sub>30</sub>	D <sub>10</sub>	%Gravel	%Sand	%Silt	%Clay
●	B-56	1 - 2	19	0.308			11.5	53.4	30.5	
☒	B-57	4 - 5	9.5	0.109			0.9	51.5	47.3	
▲	B-58	1.2 - 2.2	19	4.05	0.842	0.111	33.6	56.1	7.8	
★	B-59	1.2 - 2.2	19	5.334	1.081	0.096	36.3	47.8	8.5

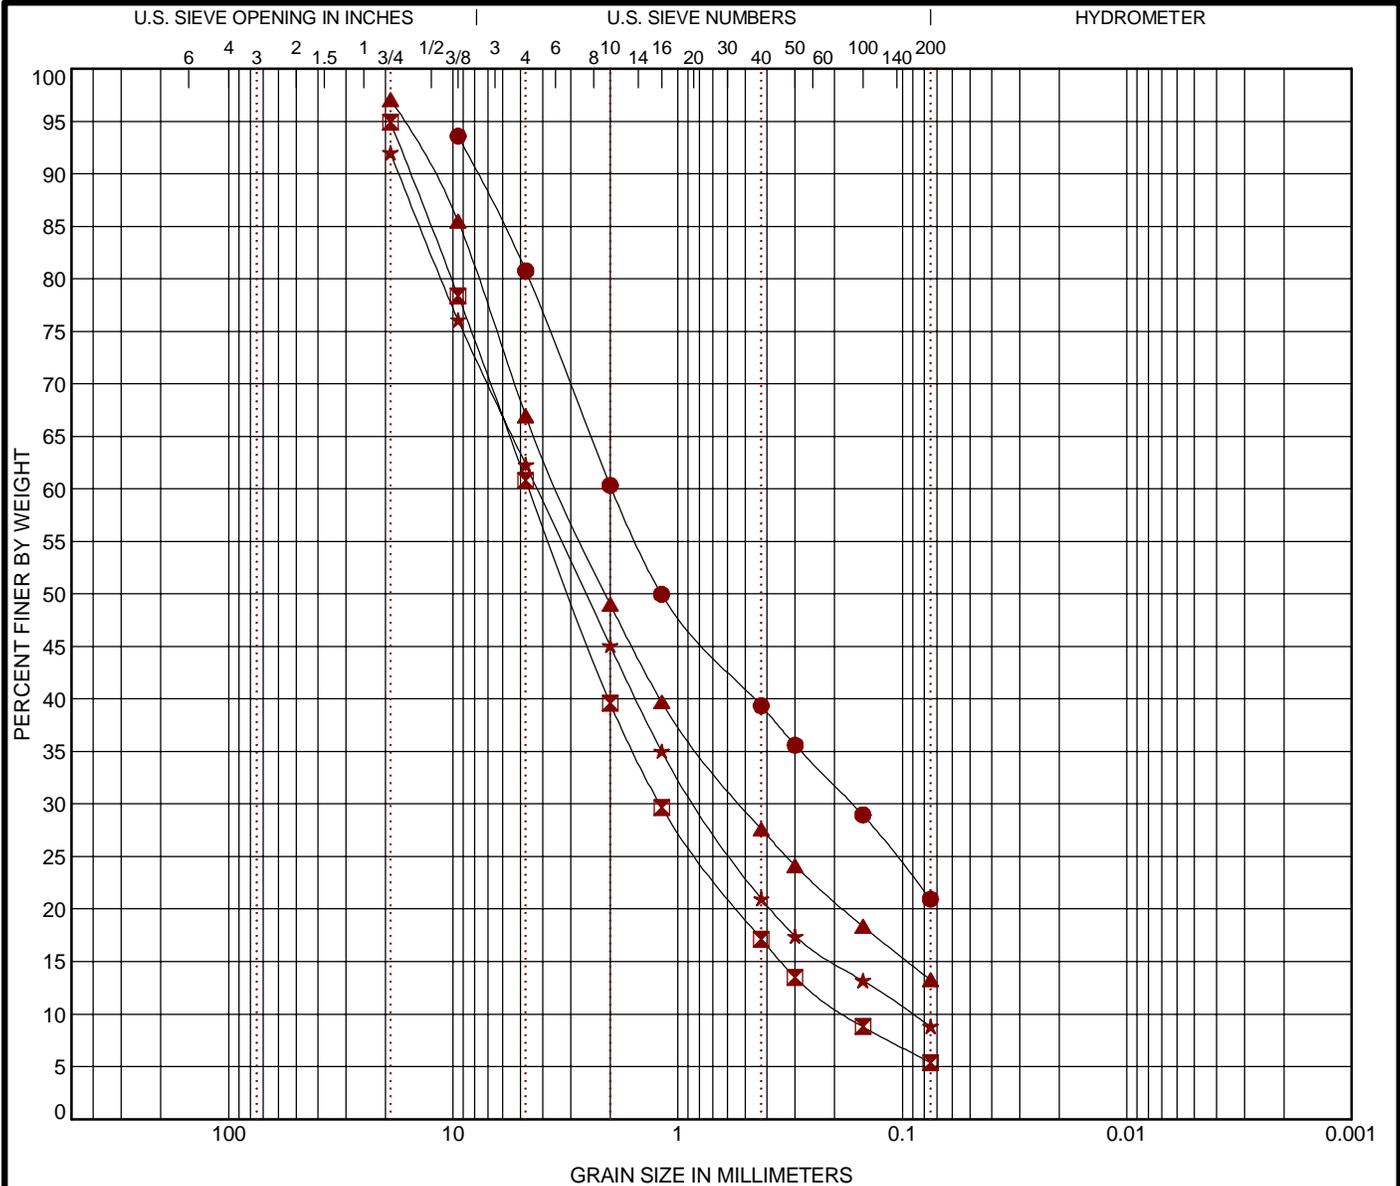
# GRAIN SIZE DISTRIBUTION

Boring ID	Depth	USCS Classification	AASHTO Classification	LL	PL	PI	Cc	Cu	
●	B-60	1.5 - 2.5	CLAYEY SAND with GRAVEL (SC)	A-2-4(0)	23	15	8			
☒	B-61	1.5 - 2.5	WELL-GRADED SAND with SILT and GRAVEL (SW-SM)	A-1-a(0)	NP	NP	NP	1.75	25.60	
▲	B-62	1.5 - 2.5	CLAYEY SAND with GRAVEL (SC)	A-2-6(0)	27	16	11			
★	B-63	1.5 - 2.5	WELL-GRADED SAND with SILTY CLAY and GRAVEL (SW-SC)	A-2-4(0)	21	14	7	1.75	46.74	
	Boring ID	Depth	D <sub>100</sub>	D <sub>60</sub>	D <sub>30</sub>	D <sub>10</sub>	%Gravel	%Sand	%Silt	%Clay
●	B-60	1.5 - 2.5	9.5	1.966	0.167		12.8	59.8	20.9	
☒	B-61	1.5 - 2.5	19	4.593	1.2	0.179	34.1	55.4	5.4	
▲	B-62	1.5 - 2.5	19	3.395	0.52		30.1	53.7	13.3	
★	B-63	1.5 - 2.5	19	4.227	0.819	0.09	29.7	53.5	8.8
