# Geotechnical Engineering Pavement Thickness Design Report

Centennial Boulevard Reconstruction  
West Fillmore Street to Garden of the Gods Road  
Colorado Springs, Colorado

Terracon Project No. 23155014

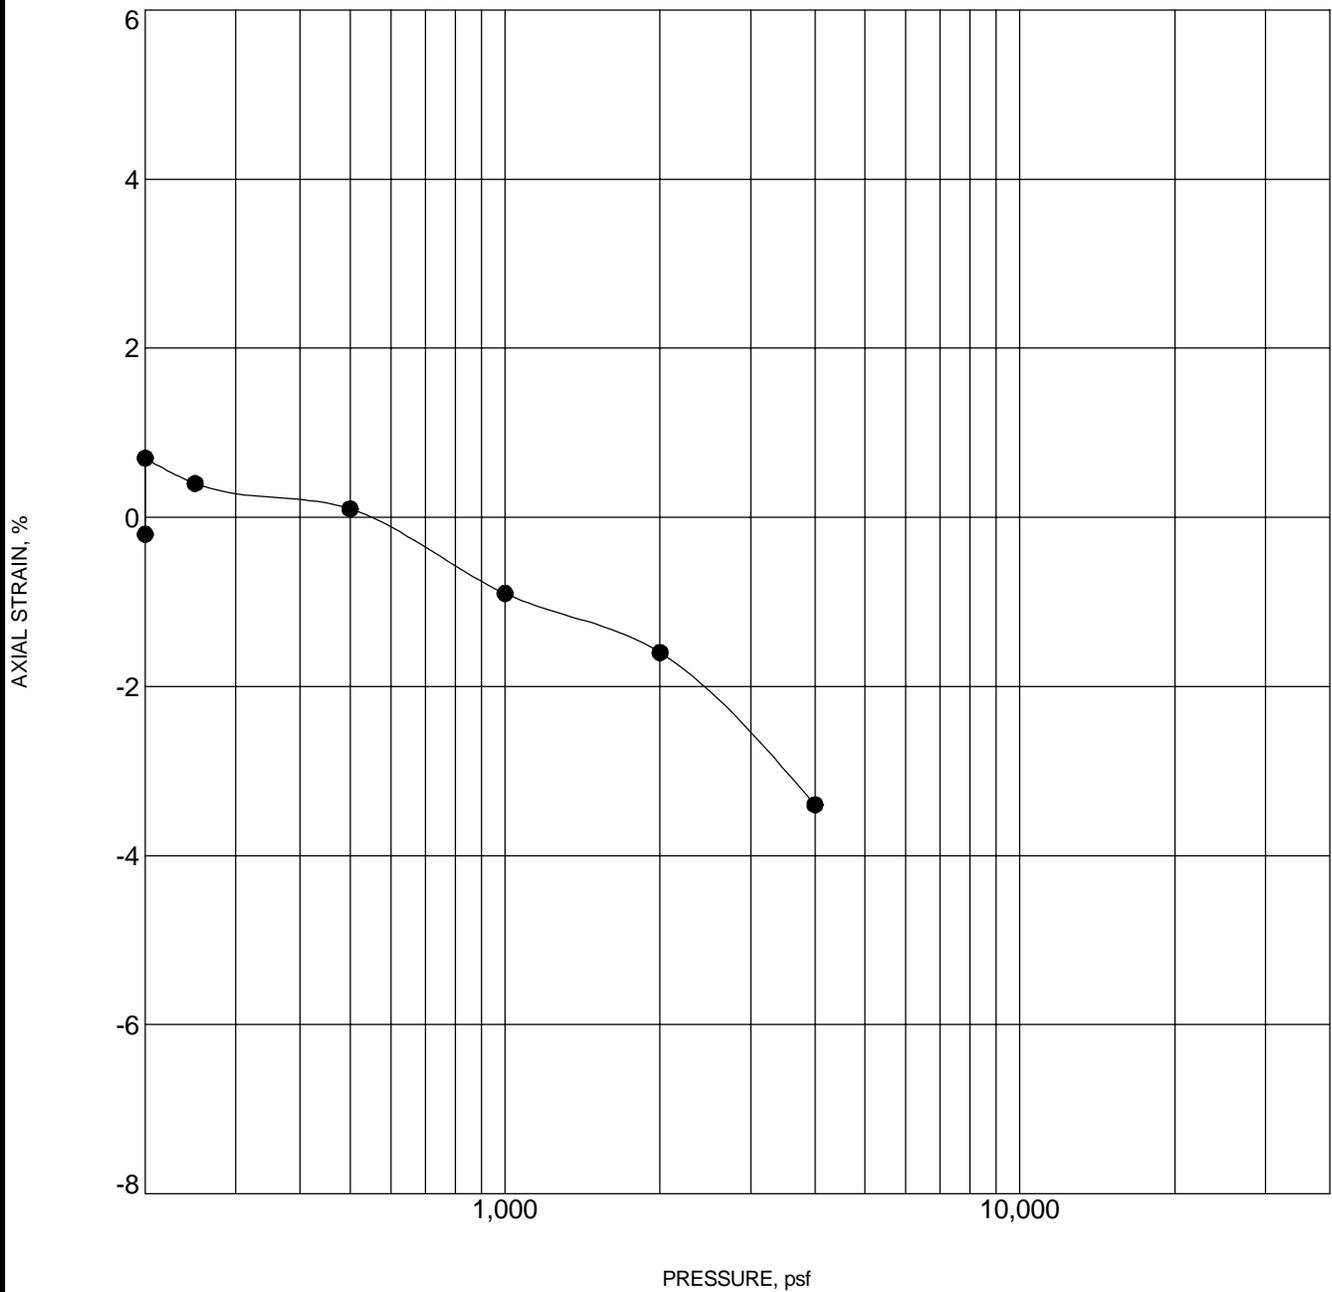
# SWELL CONSOLIDATION TEST

Specimen Identification	Classification	$\gamma_d$ , pcf	WC, %
● B-09 1 - 2 ft	CLAYEY SAND(SC)	110	12

NOTES: Sample remolded to 95 percent of ASTM D698 at optimum water content.  
 Sample inundated with water at 200 pounds per square foot (psf.)

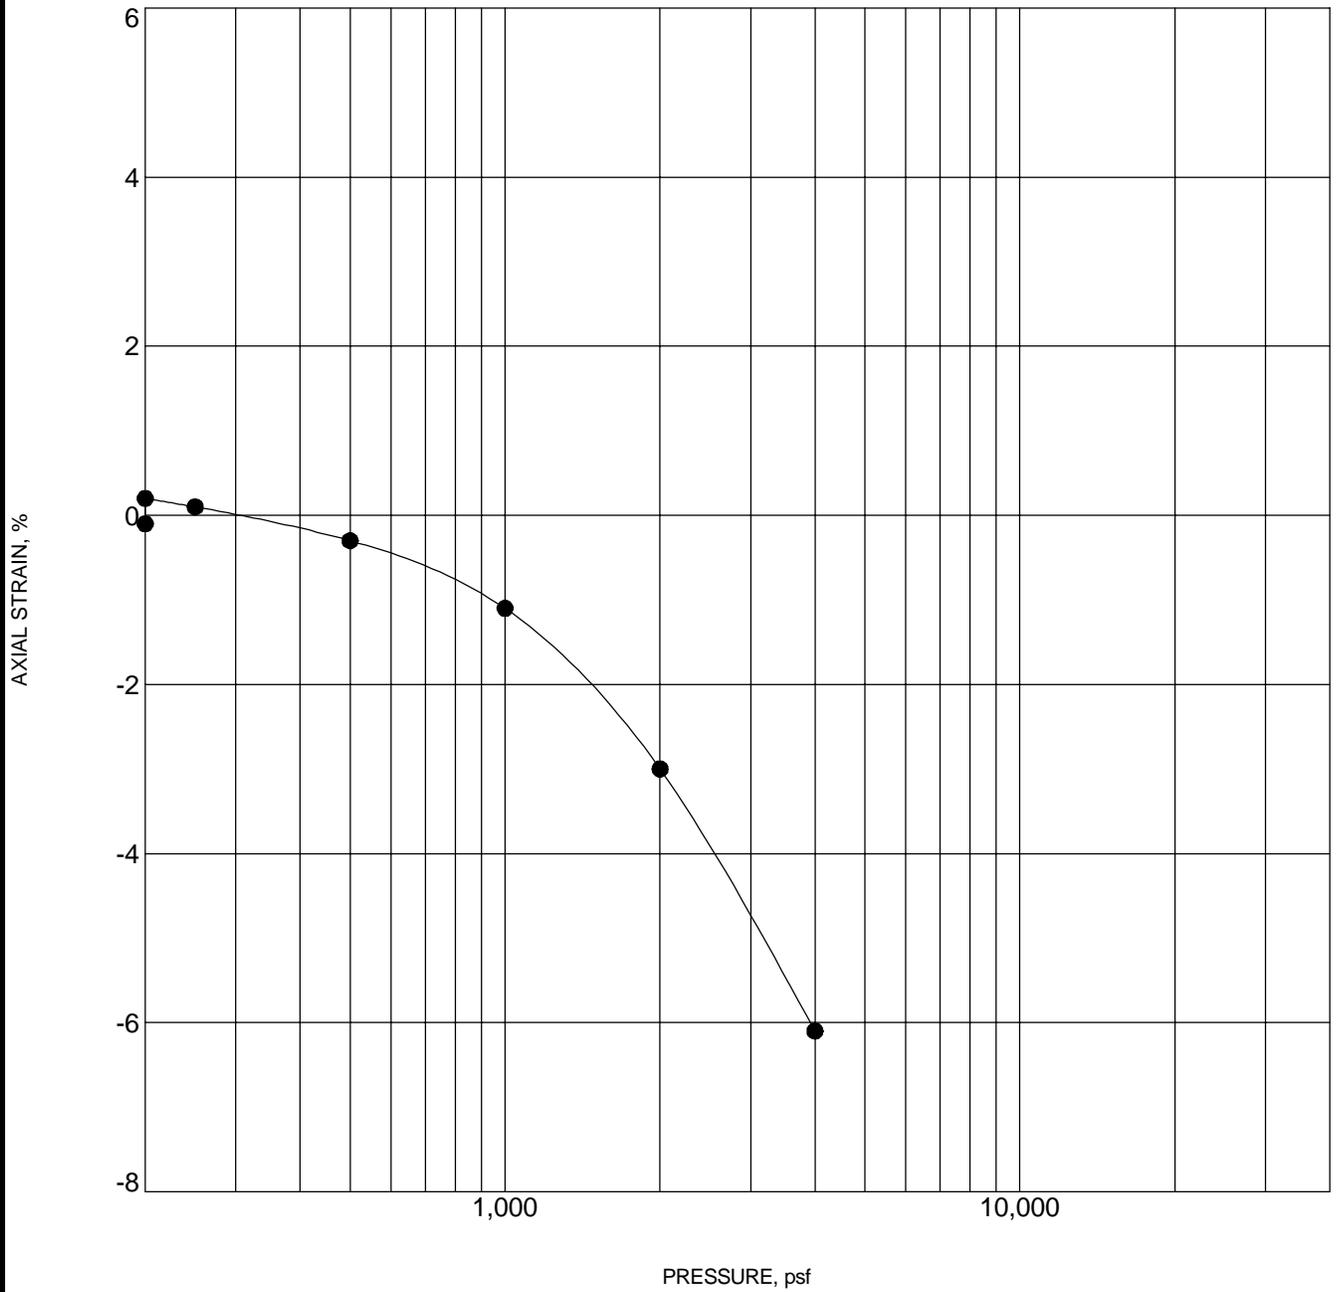
# SWELL CONSOLIDATION TEST

Specimen Identification	Classification	$\gamma_d$ , pcf	WC, %
● B-09 4 - 5 ft	CLAYEY SAND (SC)	109	11

NOTES: Sample inundated with water at 200 pounds per square foot (psf.)

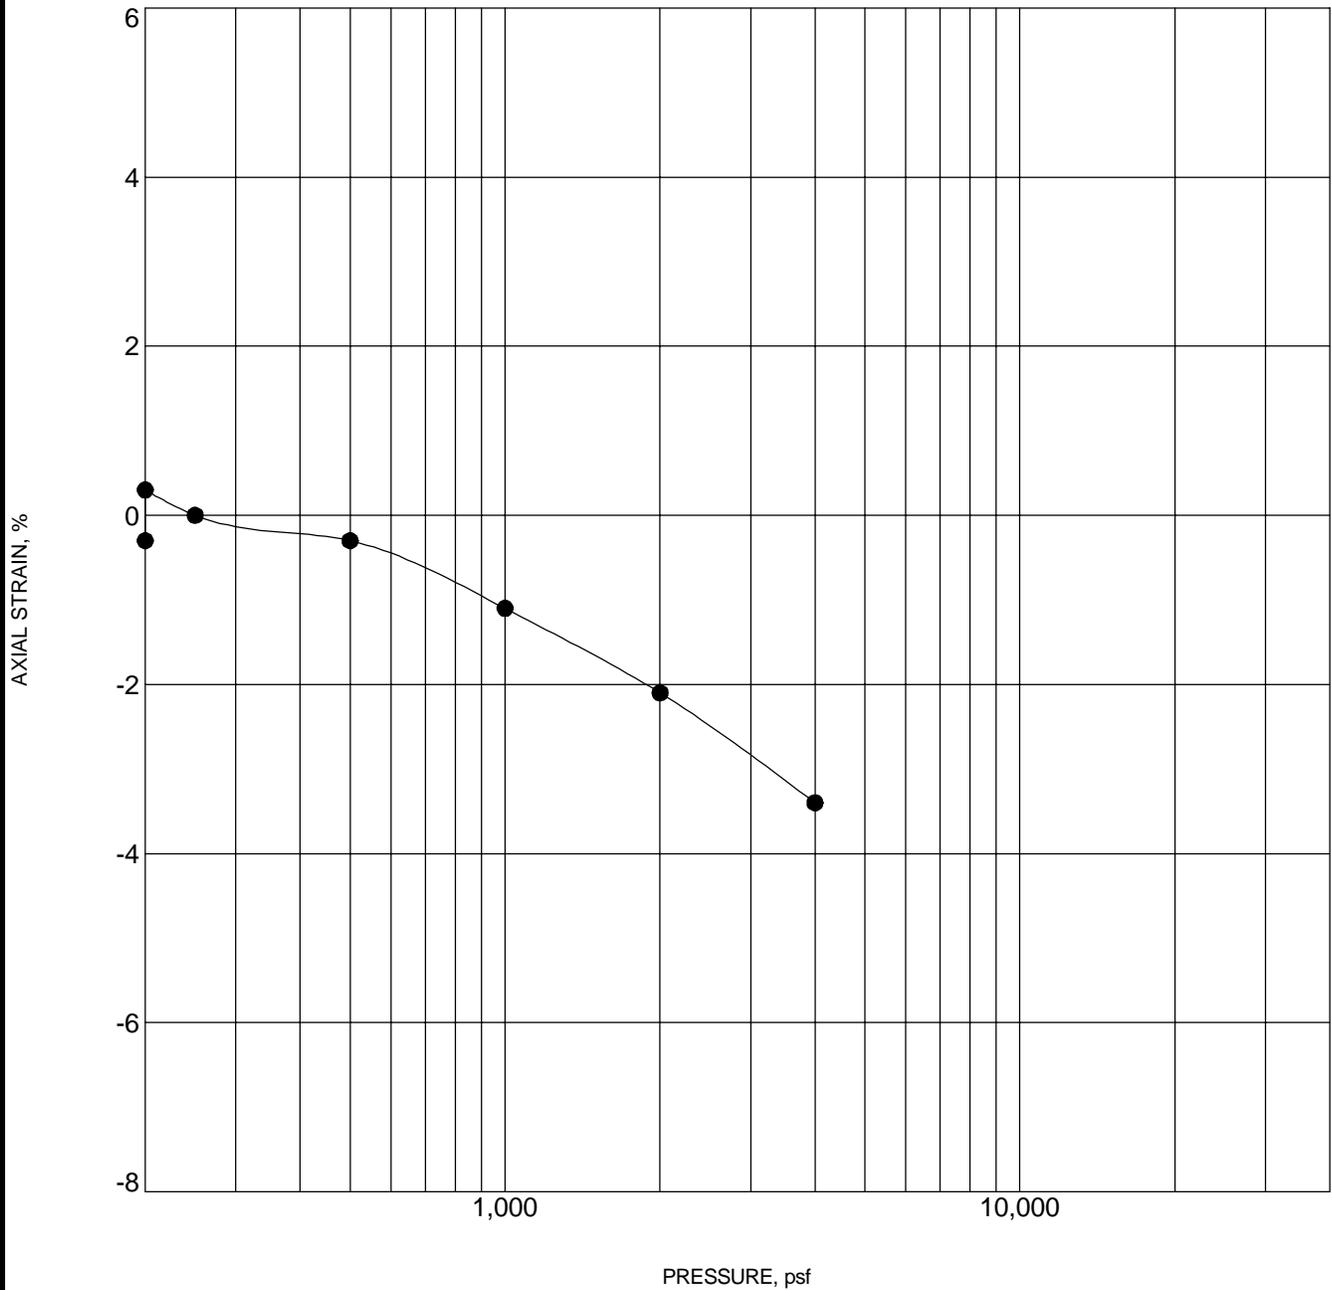
# SWELL CONSOLIDATION TEST

Specimen Identification	Classification	$\gamma_d$ , pcf	WC, %
● B-17 0 - 5 ft	CLAYEY SAND(SC)	108	13

NOTES: Sample remolded to 95 percent of ASTM D698 at optimum water content.  
 Sample inundated with water at 200 pounds per square foot (psf.)

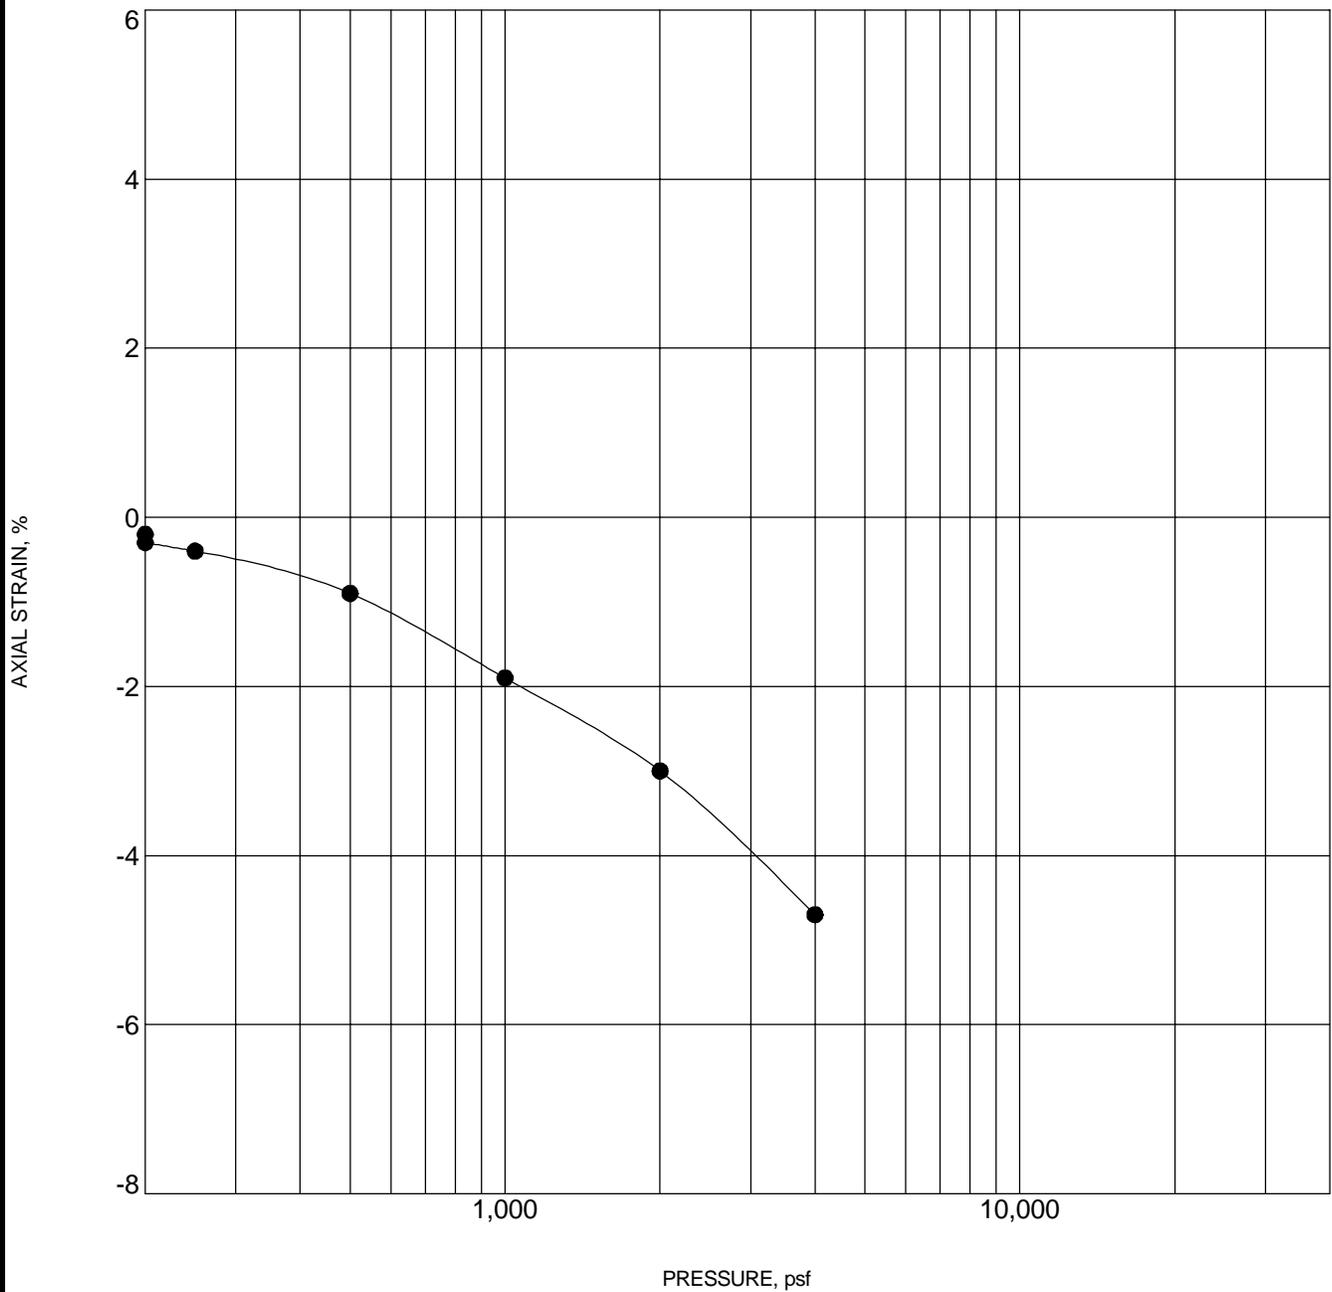
# SWELL CONSOLIDATION TEST

Specimen Identification	Classification	$\gamma_d$ , pcf	WC, %
● B-17 4 - 5 ft	SANDY LEAN CLAY (CL)	110	16

NOTES: Sample inundated with water at 200 pounds per square foot (psf.)

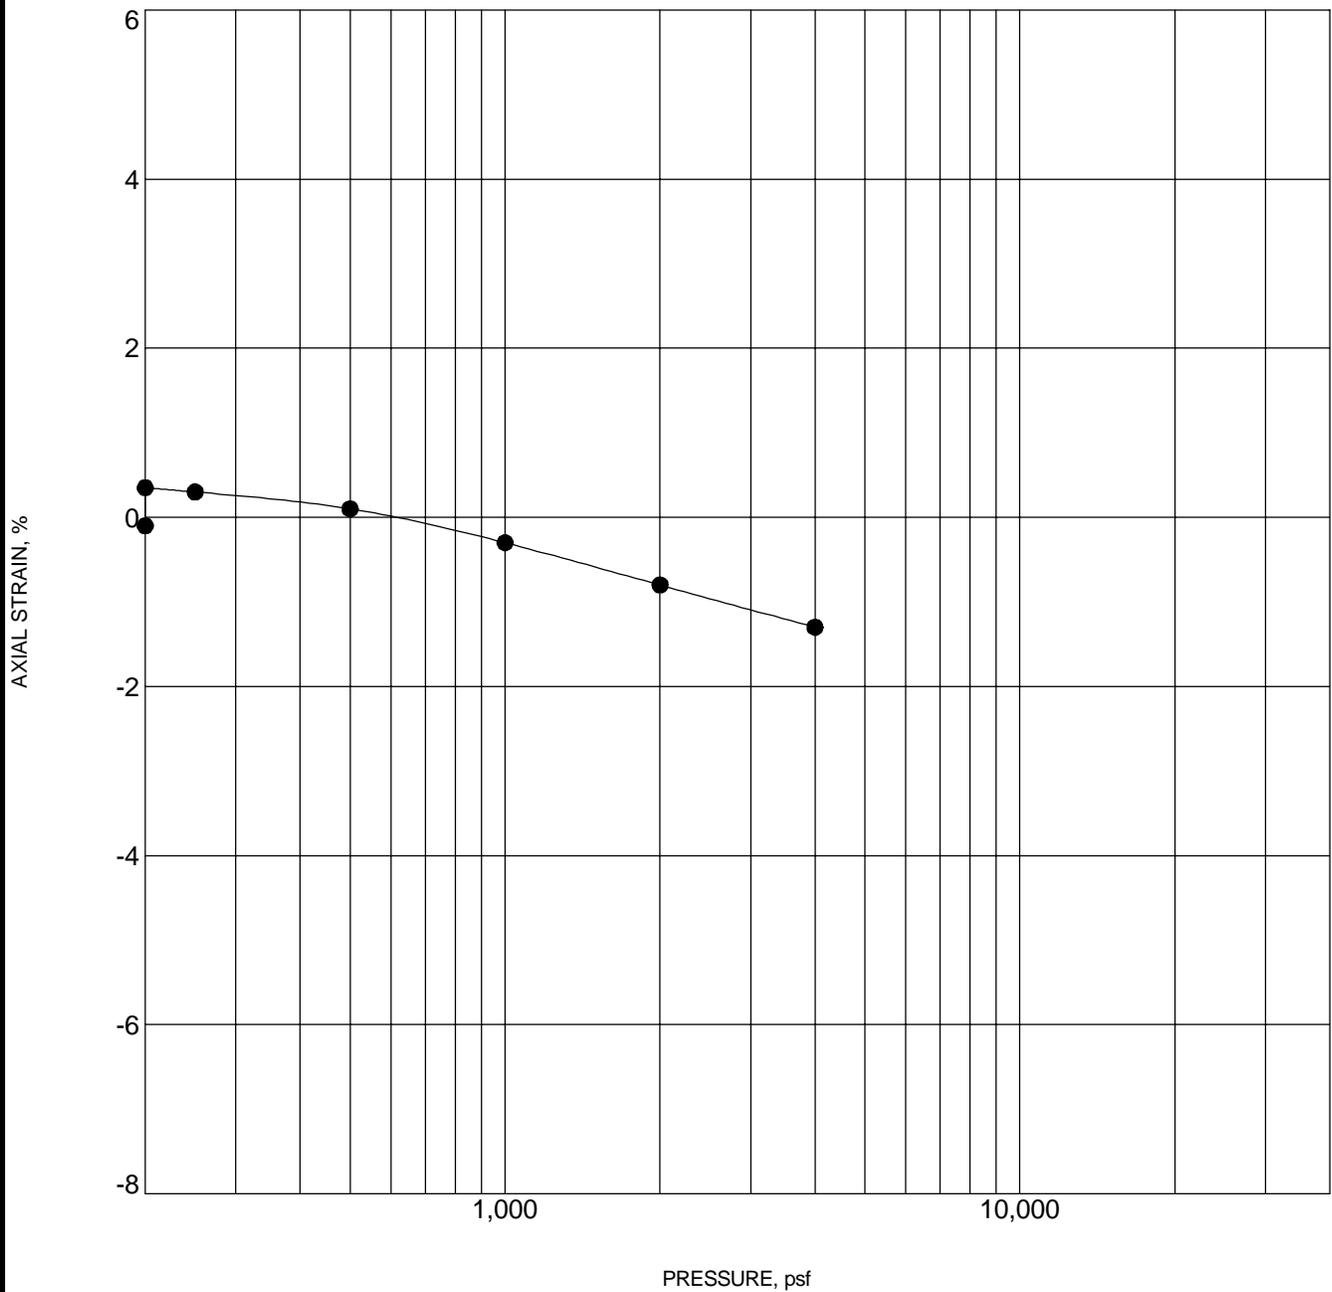
# SWELL CONSOLIDATION TEST

Specimen Identification	Classification	$\gamma_d$ , pcf	WC, %
● B-41      0 - 5 ft	CLAYEY SAND with GRAVEL(SC)	120	9

NOTES: Sample remolded to 95 percent of ASTM D698 at optimum water content.  
 Sample inundated with water at 200 pounds per square foot (psf.)

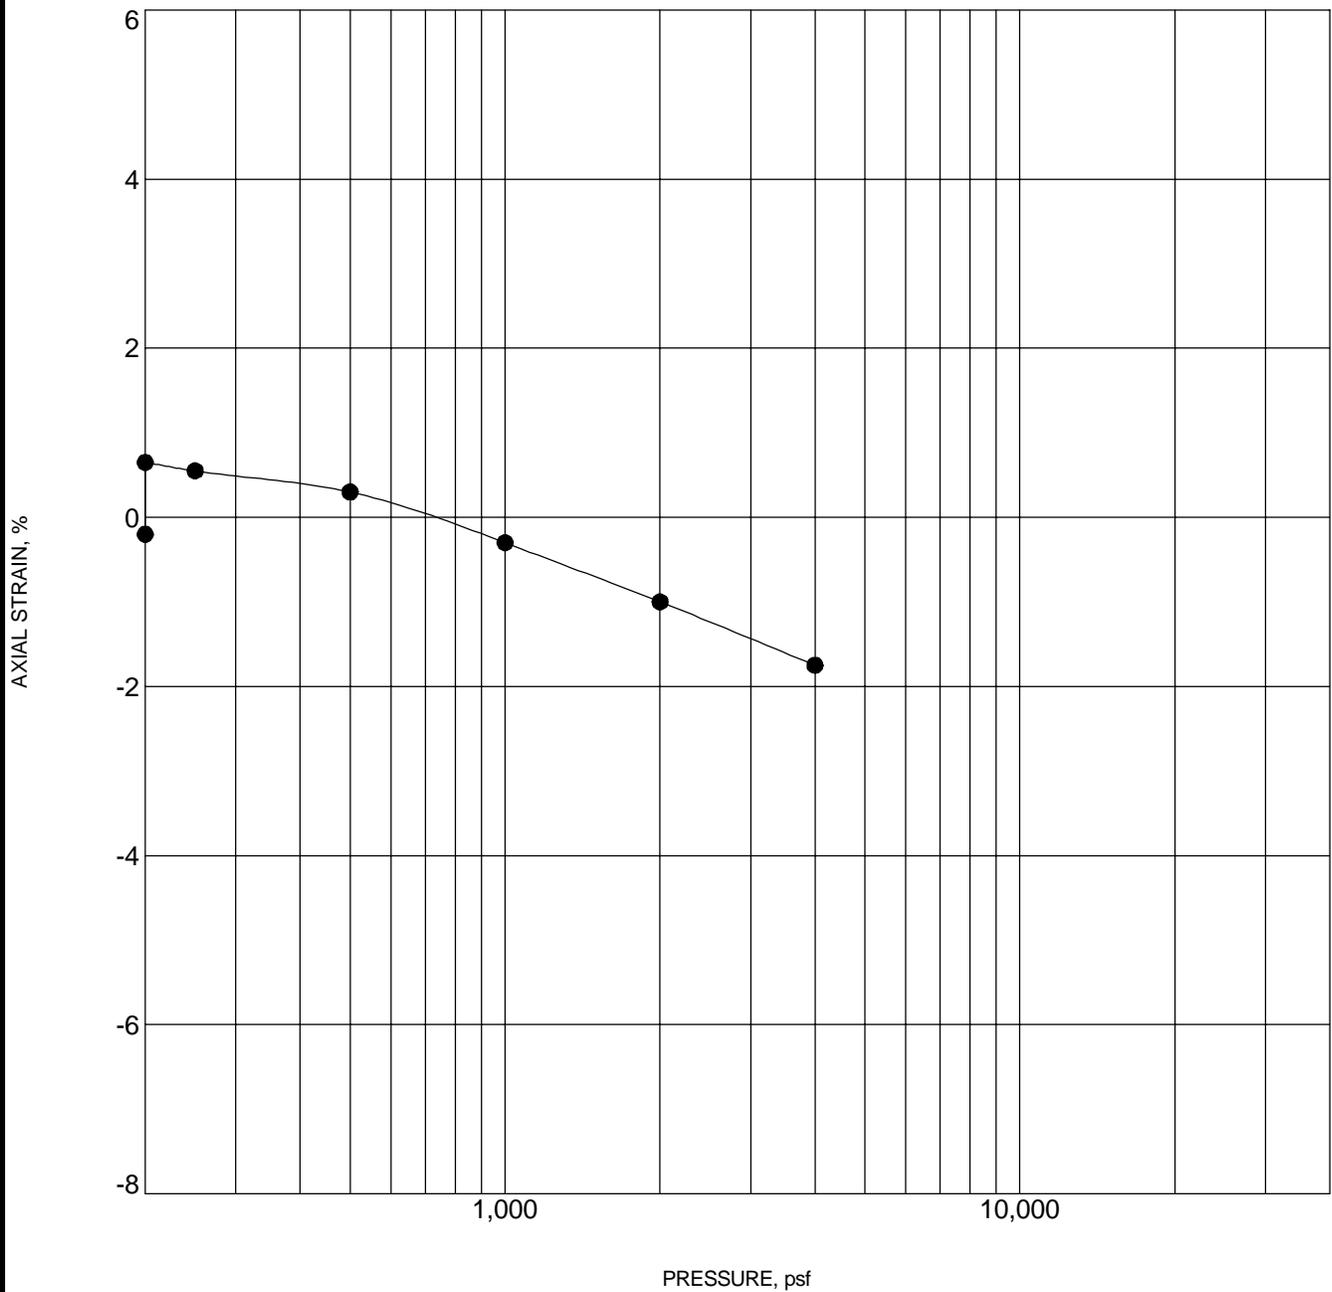
# SWELL CONSOLIDATION TEST

Specimen Identification	Classification	$\gamma_d$ , pcf	WC, %
● B-41      4 - 5 ft	SANDY LEAN CLAY(CL)	111	17

NOTES: Sample inundated with water at 200 pounds per square foot (psf.)

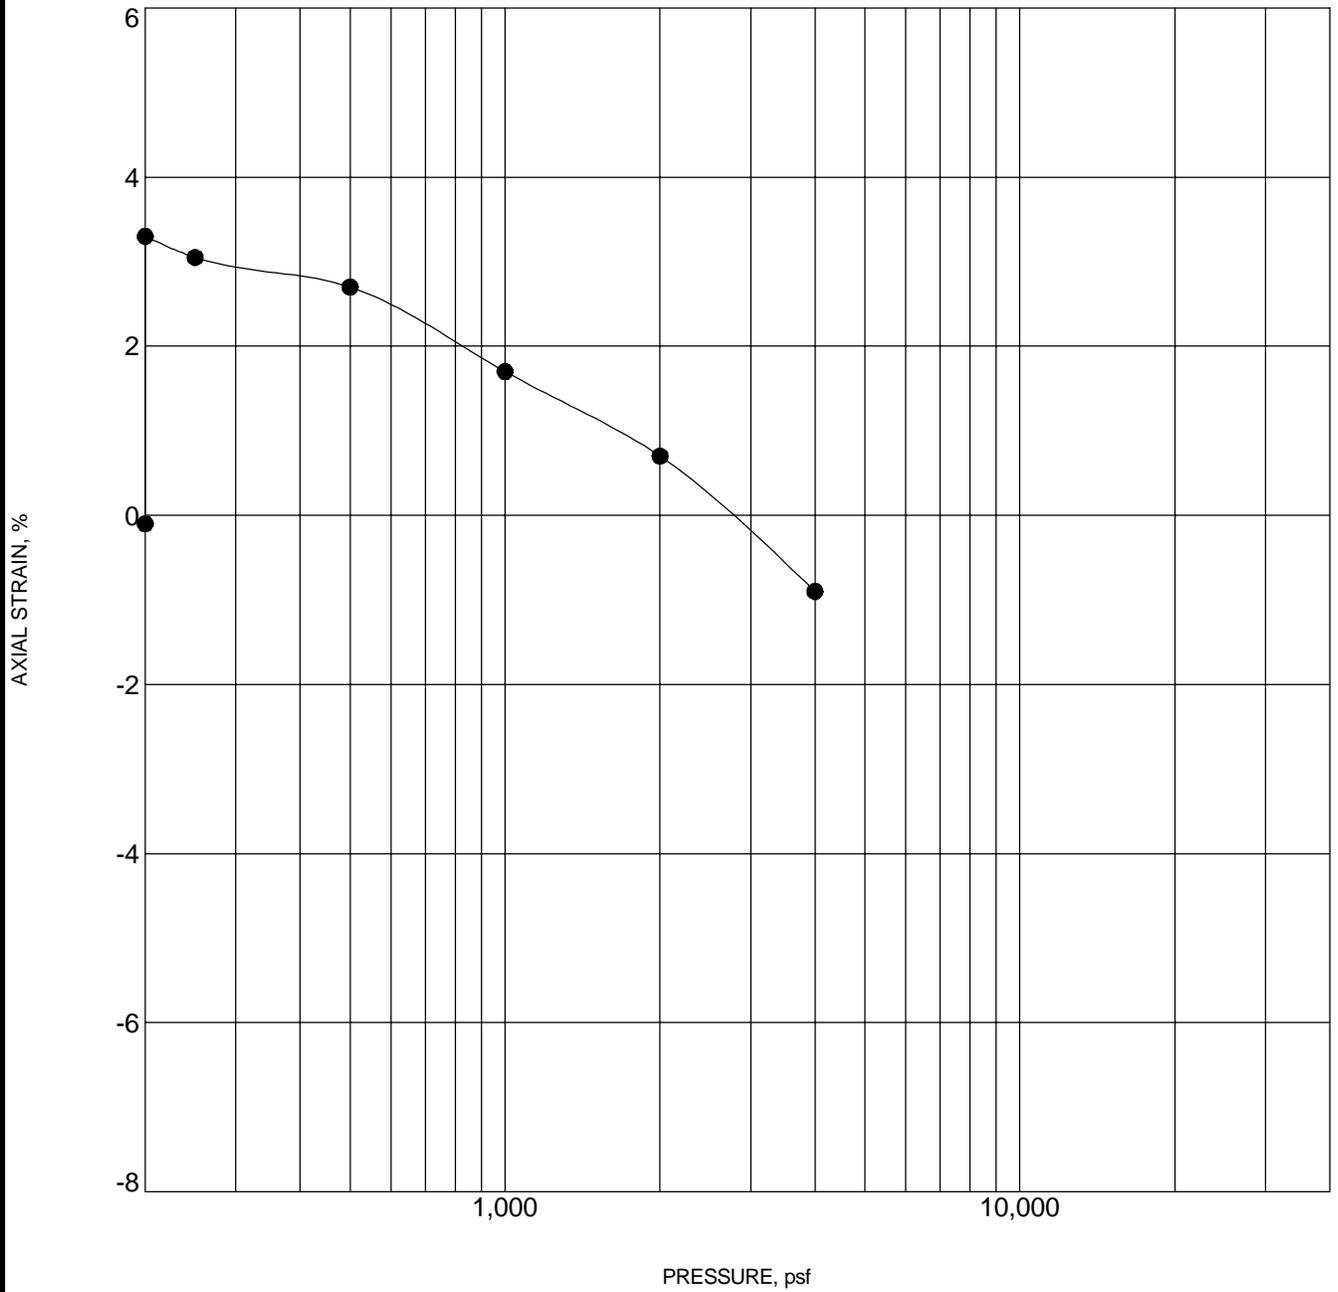
# SWELL CONSOLIDATION TEST

Specimen Identification	Classification	$\gamma_d$ , pcf	WC, %
● B-42      4 - 5 ft	CLAYSTONE	99	28

NOTES: Sample inundated with water at 200 pounds per square foot (psf.)

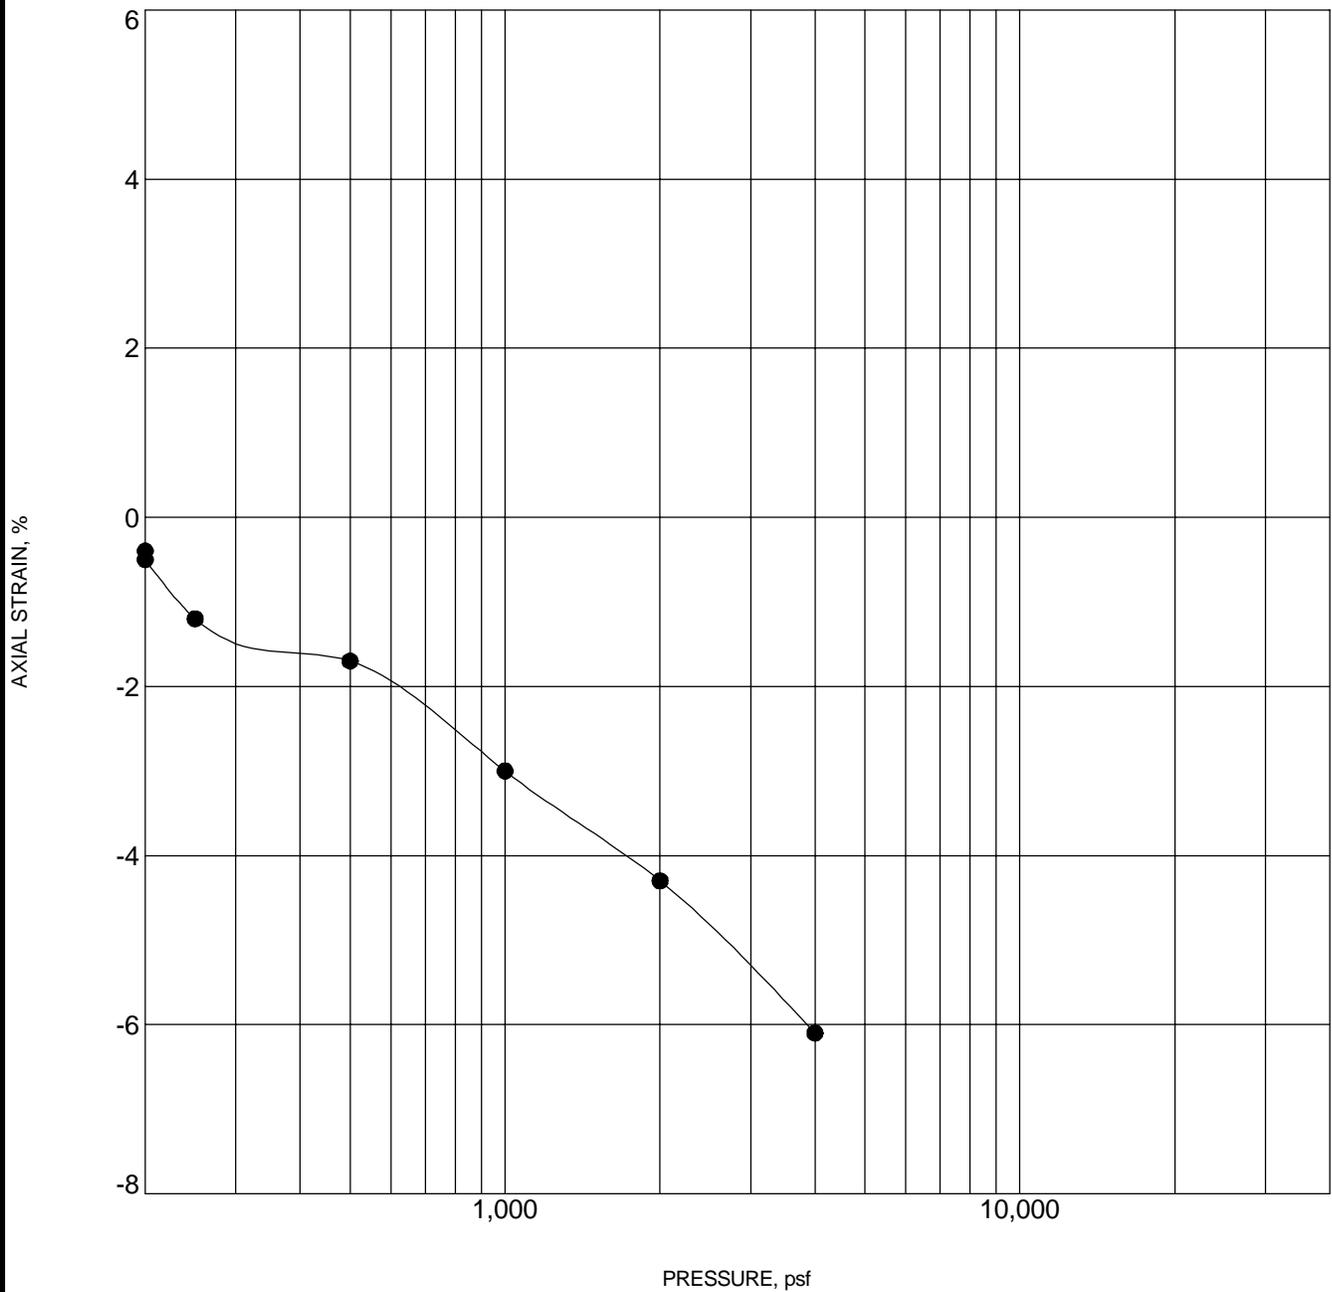
# SWELL CONSOLIDATION TEST

Specimen Identification	Classification	$\gamma_d$ , pcf	WC, %
● B-43      4 - 5 ft	SANDY CLAYSTONE	111	12

NOTES: Sample inundated with water at 200 pounds per square foot (psf.)

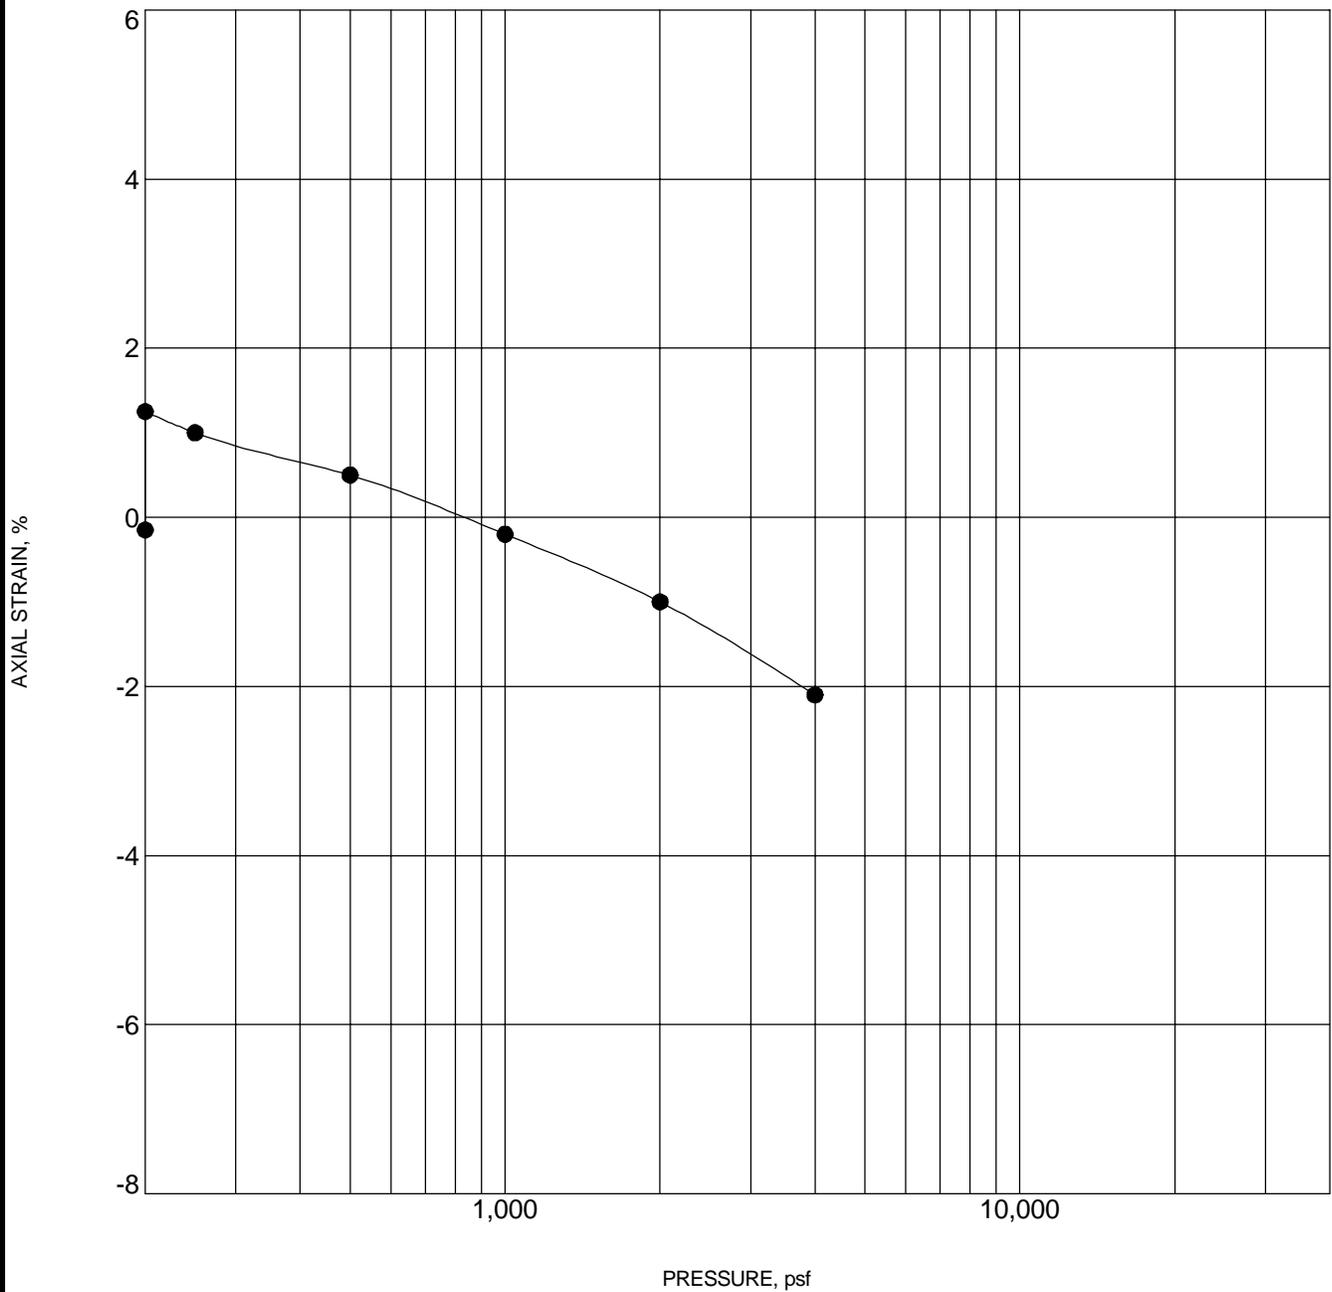
# SWELL CONSOLIDATION TEST

Specimen Identification	Classification	$\gamma_d$ , pcf	WC, %
● B-44      4 - 5 ft	SANDY CLAYSTONE	115	15

NOTES: Sample inundated with water at 200 pounds per square foot (psf.)

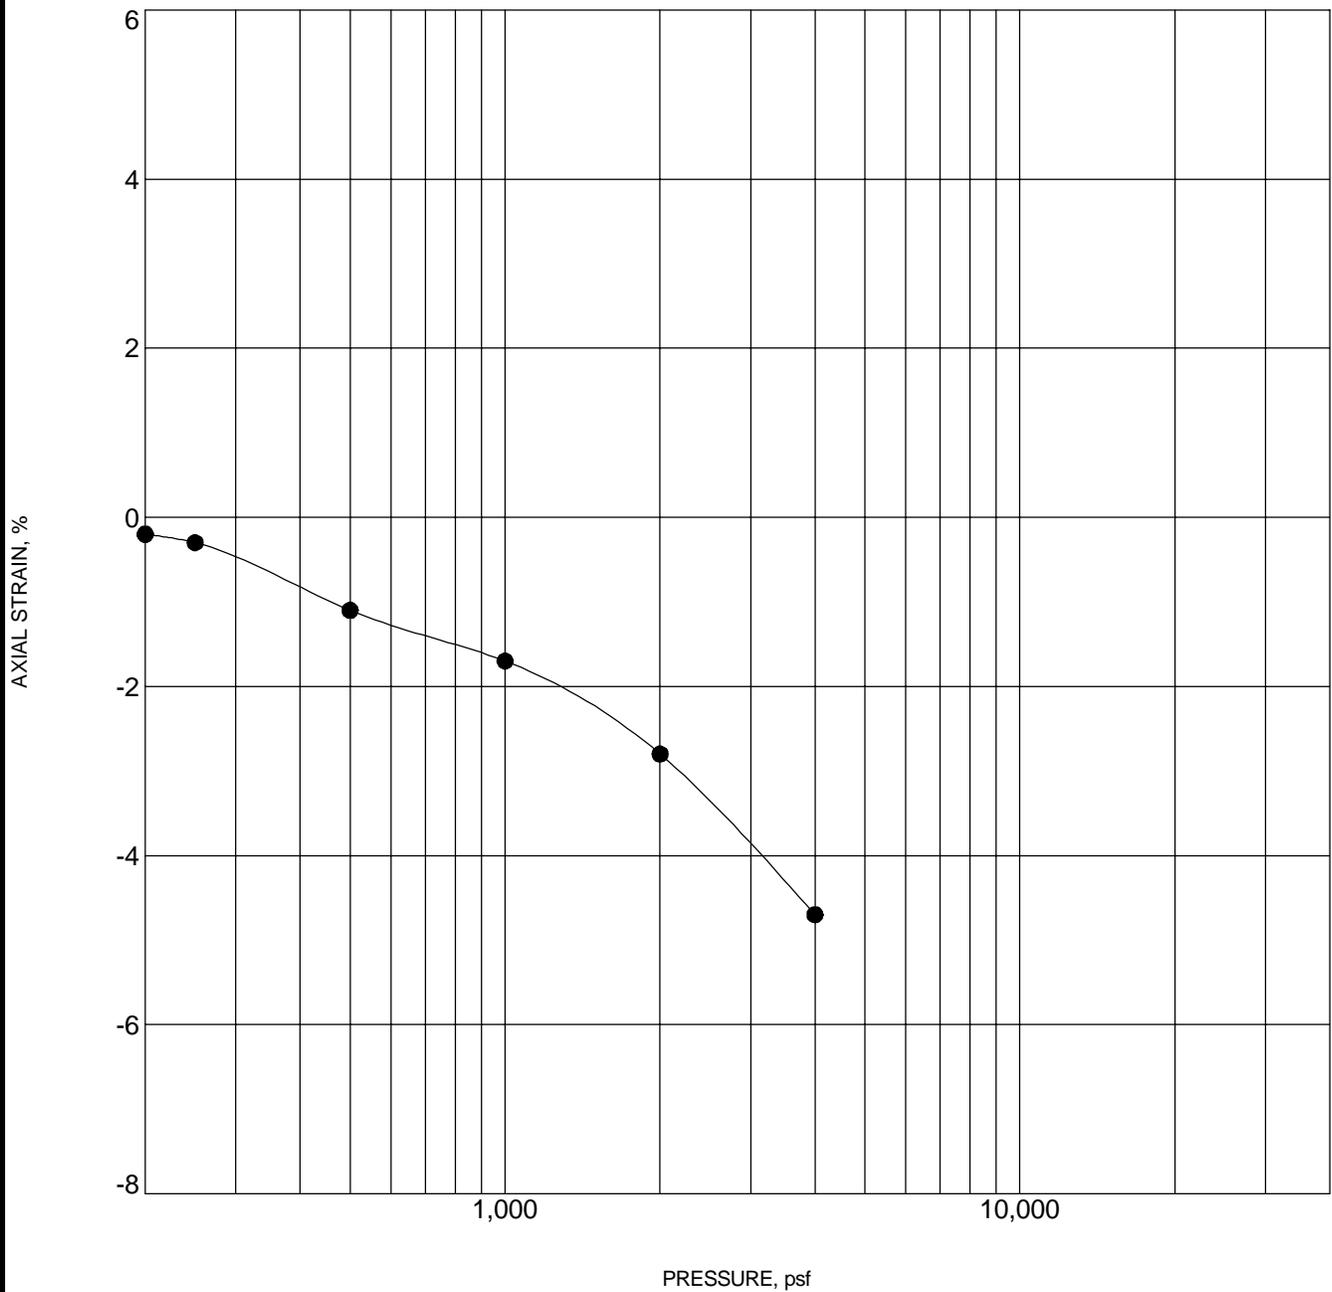
# SWELL CONSOLIDATION TEST

Specimen Identification	Classification	$\gamma_d$ , pcf	WC, %
● B-47 0.33 - 1.33 ft	LEAN CLAY with SAND(CL)	104	20

NOTES: Sample inundated with water at 200 pounds per square foot (psf.)

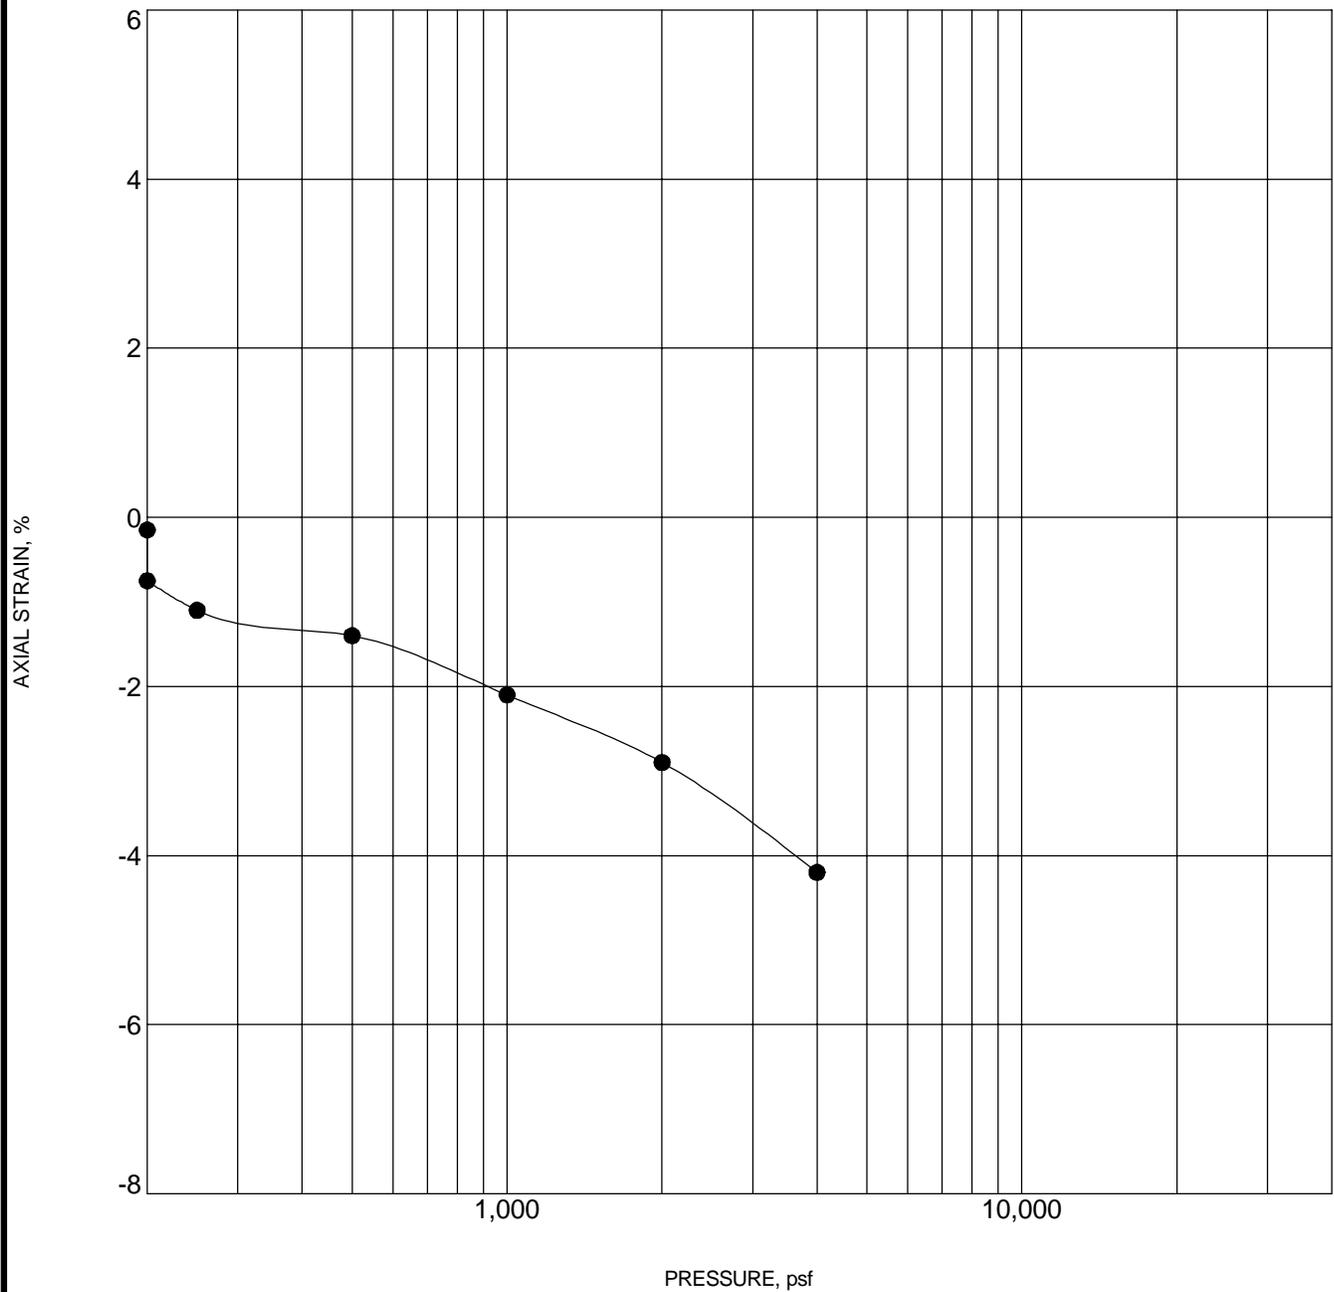
# SWELL CONSOLIDATION TEST

Specimen Identification	Classification	$\gamma_d$ , pcf	WC, %
● B-48 0.33 - 1.33 ft	CLAYEY SAND(SC)	116	14

NOTES: Sample inundated with water at 200 pounds per square foot (psf.)

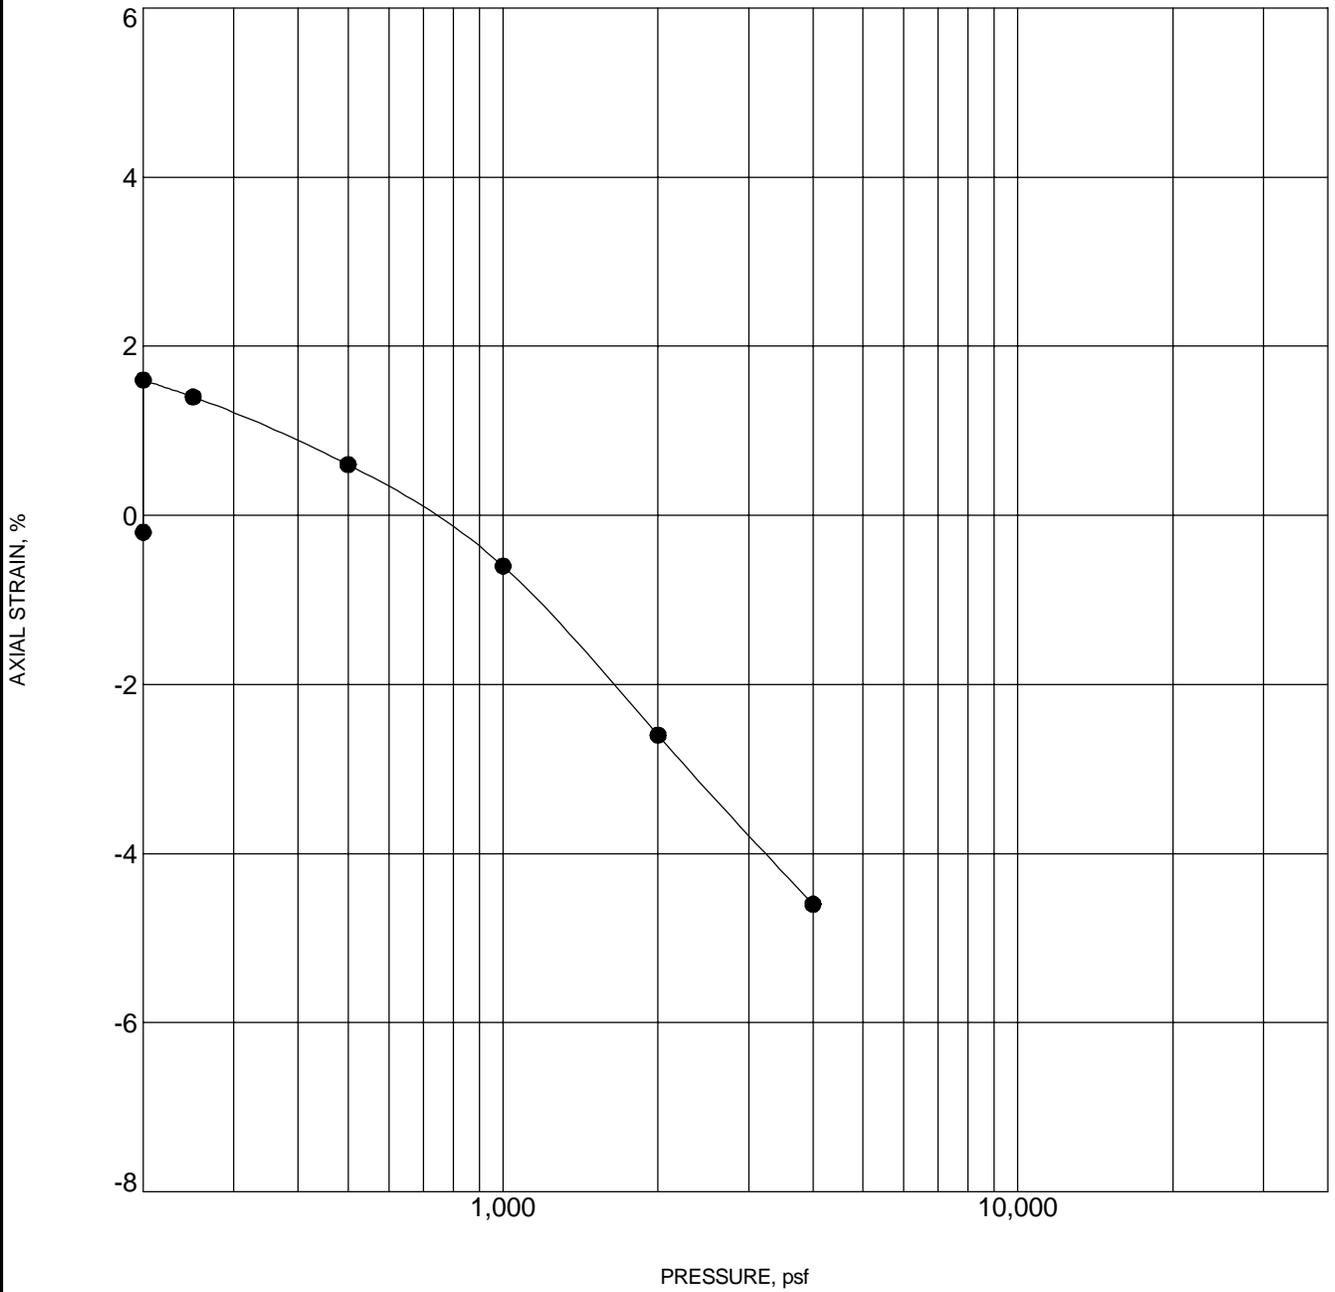
# SWELL CONSOLIDATION TEST

Specimen Identification	Classification	$\gamma_d$ , pcf	WC, %
● B-49      0 - 5 ft	SANDY CLAYSTONE	105	14

NOTES: Sample remolded to 95 percent of ASTM D698 at optimum water content.  
 Sample inundated with water at 200 pounds per square foot (psf.)

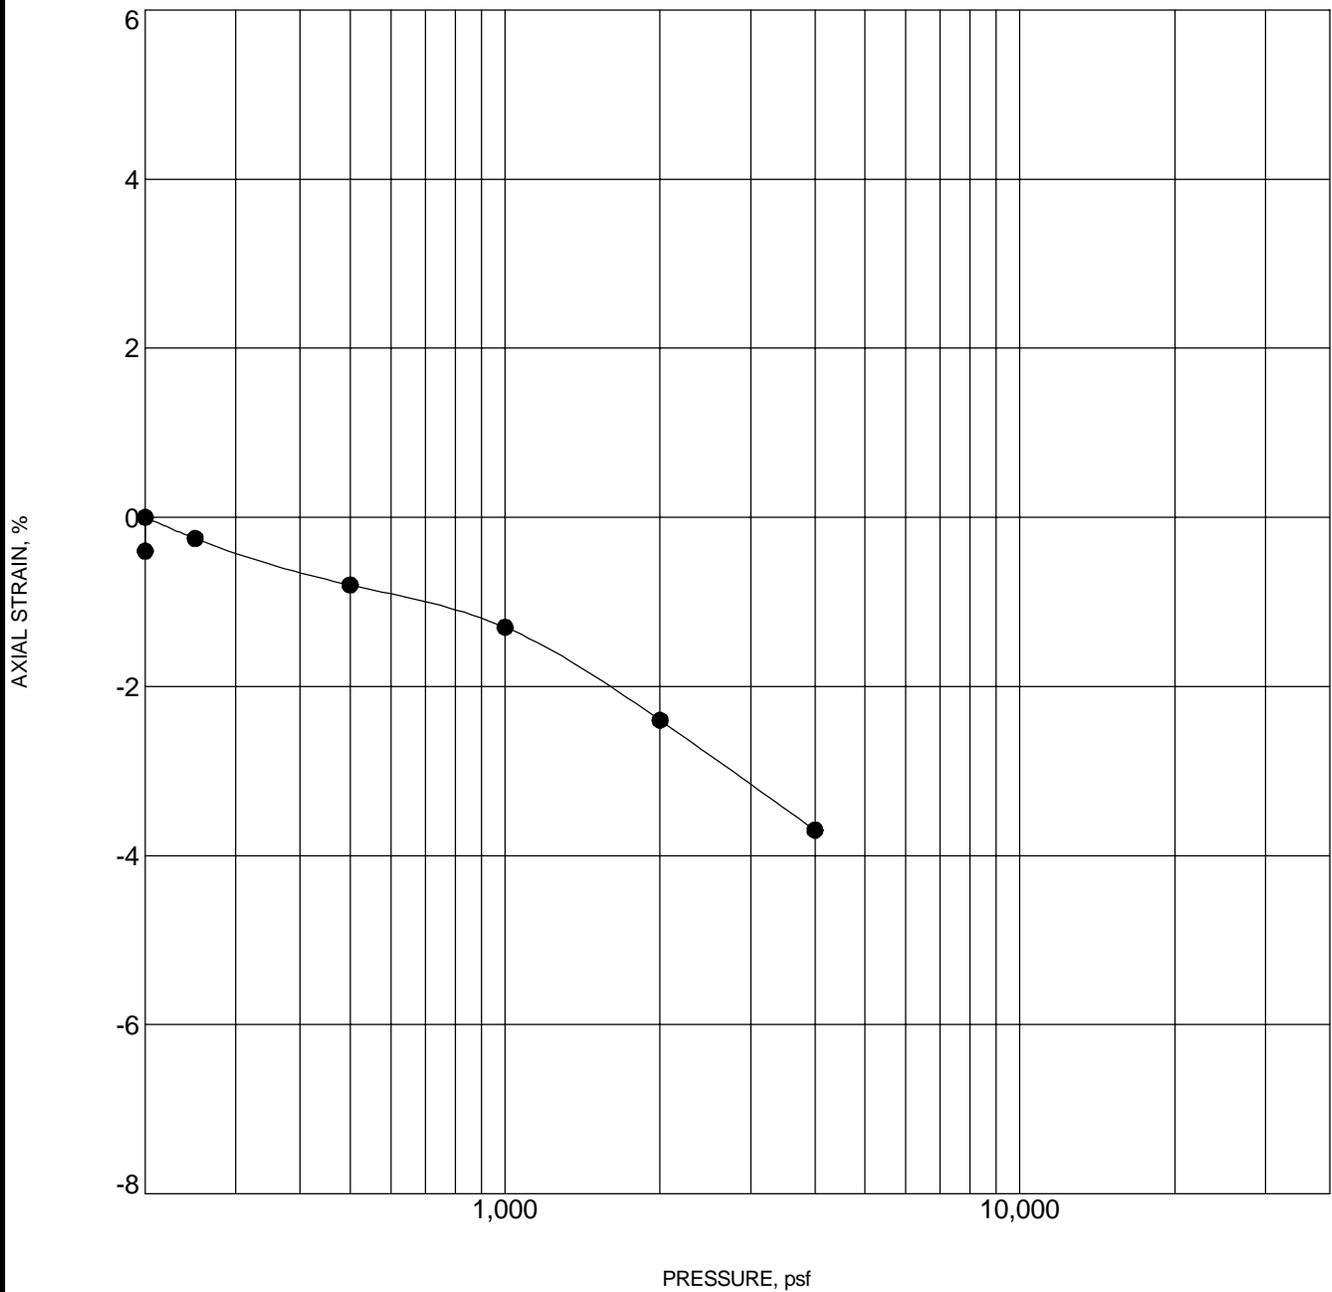
# SWELL CONSOLIDATION TEST

Specimen Identification	Classification	$\gamma_d$ , pcf	WC, %
● B-49      4 - 5 ft	SANDY CLAYSTONE	106	18

NOTES: Sample inundated with water at 200 pounds per square foot (psf.)
