# Geotechnical Engineering Pavement Thickness Design Report

Centennial Boulevard Reconstruction  
West Fillmore Street to Garden of the Gods Road  
Colorado Springs, Colorado

Terracon Project No. 23155014

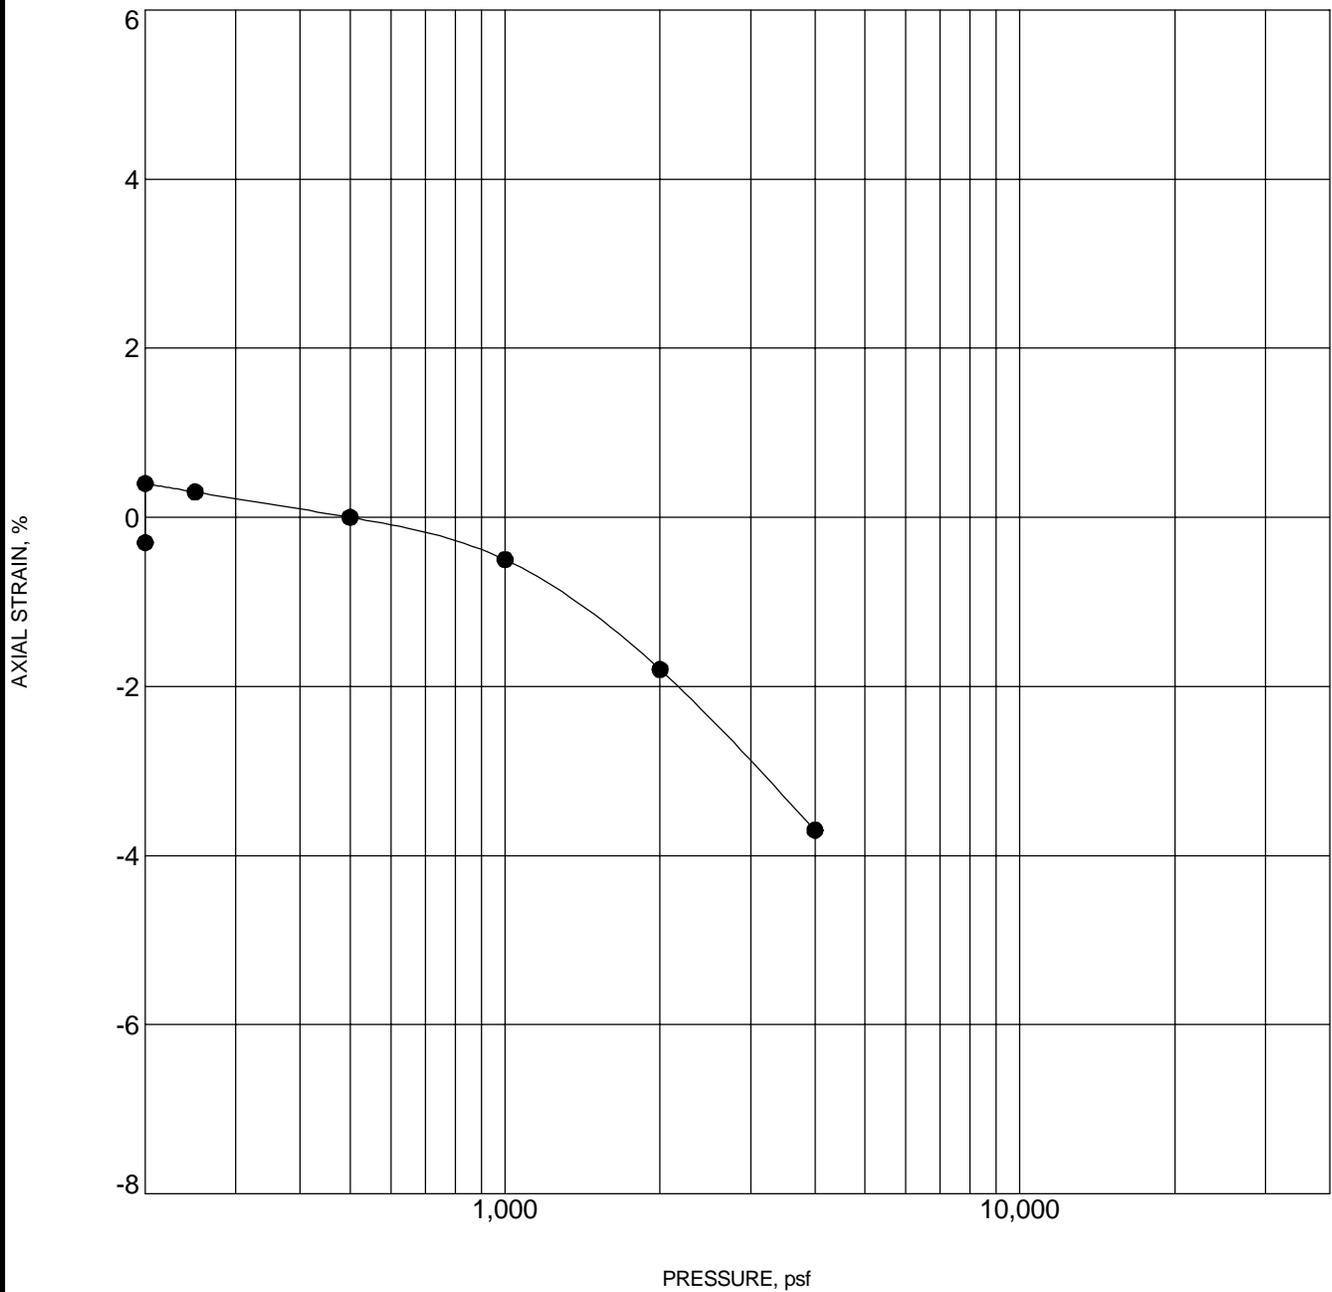
# SWELL CONSOLIDATION TEST

Specimen Identification	Classification	$\gamma_d$ , pcf	WC, %
● B-50 0.5 - 1.5 ft	SANDY LEAN CLAY(CL)	99	23

NOTES: Sample inundated with water at 200 pounds per square foot (psf.)

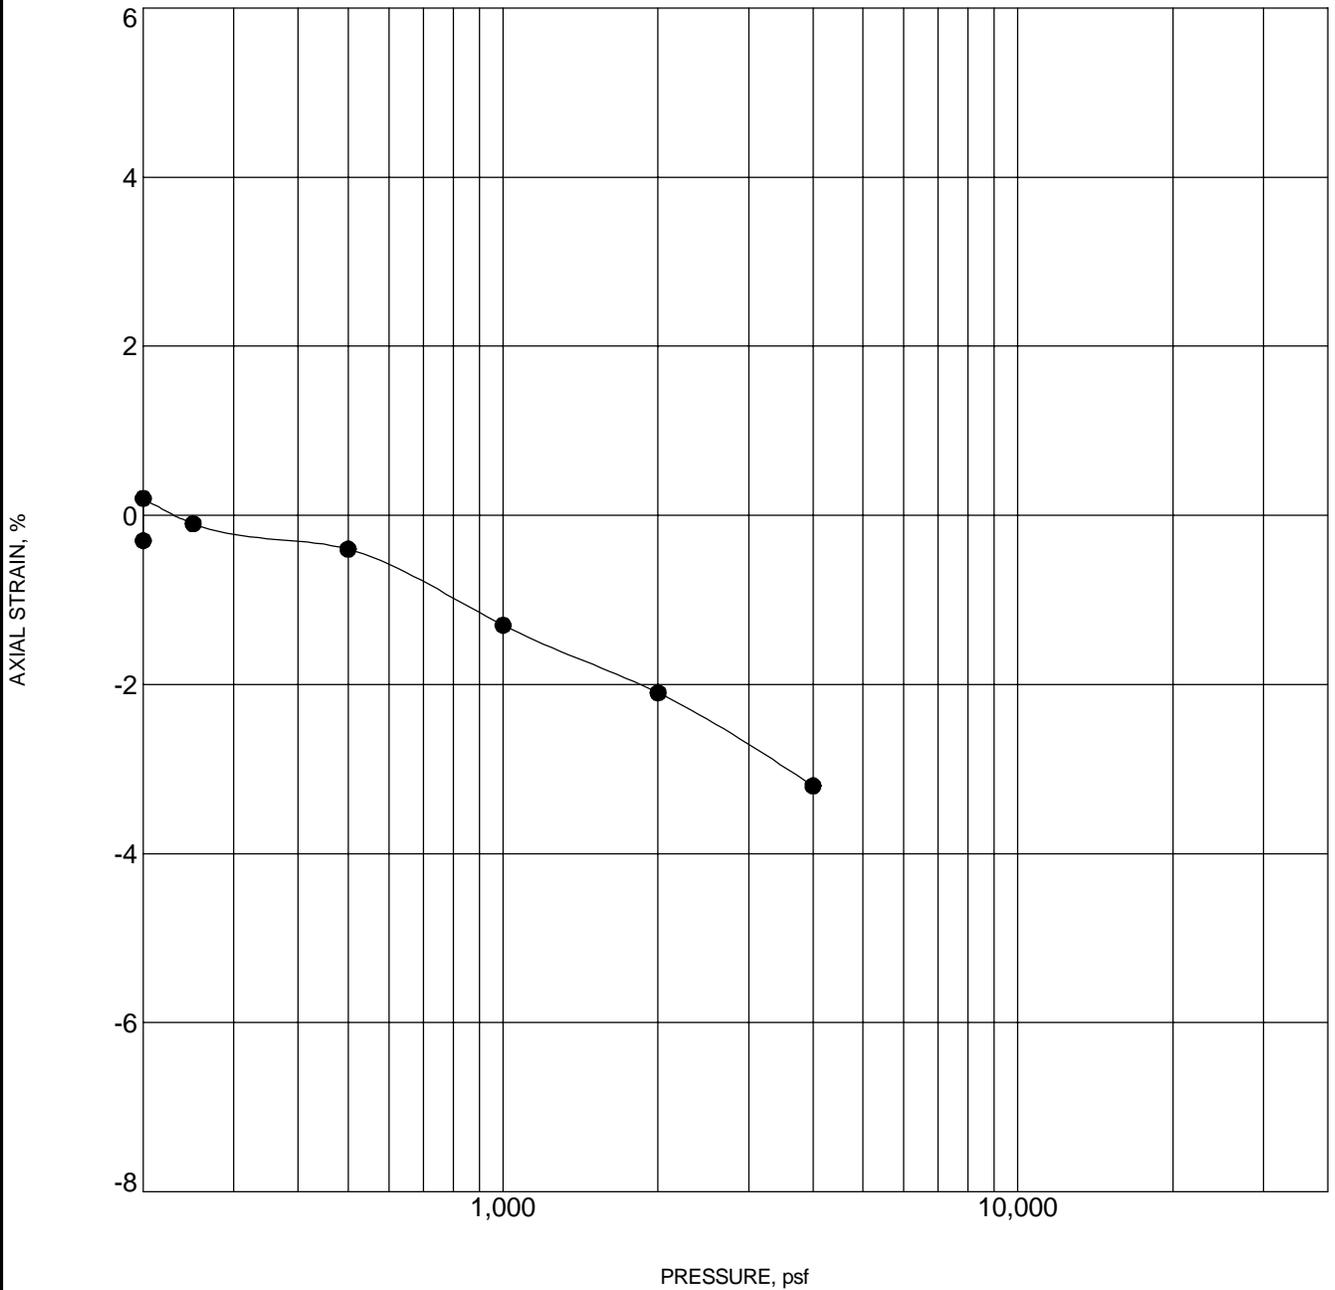
# SWELL CONSOLIDATION TEST

Specimen Identification	Classification	$\gamma_d$ , pcf	WC, %
● B-51 1.3 - 2.3 ft	SANDY LEAN CLAY	106	18

NOTES: Sample inundated with water at 200 pounds per square foot (psf.)

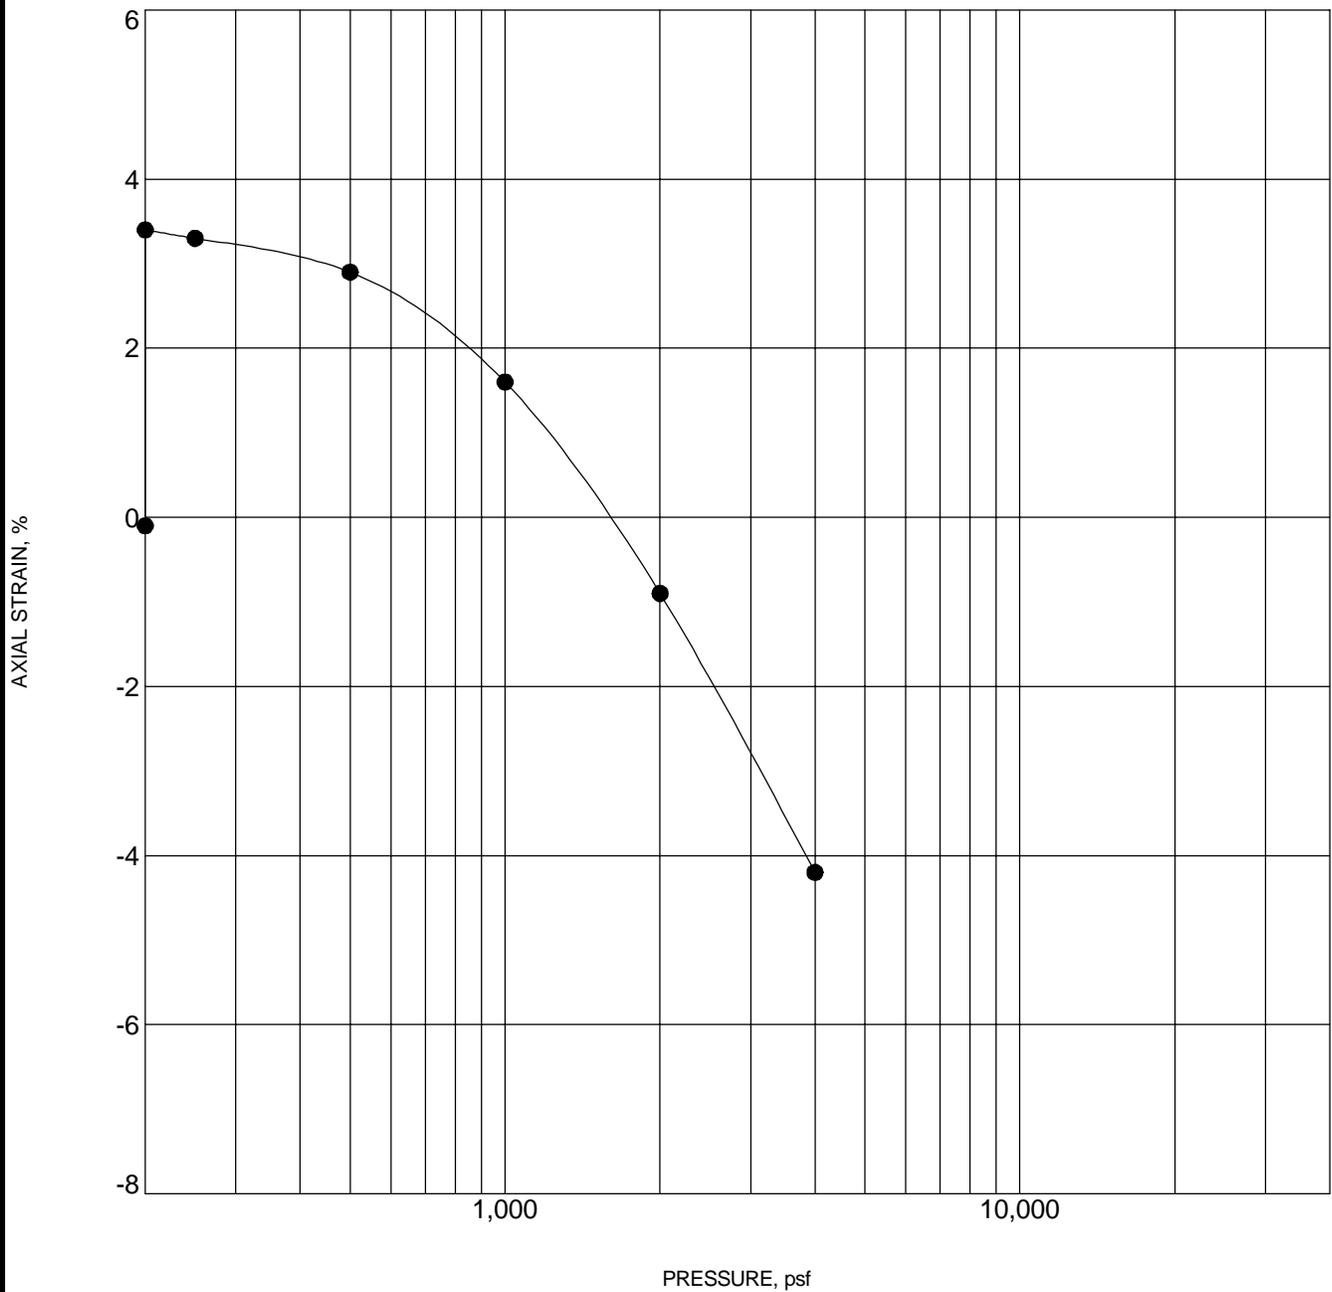
# SWELL CONSOLIDATION TEST

Specimen Identification	Classification	$\gamma_d$ , pcf	WC, %
● B-53      0 - 5 ft	WEATHERED SANDY CLAYSTONE	107	15

NOTES: Sample remolded to 95 percent of ASTM D698 at optimum water content.  
 Sample inundated with water at 200 pounds per square foot (psf.)

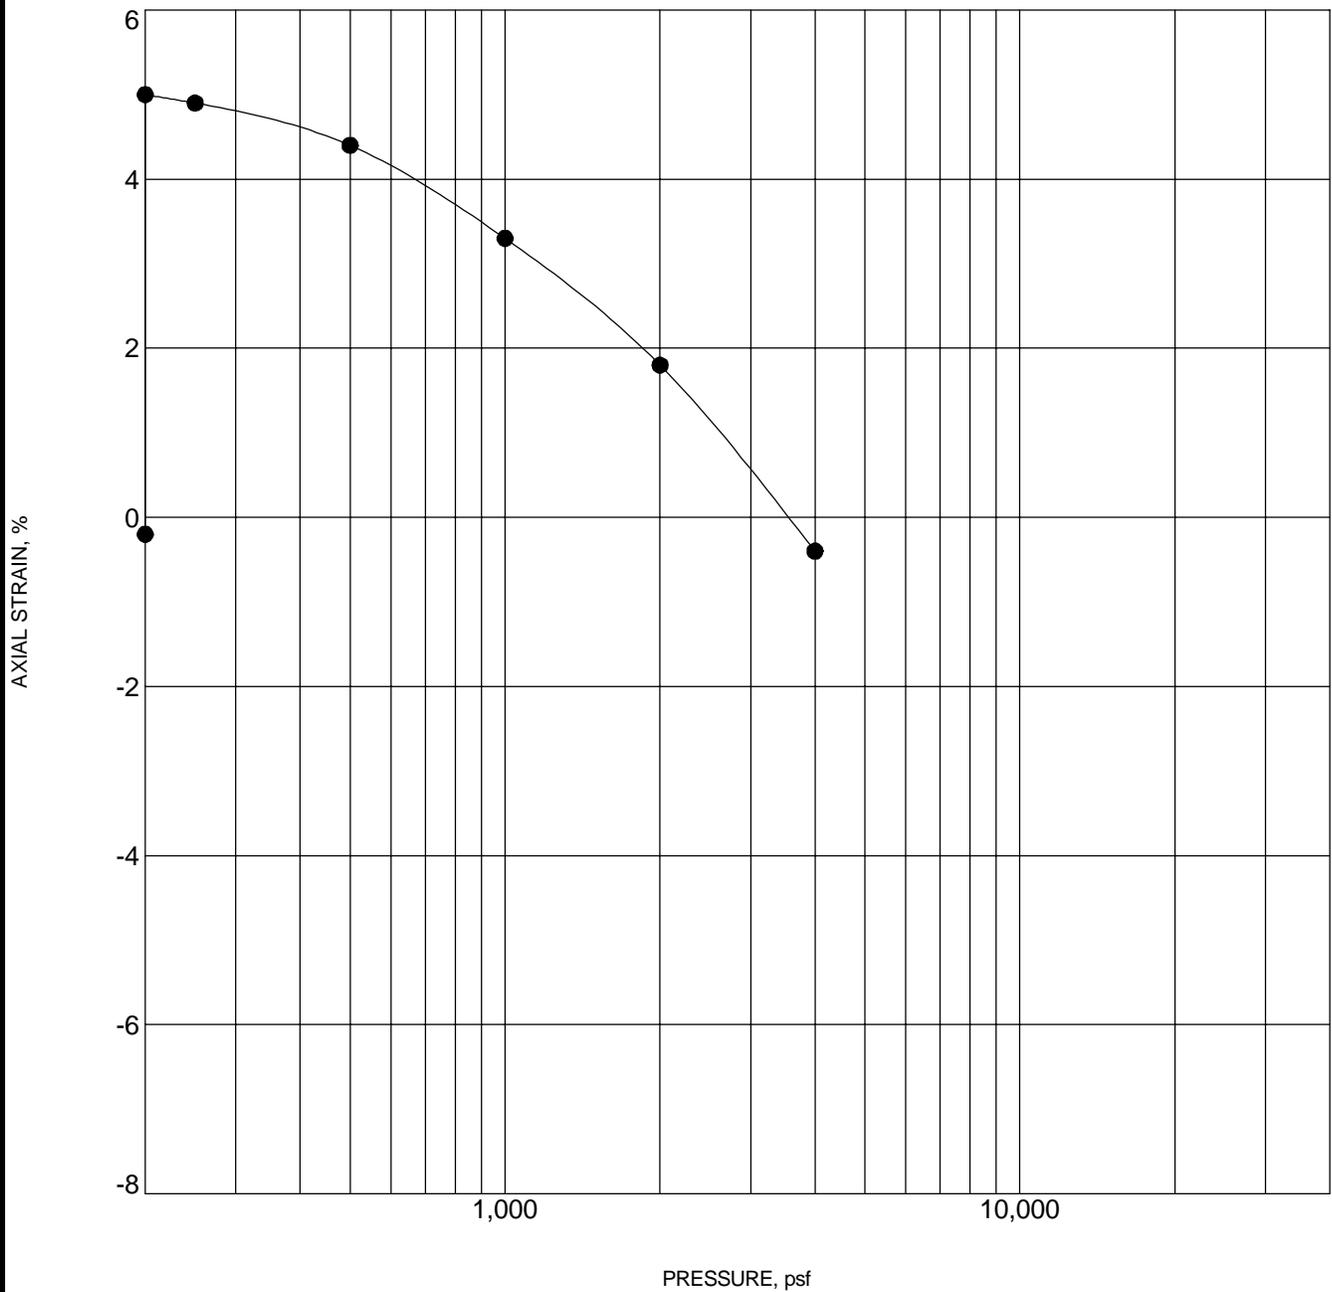
# SWELL CONSOLIDATION TEST

Specimen Identification	Classification	$\gamma_d$ , pcf	WC, %
● B-53      4 - 5 ft	WEATHERED CLAYEY SANDSTONE	105	19

NOTES: Sample inundated with water at 200 pounds per square foot (psf.)

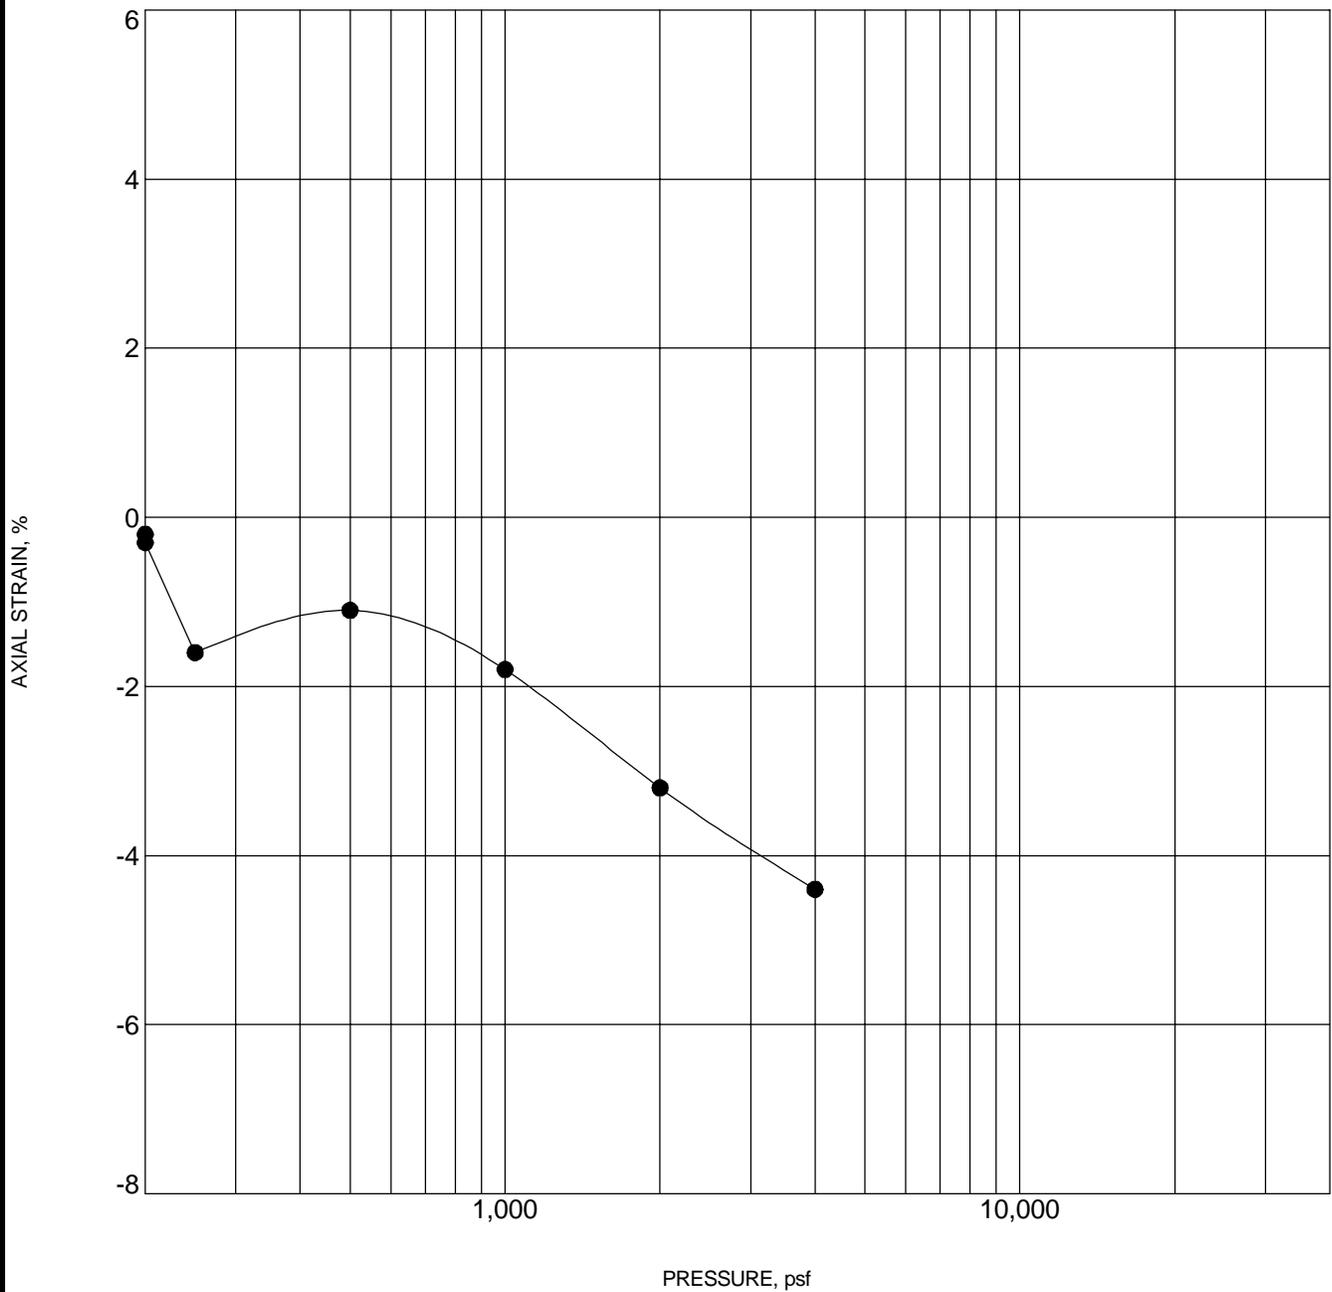
# SWELL CONSOLIDATION TEST

Specimen Identification	Classification	$\gamma_d$ , pcf	WC, %
● B-57      4 - 5 ft	CLAYEY SAND(SC)	111	9

NOTES: Sample inundated with water at 200 pounds per square foot (psf.)

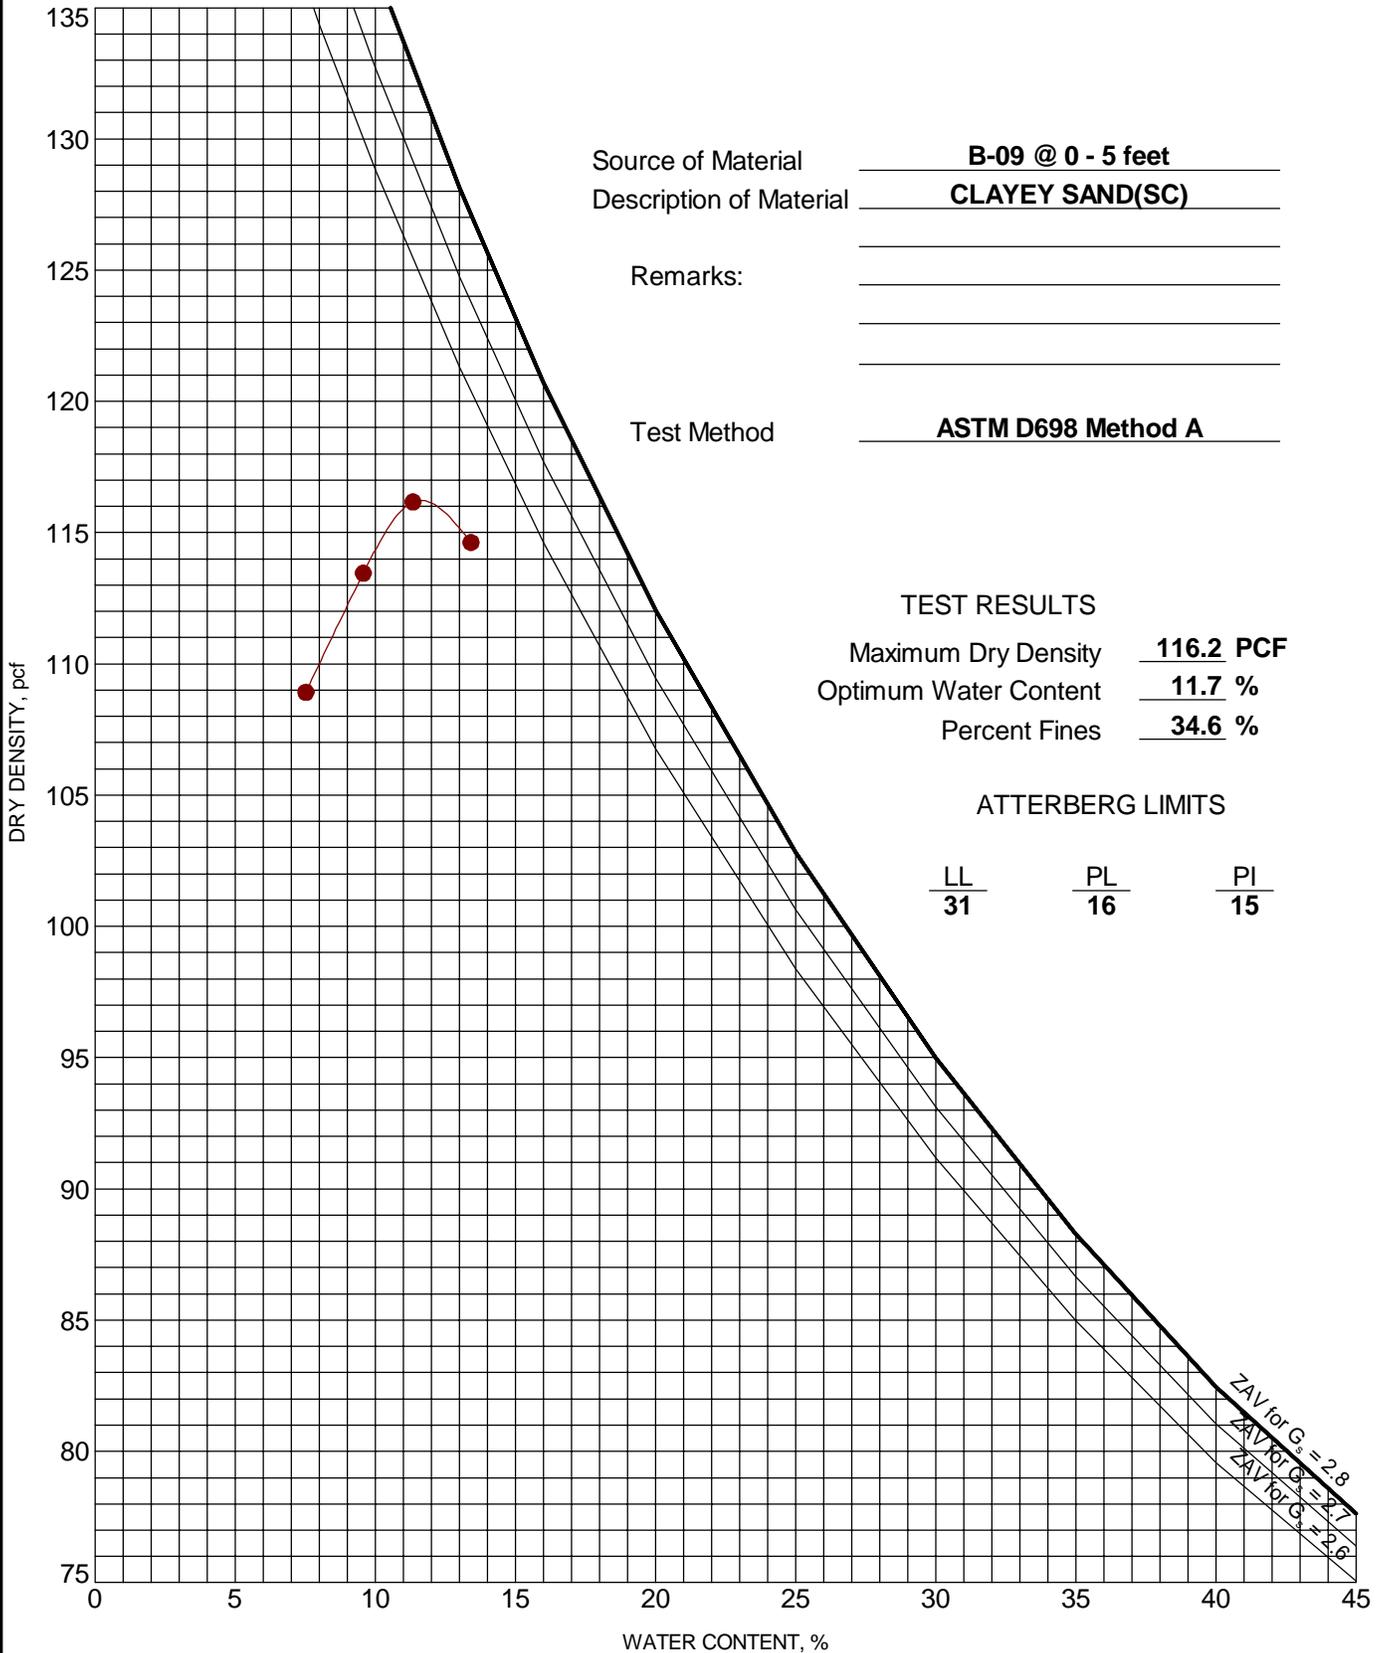
# MOISTURE-DENSITY RELATIONSHIP

Source of Material B-09 @ 0 - 5 feet  
 Description of Material CLAYEY SAND(SC)  
 Remarks: \_\_\_\_\_  
 \_\_\_\_\_  
 \_\_\_\_\_  
 Test Method ASTM D698 Method A

**TEST RESULTS**  
 Maximum Dry Density 116.2 PCF  
 Optimum Water Content 11.7 %  
 Percent Fines 34.6 %

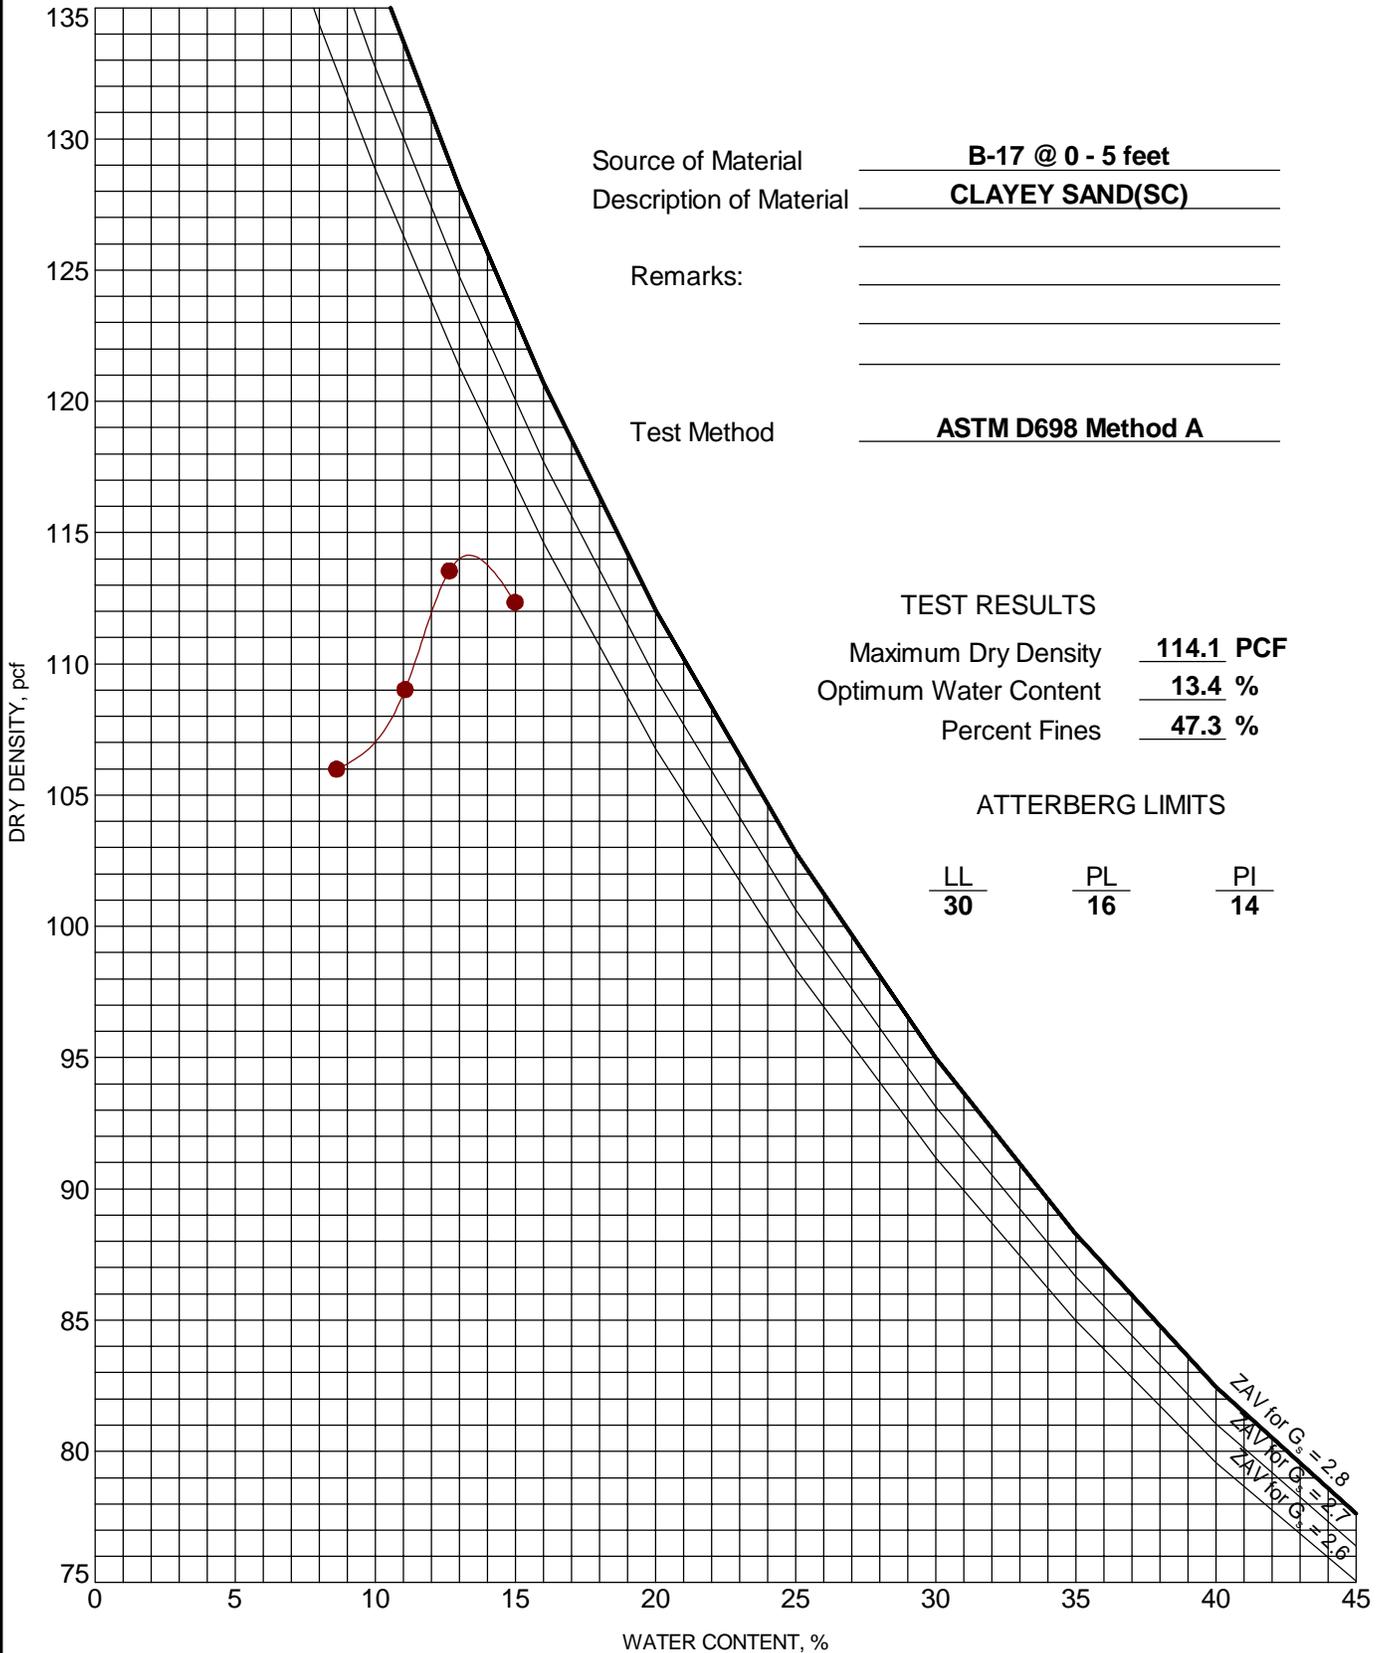
# MOISTURE-DENSITY RELATIONSHIP

Source of Material B-17 @ 0 - 5 feet  
 Description of Material CLAYEY SAND(SC)  
 Remarks: \_\_\_\_\_  
 Test Method ASTM D698 Method A

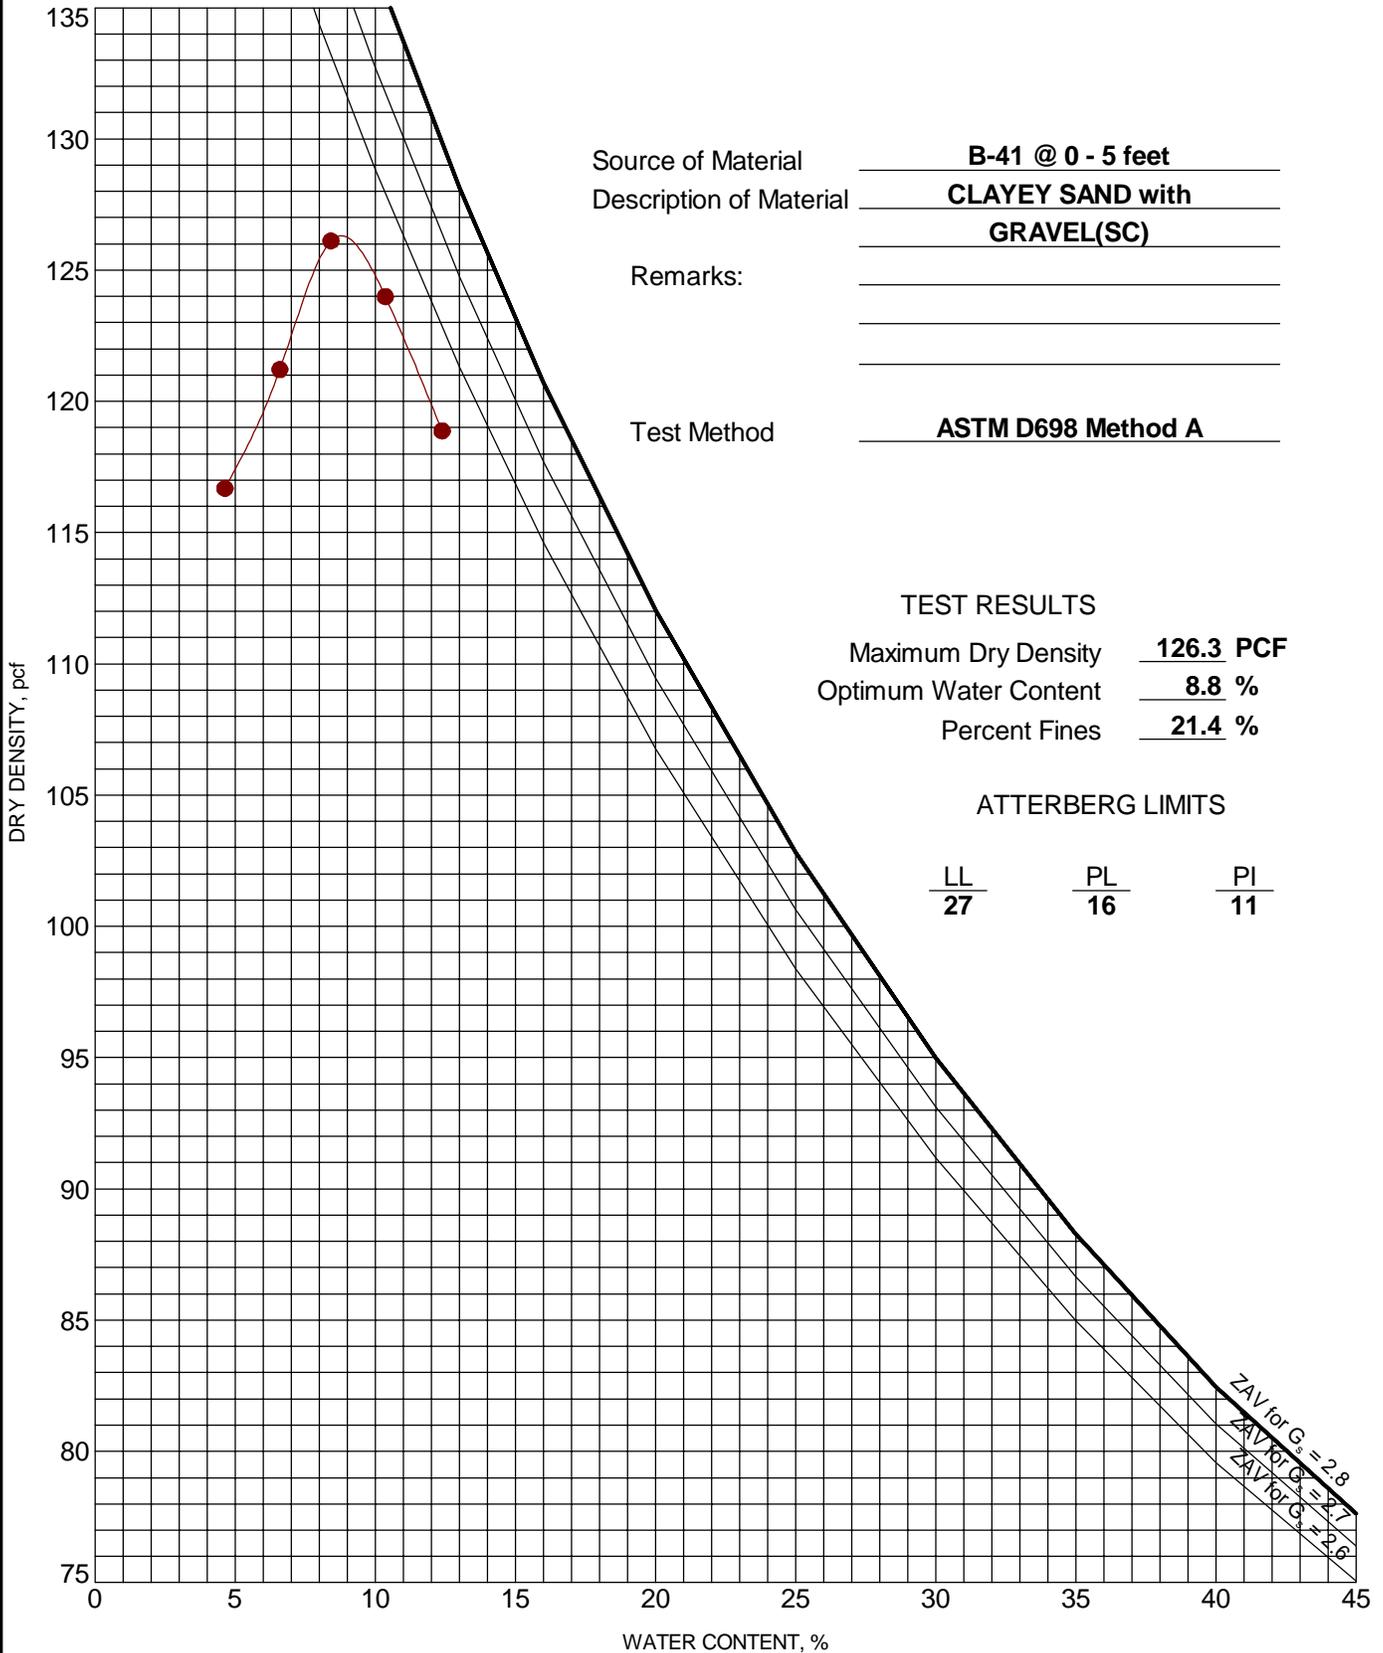
# MOISTURE-DENSITY RELATIONSHIP

Source of Material B-41 @ 0 - 5 feet  
 Description of Material CLAYEY SAND with GRAVEL(SC)  
 Remarks: \_\_\_\_\_  
 Test Method ASTM D698 Method A

**TEST RESULTS**  
 Maximum Dry Density 126.3 PCF  
 Optimum Water Content 8.8 %  
 Percent Fines 21.4 %

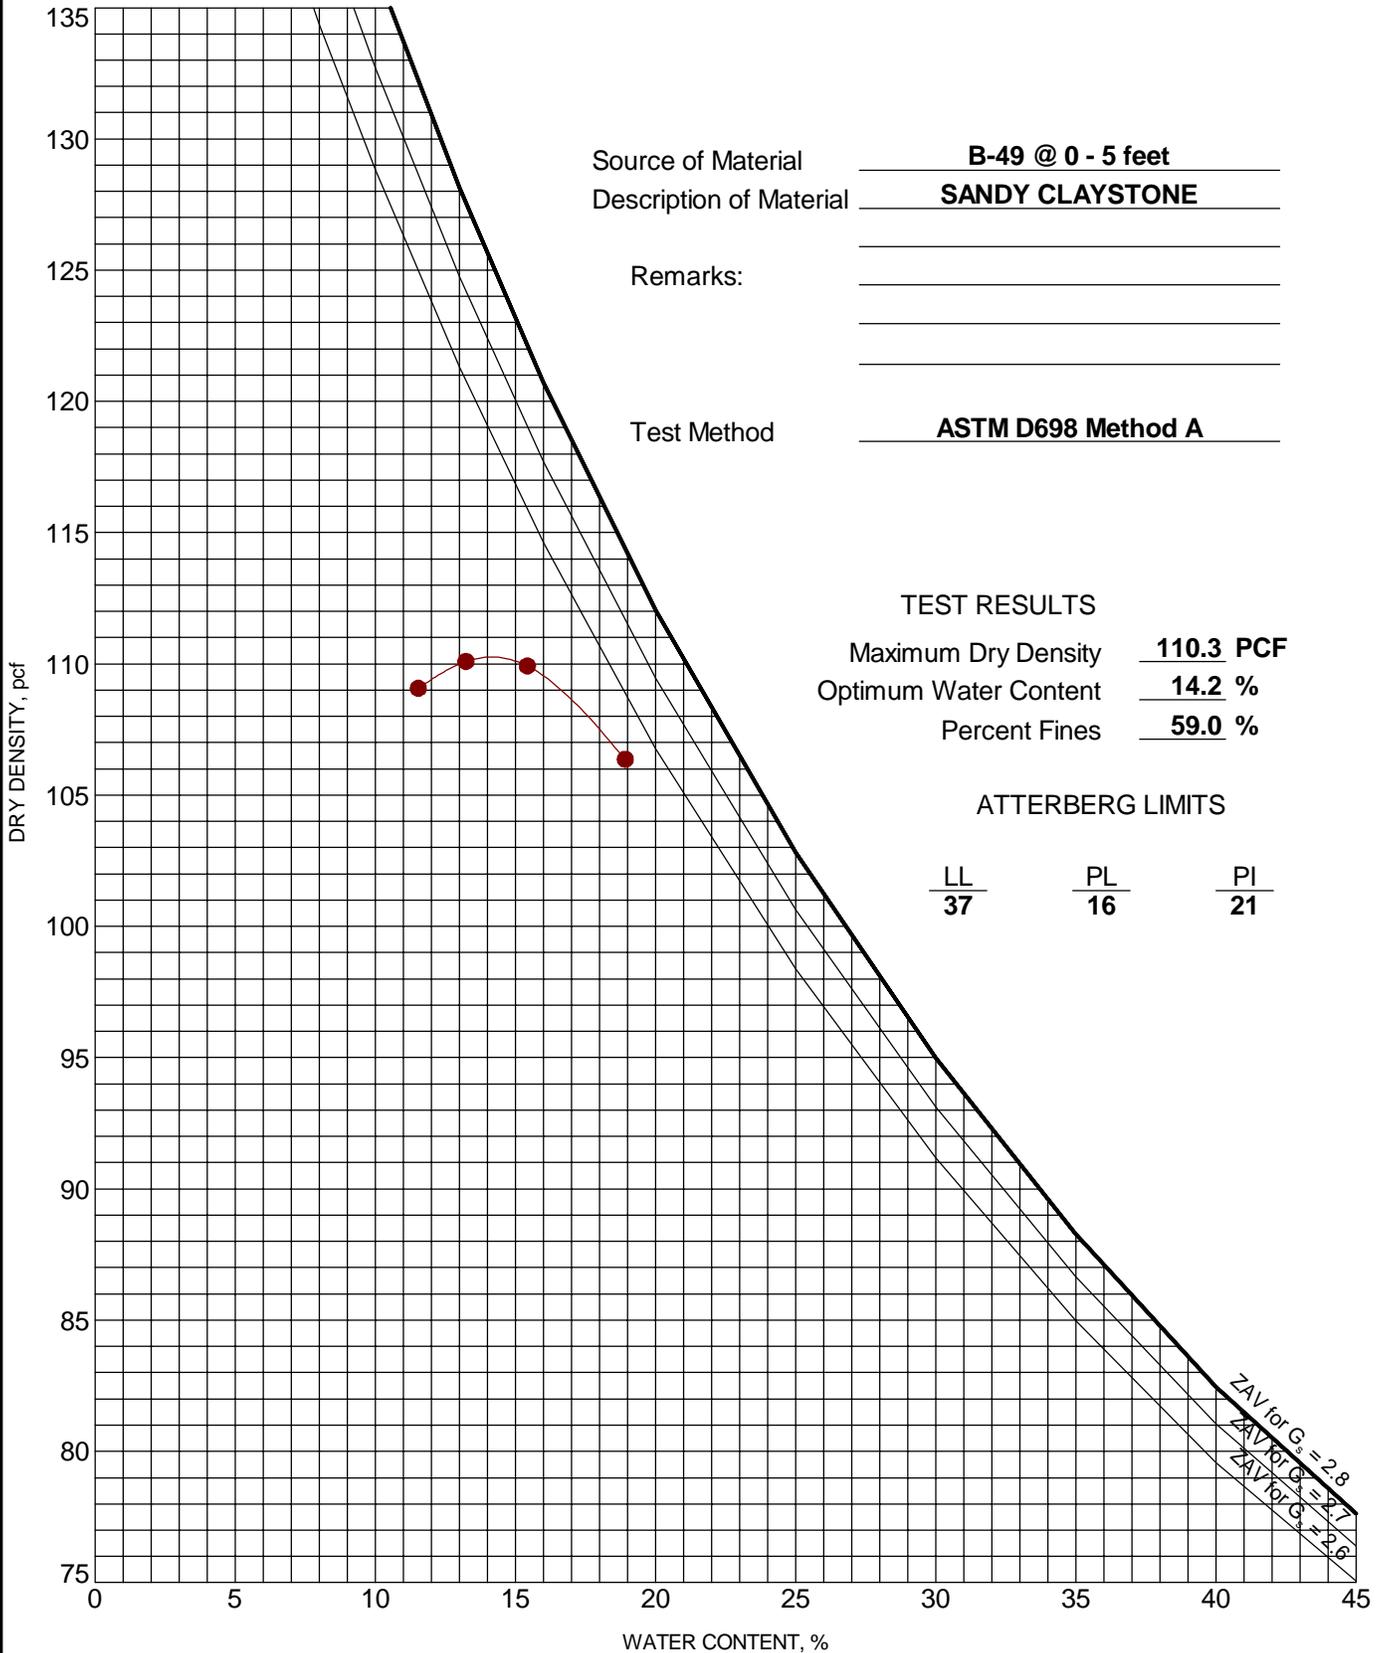
# MOISTURE-DENSITY RELATIONSHIP

Source of Material B-49 @ 0 - 5 feet  
 Description of Material SANDY CLAYSTONE  
 Remarks: \_\_\_\_\_  
 Test Method ASTM D698 Method A

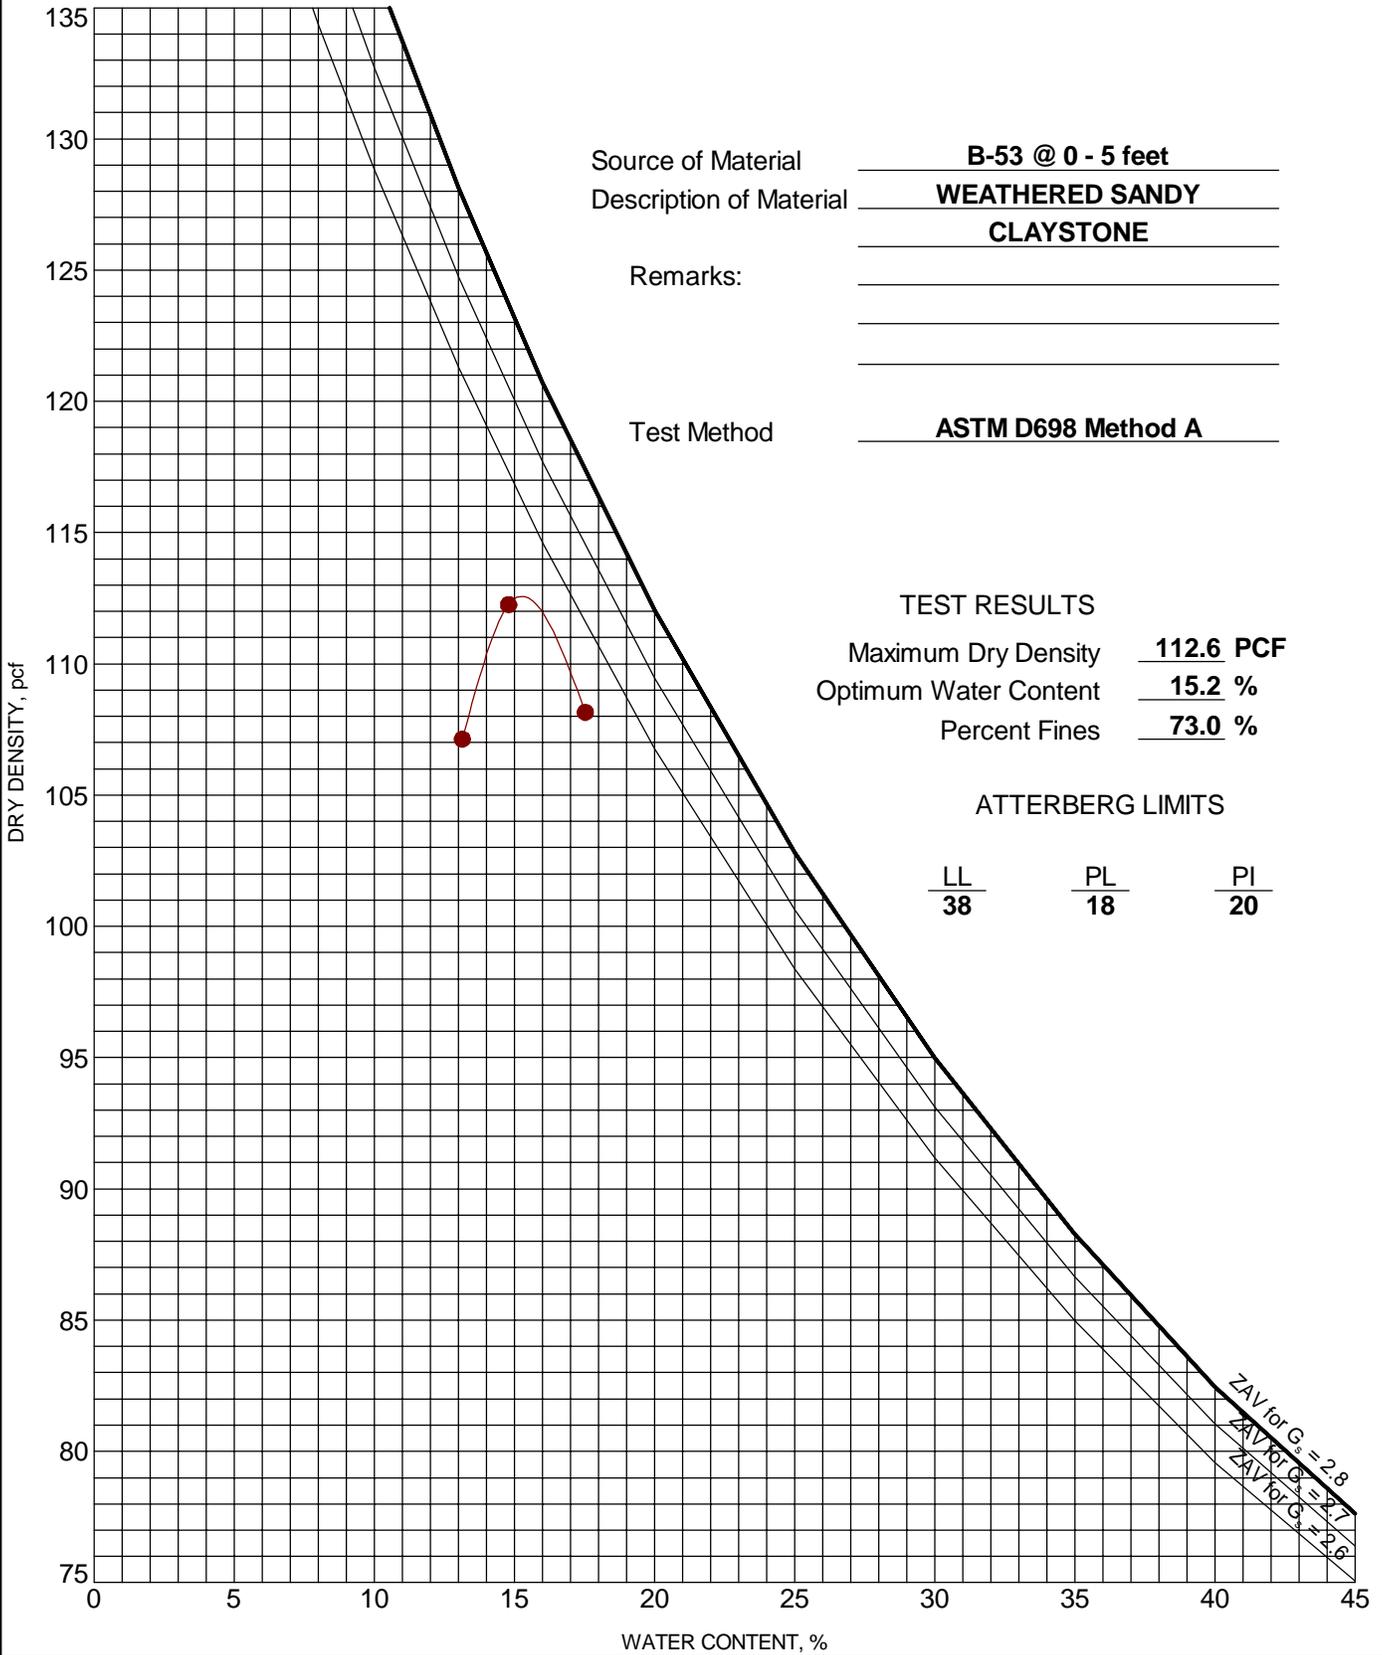
# MOISTURE-DENSITY RELATIONSHIP

Source of Material B-53 @ 0 - 5 feet  
 Description of Material WEATHERED SANDY CLAYSTONE  
 Remarks: \_\_\_\_\_  
 Test Method ASTM D698 Method A

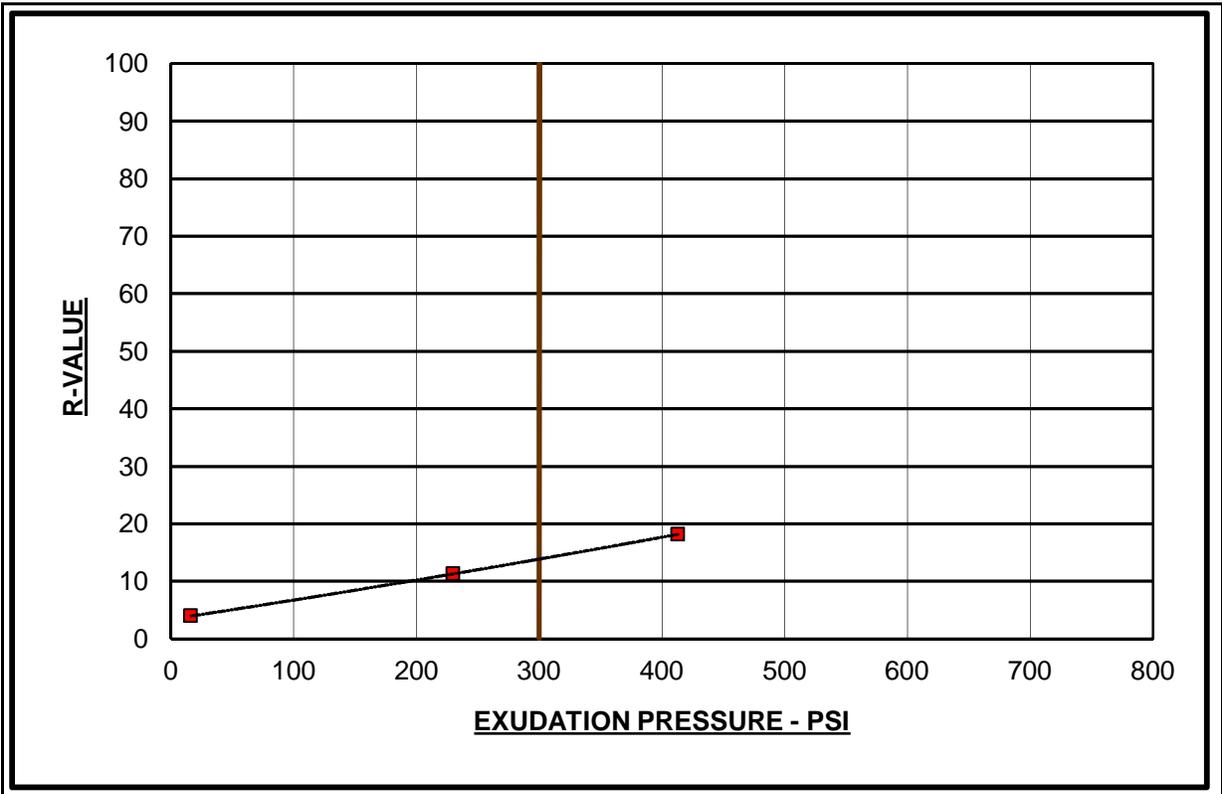
TEST SPECIMEN NO.	1	2	3
COMPACTION PRESSURE (PSI)	10	60	120
DENSITY (PCF)	117.7	119.6	123.9
MOISTURE CONTENT (%)	14.8	9.2	7.8
EXPANSION PRESSURE (PSI)	-0.17	0.00	0.00
HORIZONTAL PRESSURE @ 160 PSI	148	133	125
SAMPLE HEIGHT (INCHES)	2.54	2.45	2.55
EXUDATION PRESSURE (PSI)	16.1	229.6	413.0
CORRECTED R-VALUE	4.0	11.3	18.2
UNCORRECTED R-VALUE	4.0	11.3	18.2

R-VALUE @ 300 PSI EXUDATION PRESSURE = 14

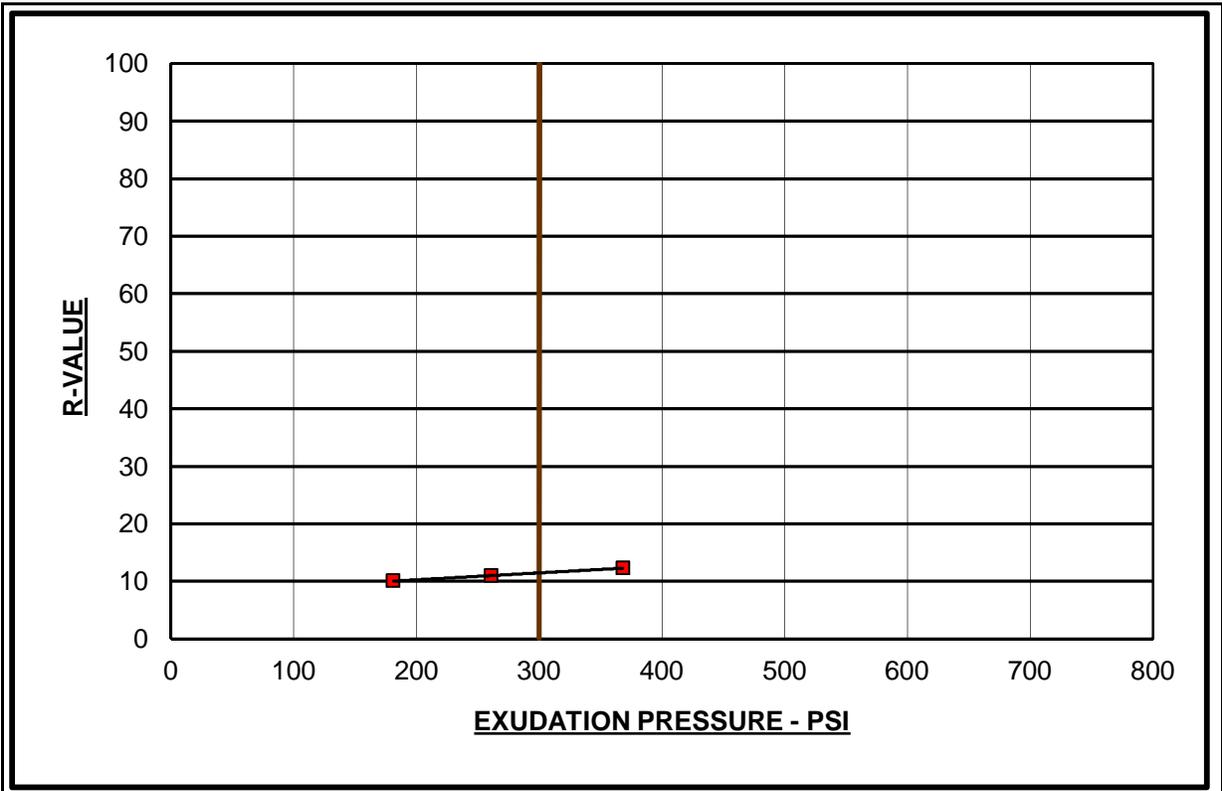
TEST SPECIMEN NO.	1	2	3
COMPACTION PRESSURE (PSI)	30	60	90
DENSITY (PCF)	109.2	115.6	119.7
MOISTURE CONTENT (%)	18.9	16.3	14.8
EXPANSION PRESSURE (PSI)	-0.40	-0.16	0.11
HORIZONTAL PRESSURE @ 160 PSI	136	134	132
SAMPLE HEIGHT (INCHES)	2.76	2.65	2.63
EXUDATION PRESSURE (PSI)	181.1	260.7	368.2
CORRECTED R-VALUE	10.0	11.0	12.3
UNCORRECTED R-VALUE	9.1	10.4	11.7

R-VALUE @ 300 PSI EXUDATION PRESSURE = 11
