# Geotechnical Engineering Pavement Thickness Design Report

Centennial Boulevard Reconstruction  
West Fillmore Street to Garden of the Gods Road  
Colorado Springs, Colorado

Terracon Project No. 23155014

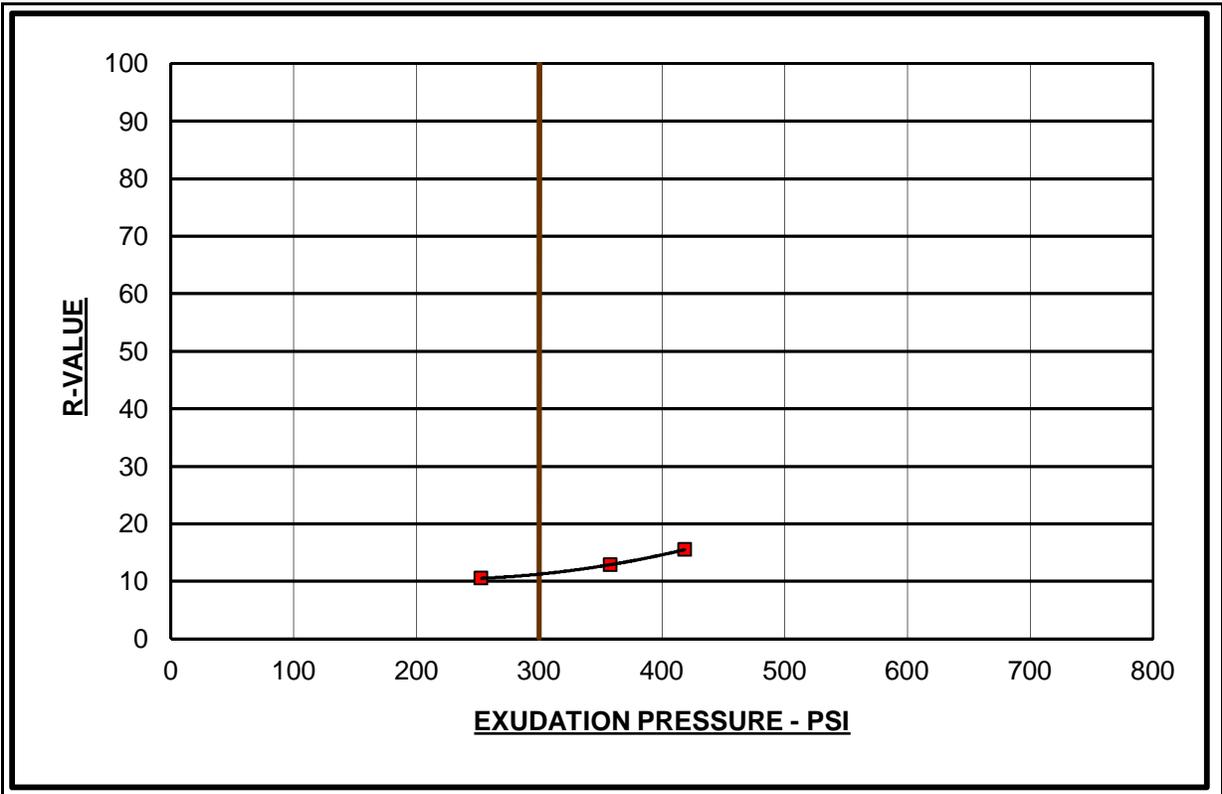
TEST SPECIMEN NO.	1	2	3
COMPACTION PRESSURE (PSI)	60	90	120
DENSITY (PCF)	117.2	119.1	123.2
MOISTURE CONTENT (%)	16.5	14.8	12.8
EXPANSION PRESSURE (PSI)	-0.16	0.12	0.31
HORIZONTAL PRESSURE @ 160 PSI	135	131	127
SAMPLE HEIGHT (INCHES)	2.61	2.64	2.68
EXUDATION PRESSURE (PSI)	252.7	357.8	418.7
CORRECTED R-VALUE	10.5	12.9	15.5
UNCORRECTED R-VALUE	10.1	12.2	14.5

R-VALUE @ 300 PSI EXUDATION PRESSURE = 12

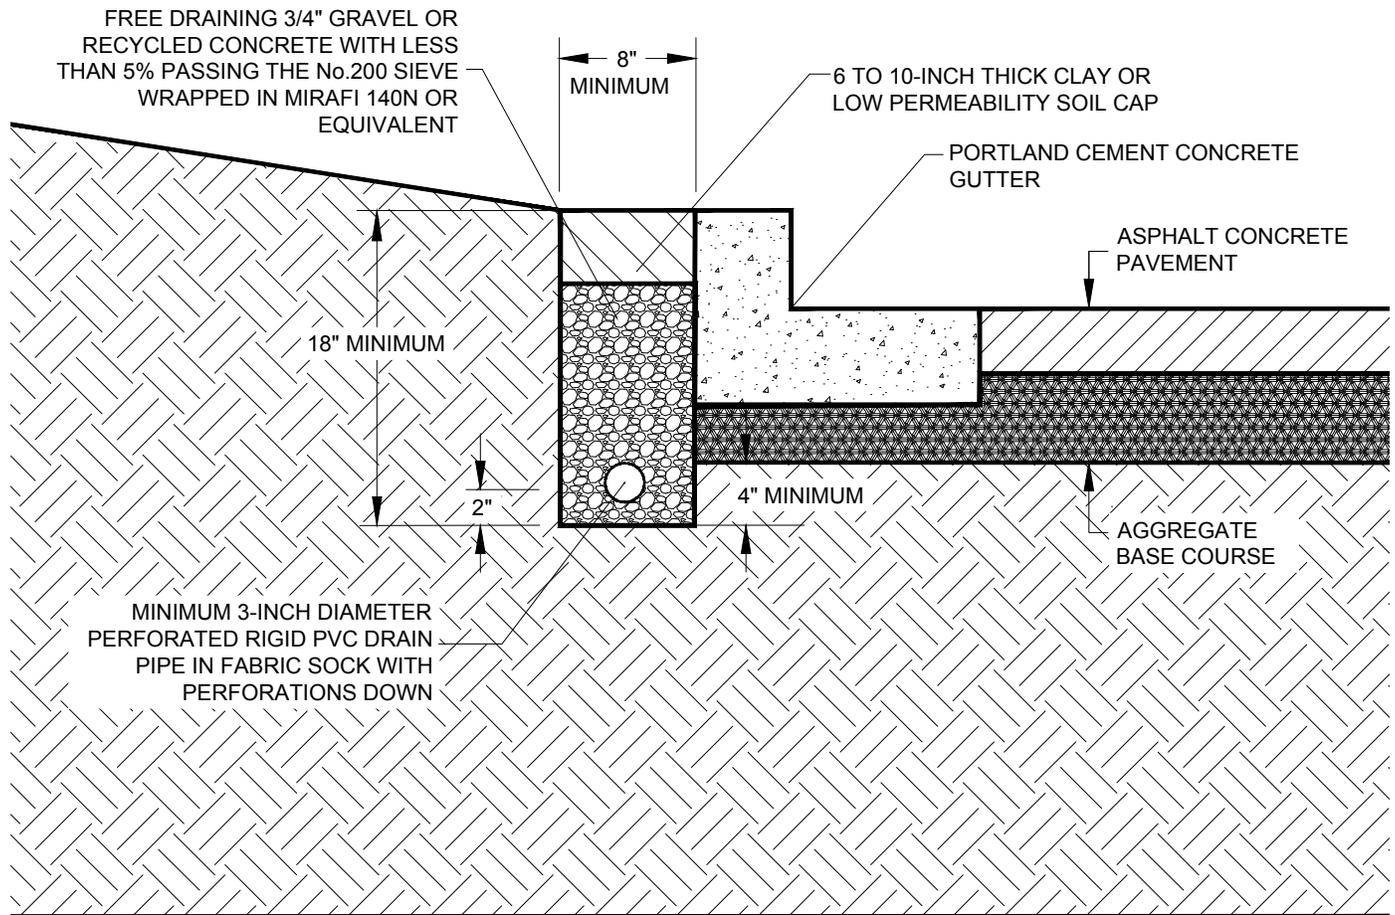
**NOTE:** DRAIN PIPE SHOULD BE SLOPED AT A MINIMUM OF 1/8-INCH PER FOOT TO STORM SEWER OR OTHER SUITABLE OUTLET

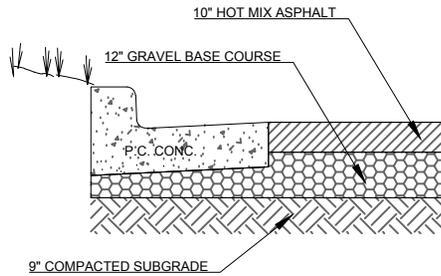
①  
C-3 R-VALUE = 5  
FLEXIBLE PAVEMENT SECTION  
N.T.S.

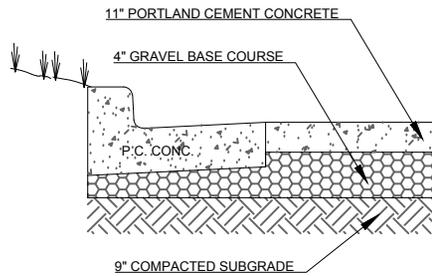
②  
C-3 R-VALUE = 5  
RIGID PAVEMENT SECTION  
N.T.S.

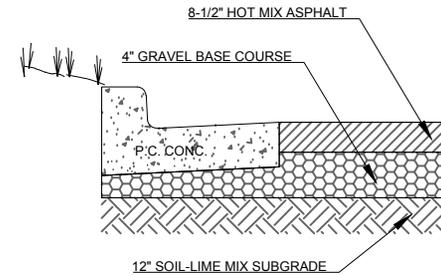
③  
C-3 R-VALUE = 5  
FLEXIBLE PAVEMENT SECTION (SOIL-LIME MIX)  
N.T.S.

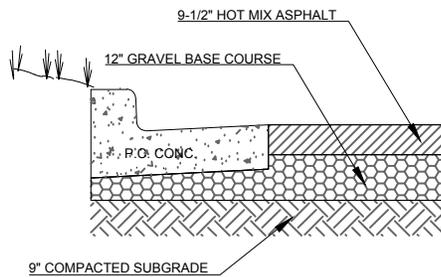
⑤  
C-3 R-VALUE = 11  
FLEXIBLE PAVEMENT SECTION  
N.T.S.

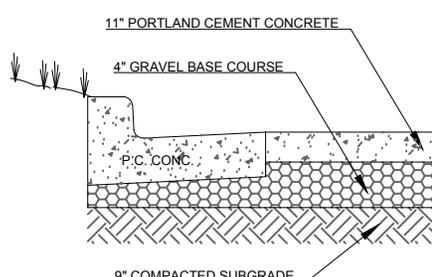
⑥  
C-3 R-VALUE = 11  
RIGID PAVEMENT SECTION  
N.T.S.

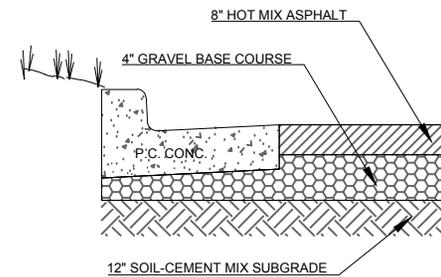
⑦  
C-3 R-VALUE = 11  
FLEXIBLE PAVEMENT SECTION (SOIL-CEMENT MIX)  
N.T.S.

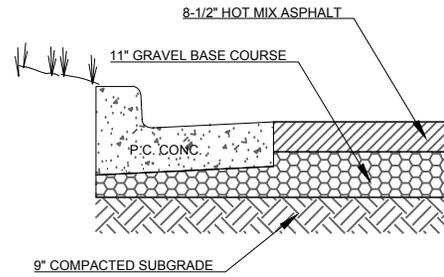
1  
C-4  
R-VALUE = 20  
FLEXIBLE PAVEMENT SECTION  
N.T.S.

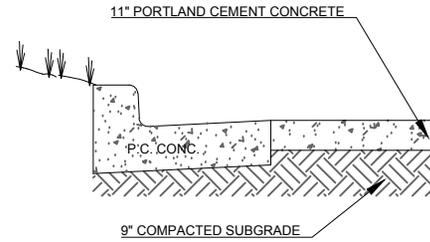
2  
C-4  
R-VALUE = 20  
RIGID PAVEMENT SECTION  
N.T.S.

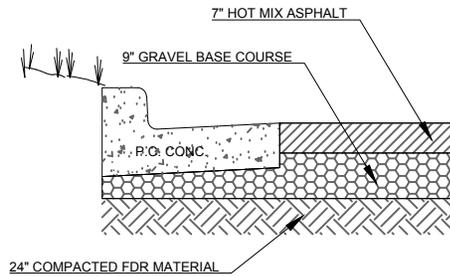
5  
C-3  
R-VALUE = 40  
FLEXIBLE PAVEMENT SECTION (FULL-DEPTH RECLAMATION)  
N.T.S.

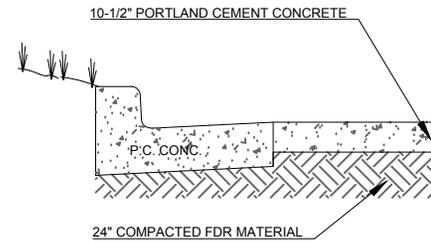
7  
C-3  
R-VALUE = 40  
RIGID PAVEMENT SECTION (FULL-DEPTH RECLAMATION)  
N.T.S.

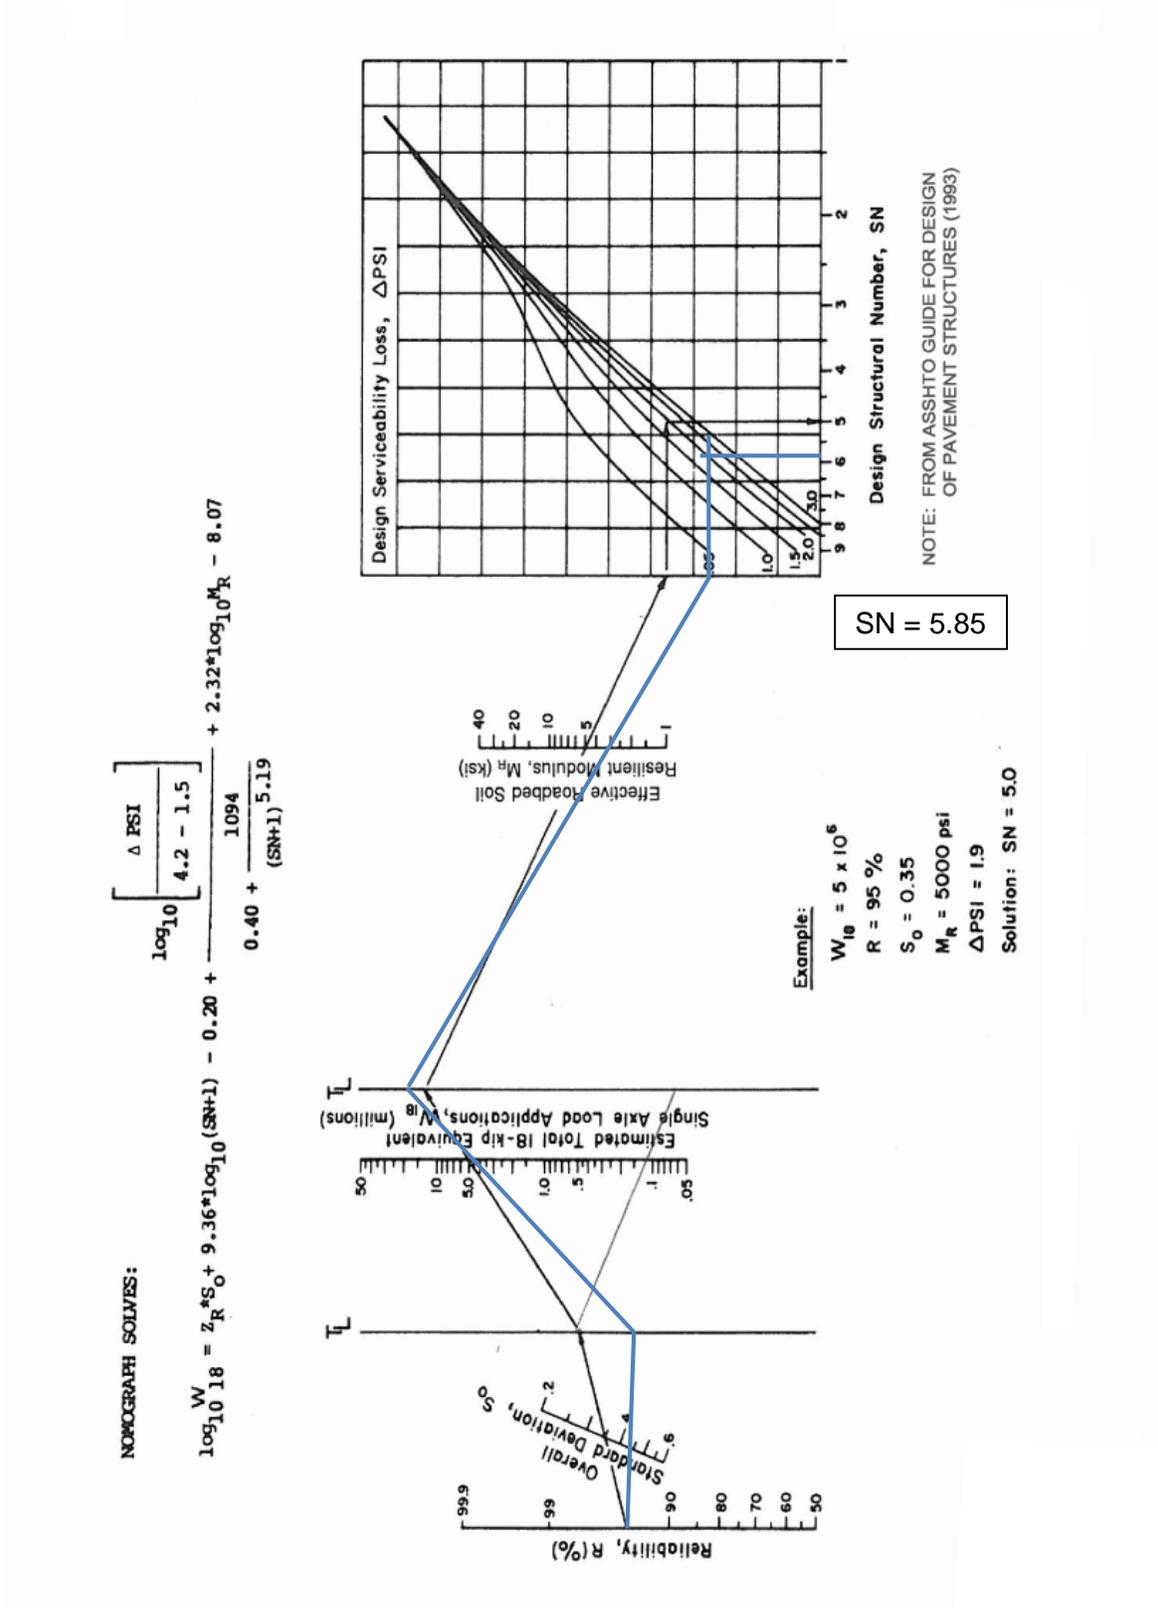
## Design chart for flexible pavements

R-VALUE = 5

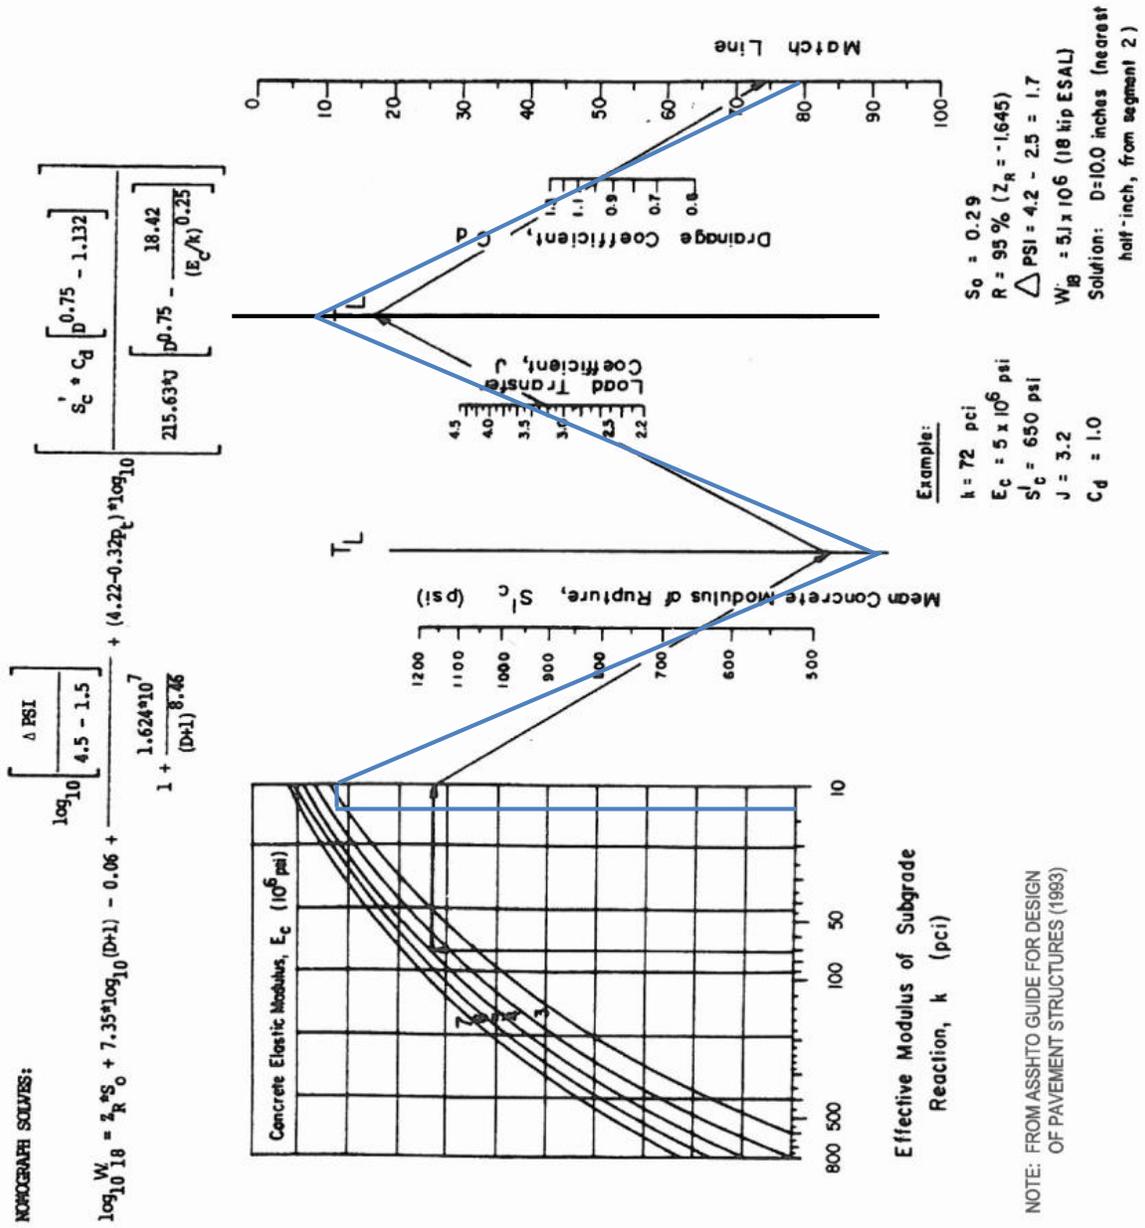
### Design chart for rigid pavements

R-VALUE = 5

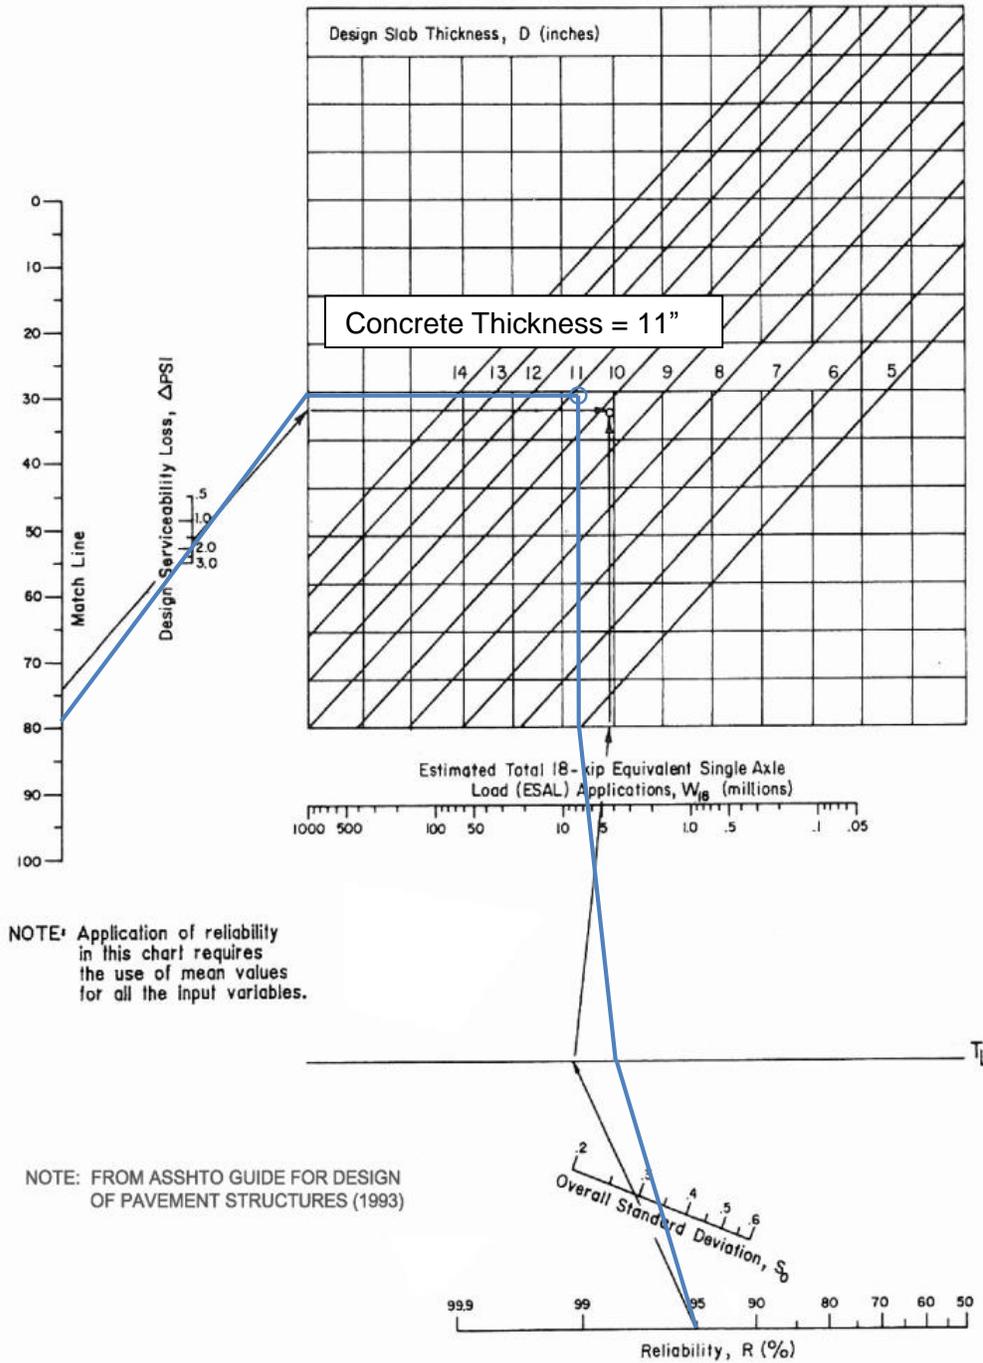
### Design chart for rigid pavements (Cont.)

R-VALUE = 5

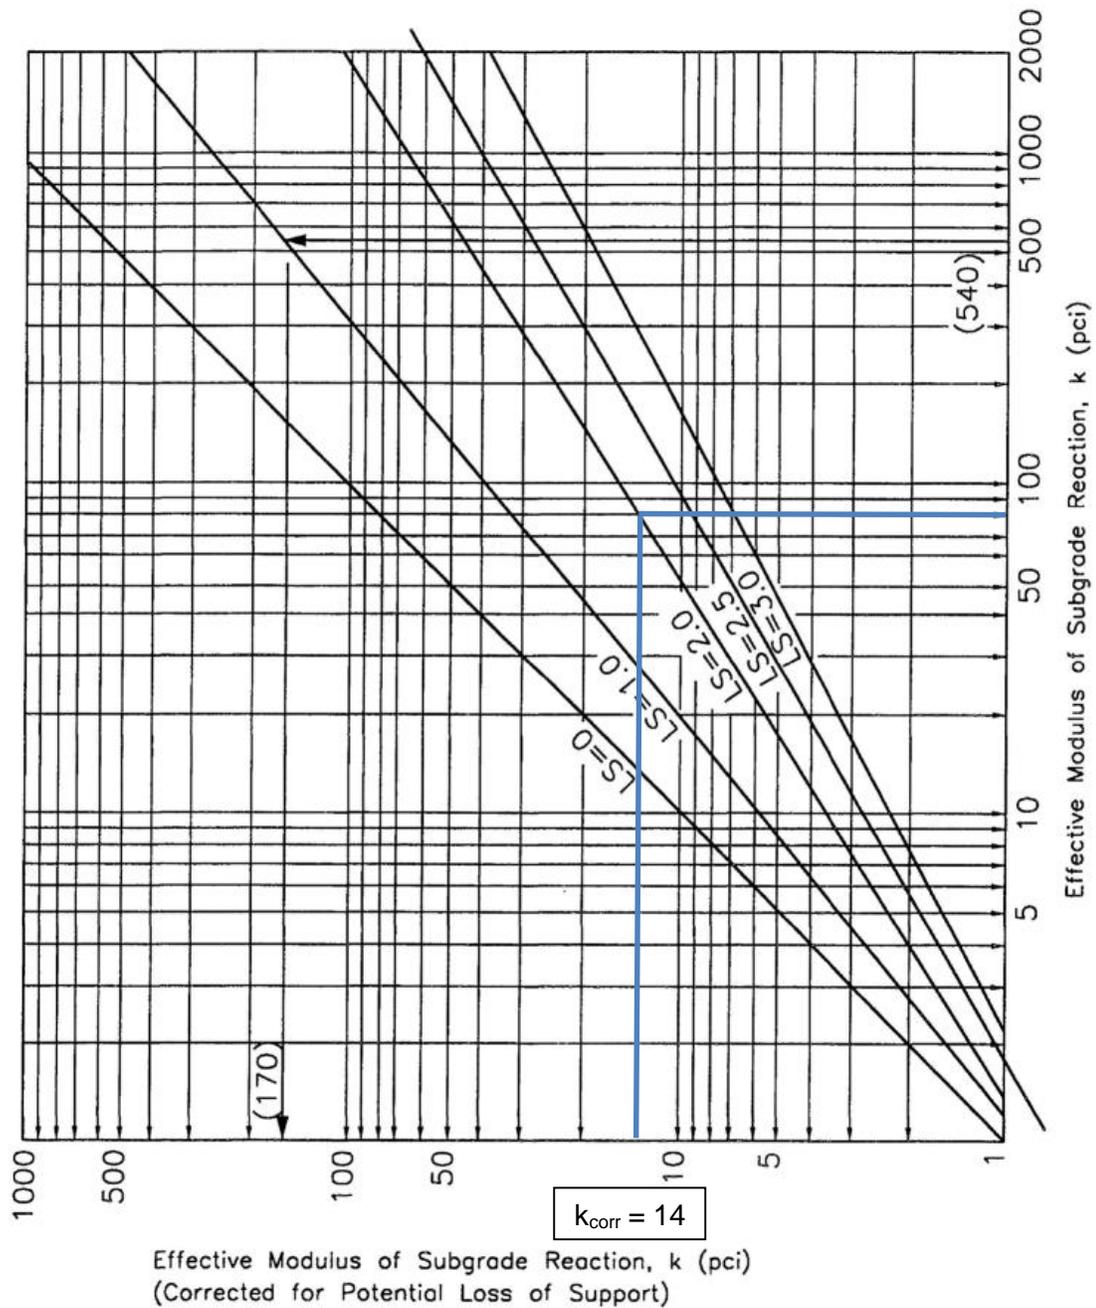
# CORRECTION OF EFFECTIVE MODULUS OF SUBGRADE REACTION FOR LOSS OF SUPPORT

R-VALUE = 5

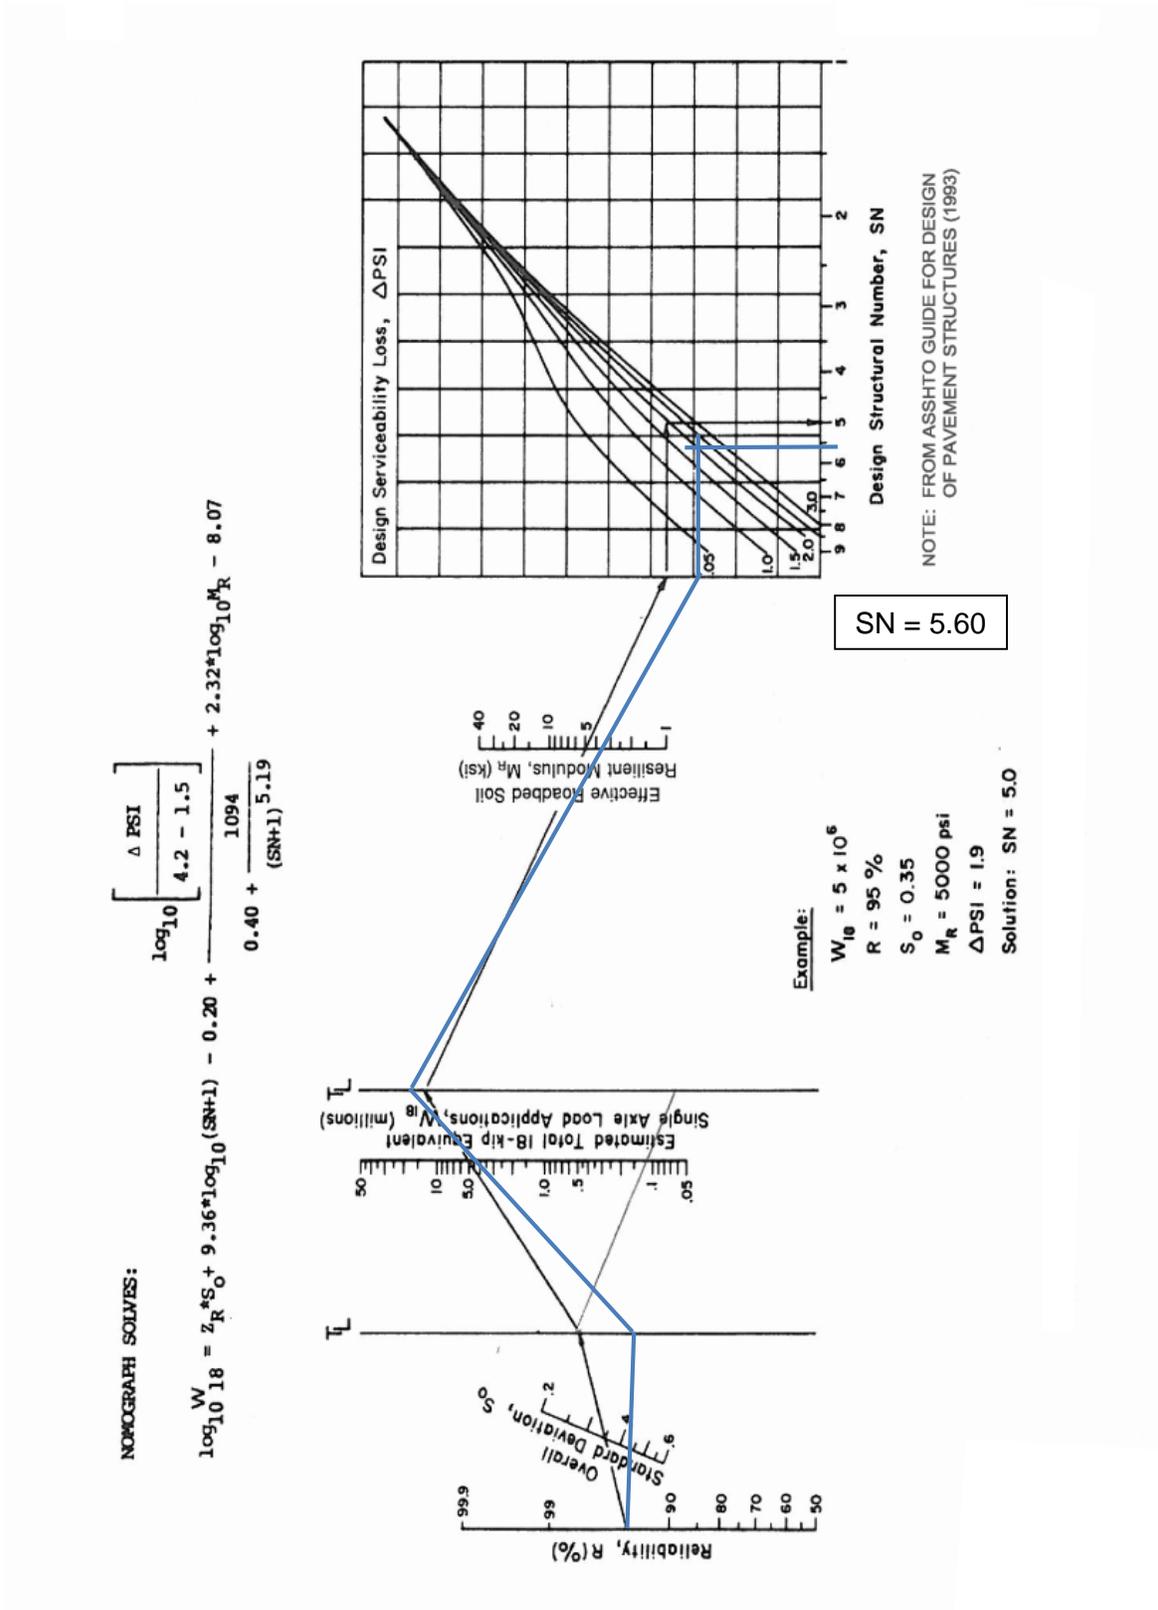
## Design chart for flexible pavements

R-VALUE = 11

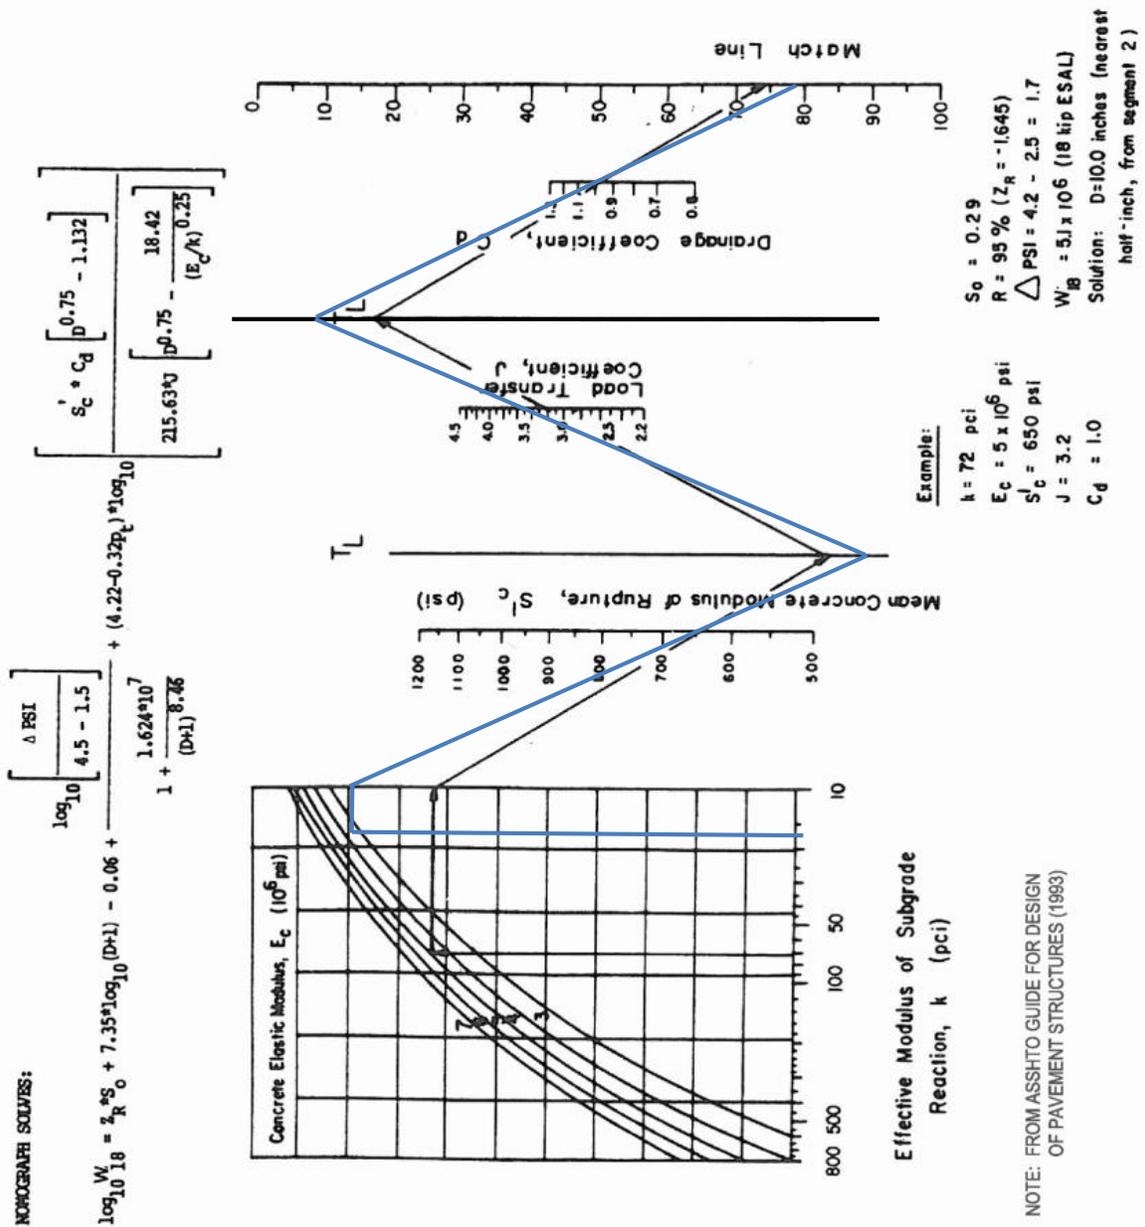
### Design chart for rigid pavements

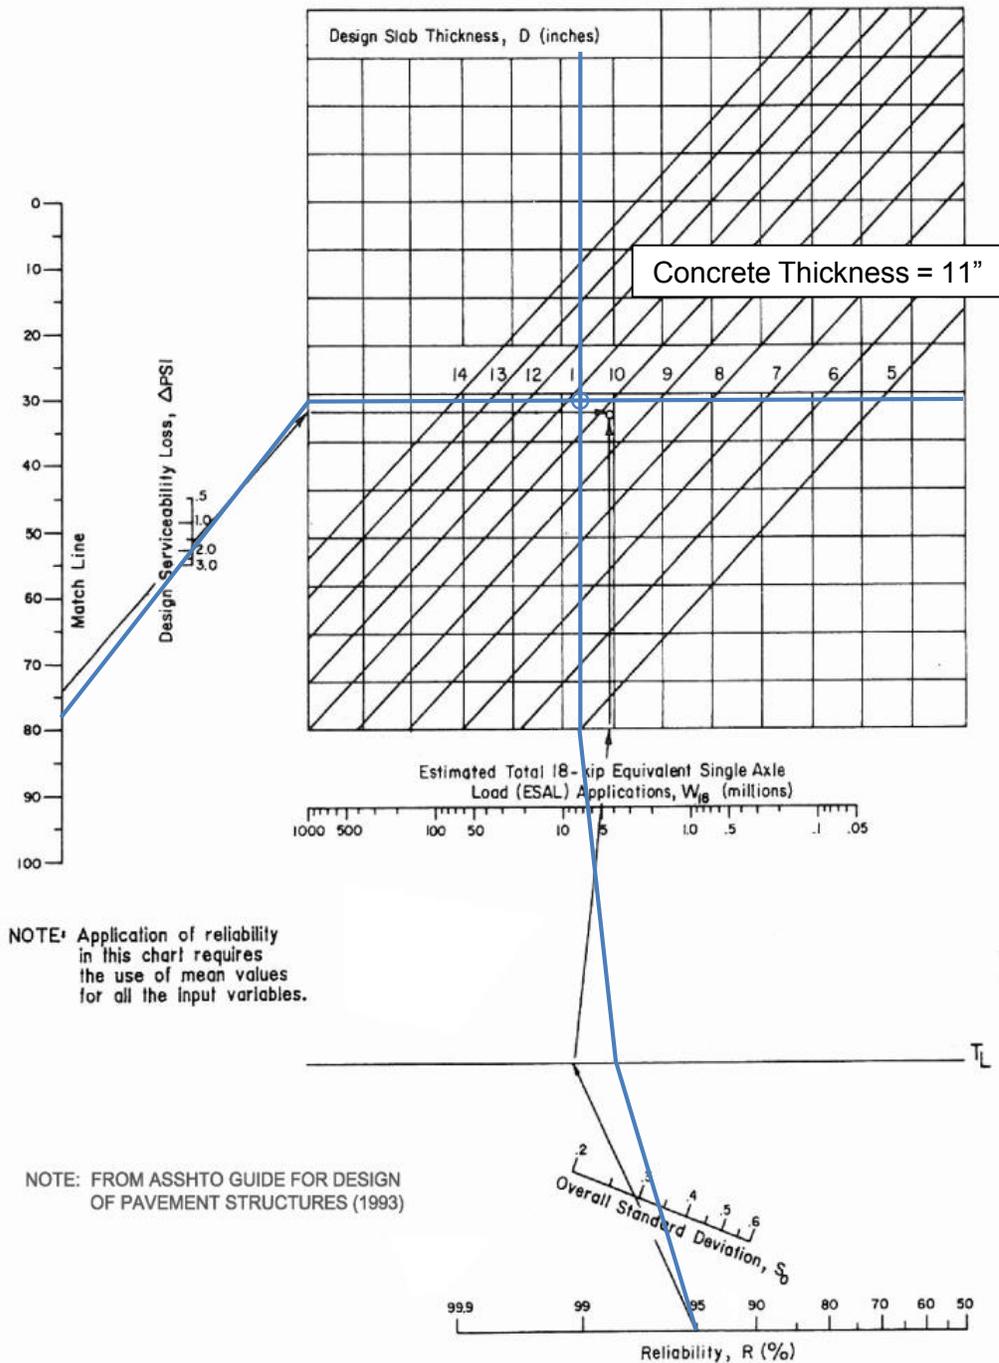
### Design chart for rigid pavements (Cont.)

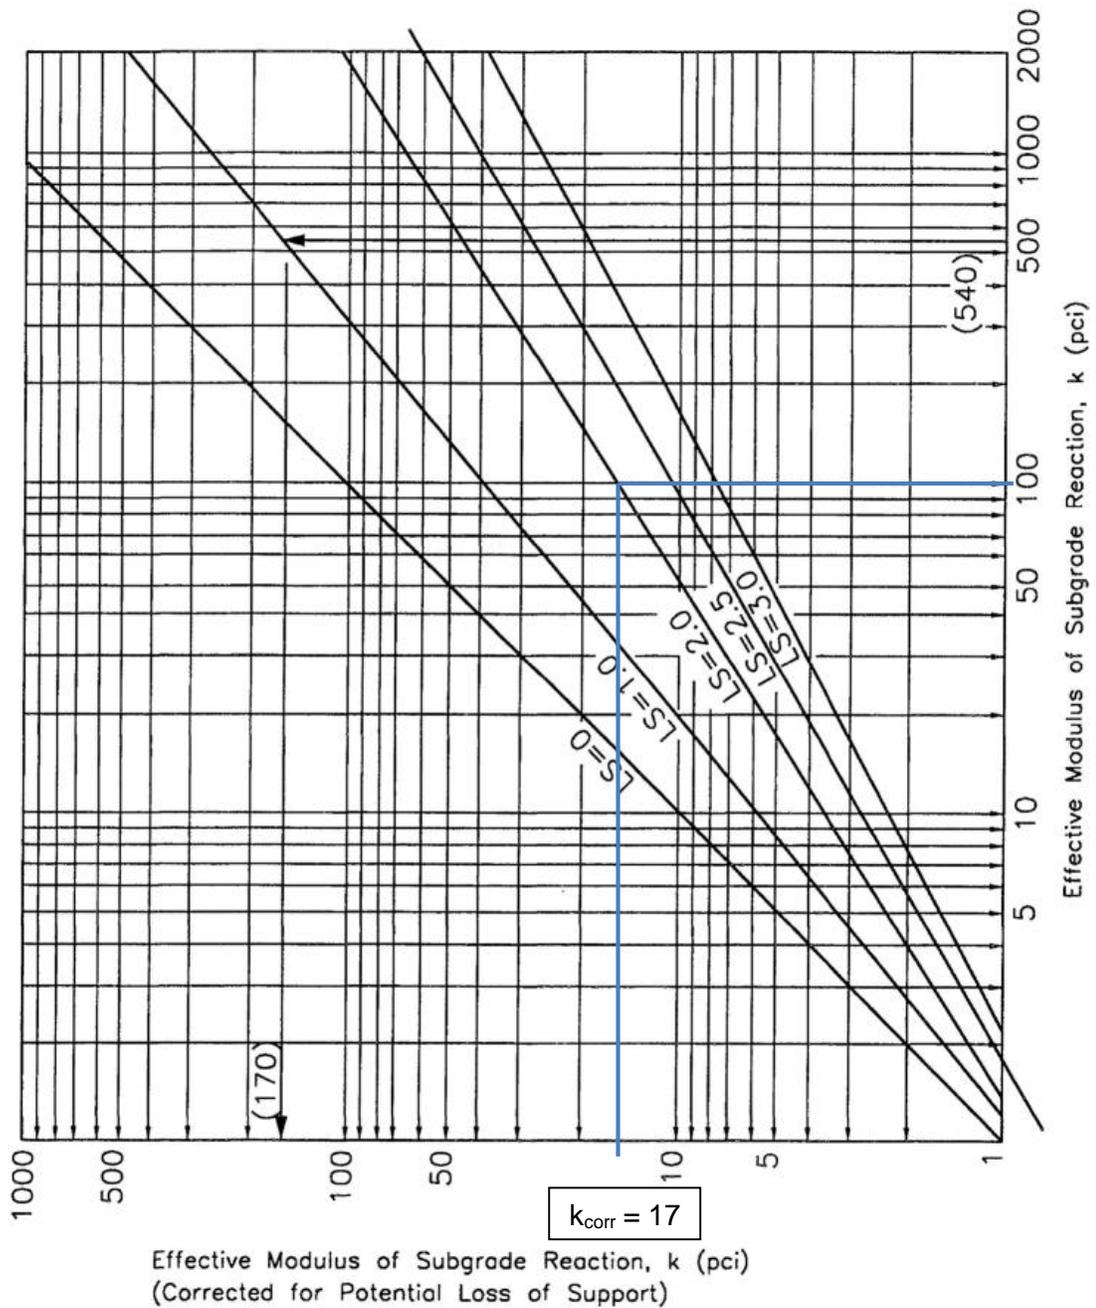
## CORRECTION OF EFFECTIVE MODULUS OF SUBGRADE REACTION FOR LOSS OF SUPPORT

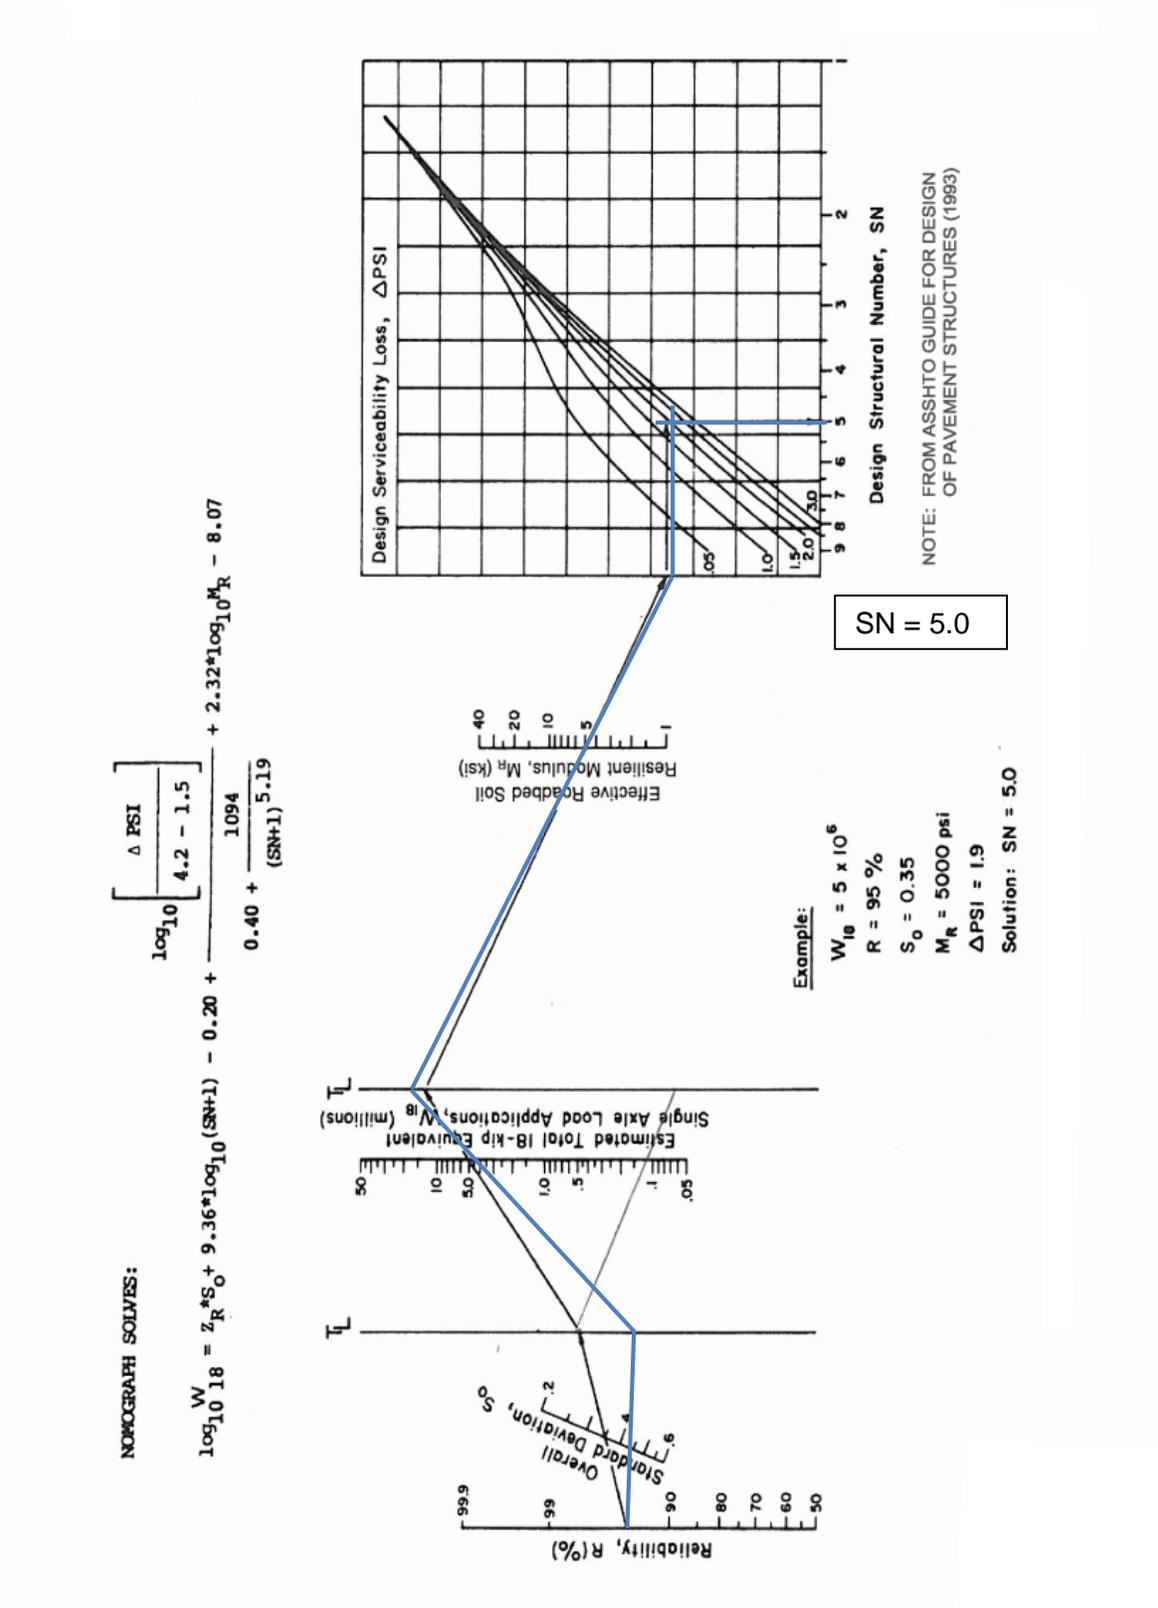
## Design chart for flexible pavements

R-VALUE = 20

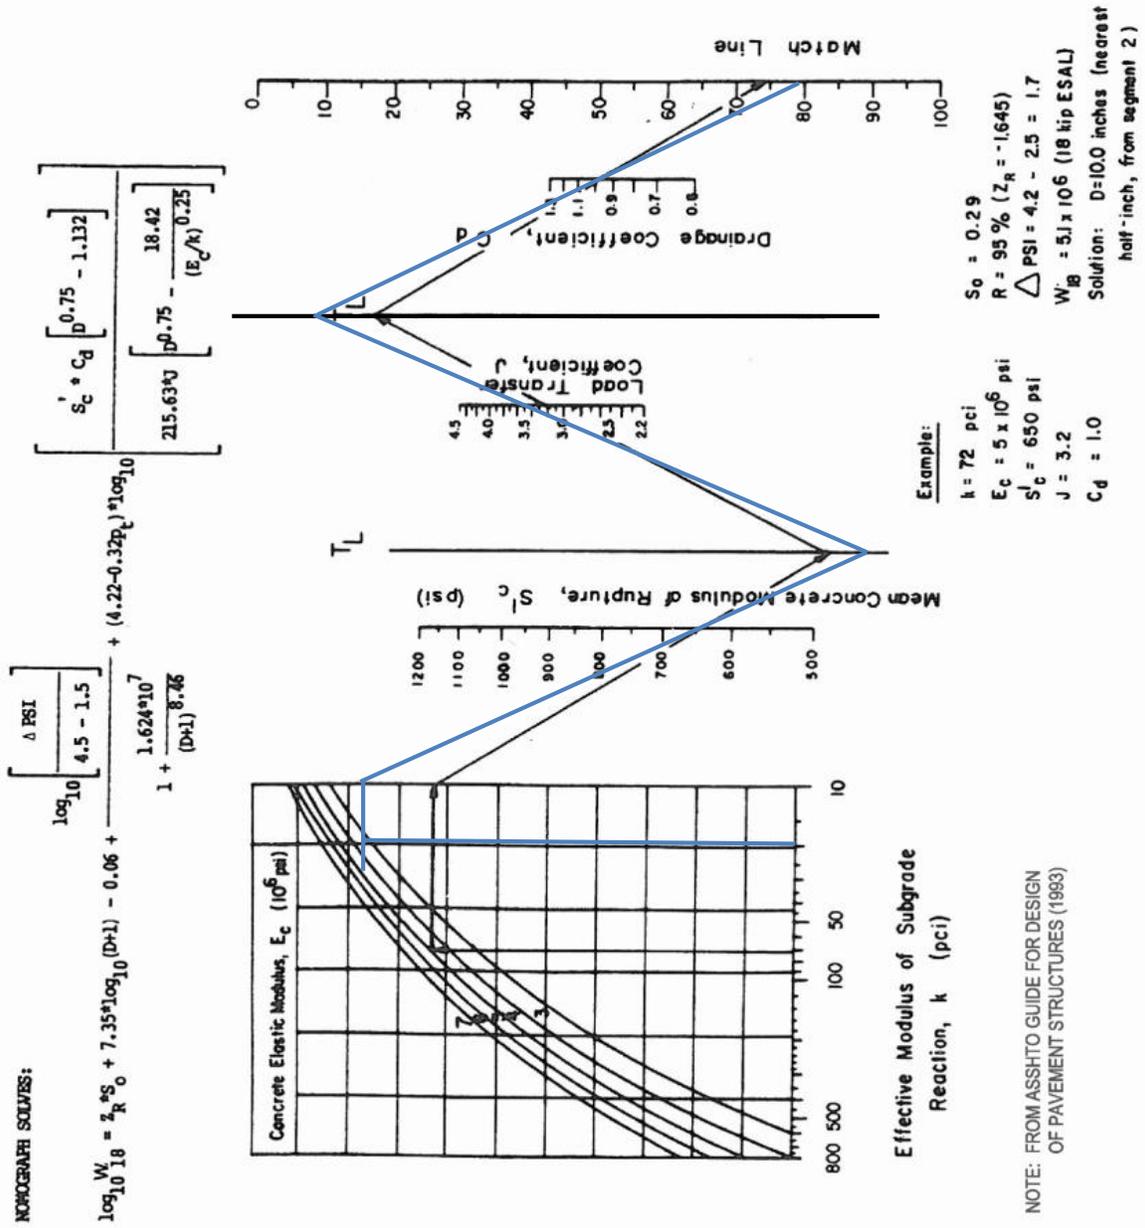
### Design chart for rigid pavements

R-VALUE = 20

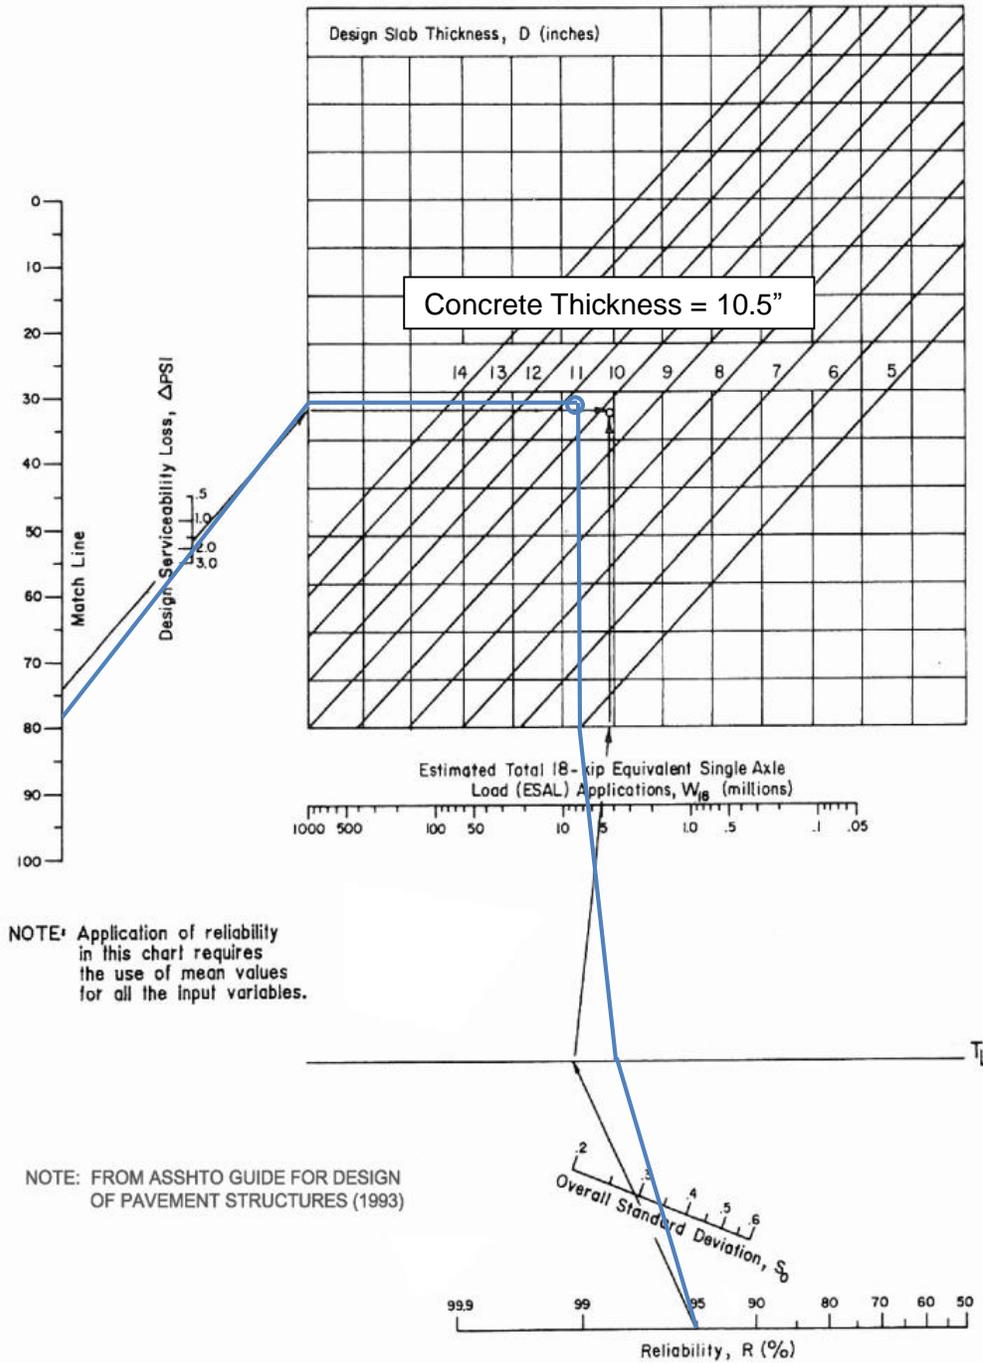
### Design chart for rigid pavements (Cont.)

R-VALUE = 20

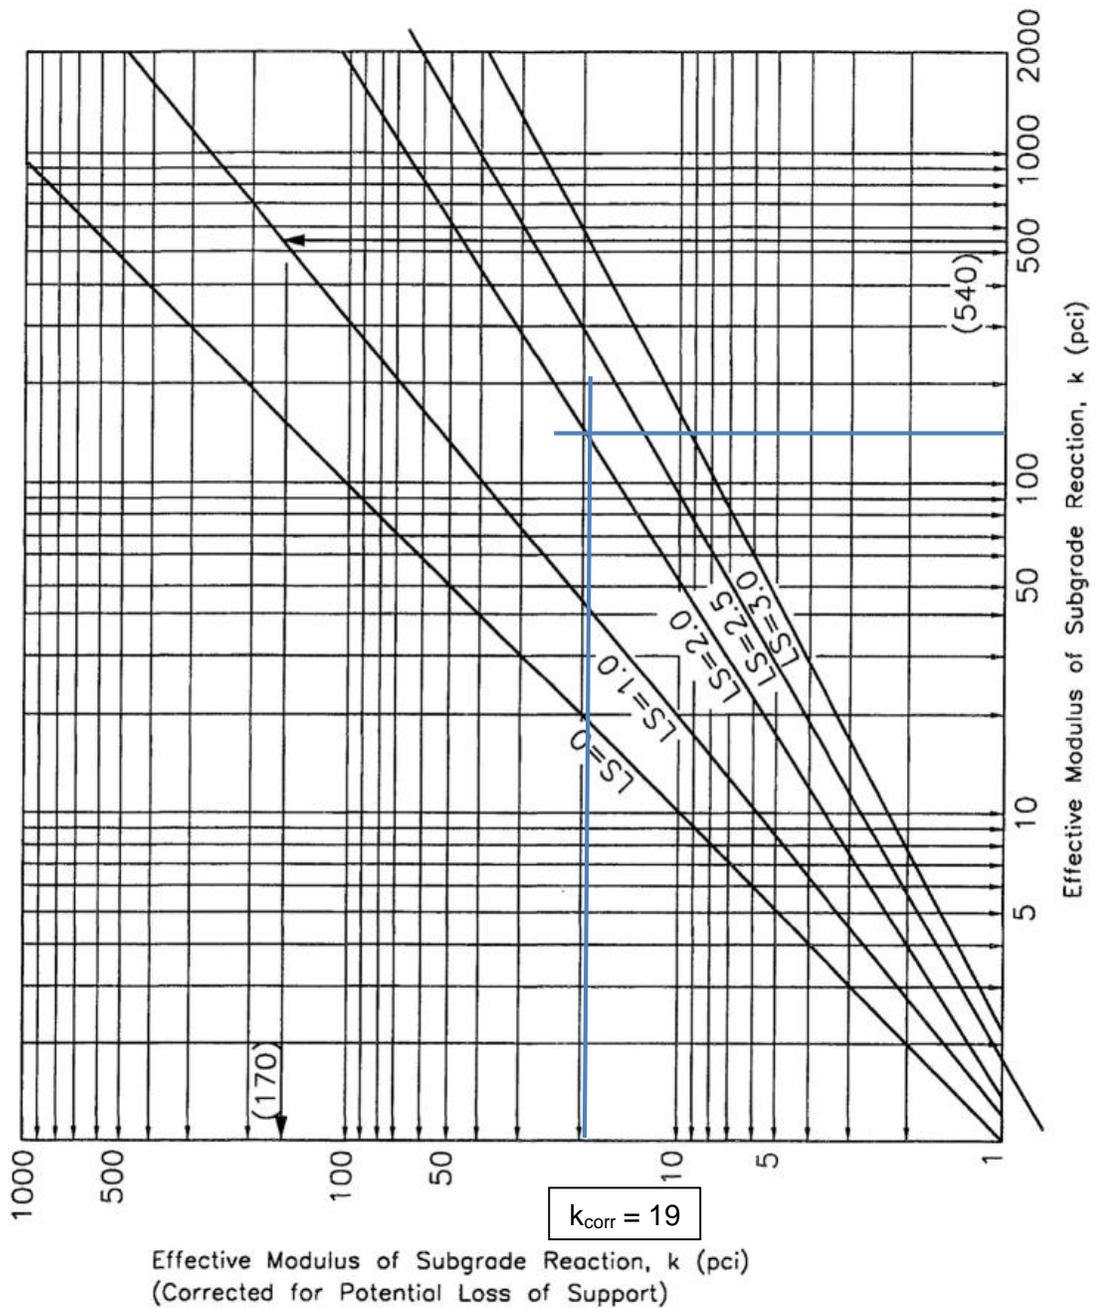
# CORRECTION OF EFFECTIVE MODULUS OF SUBGRADE REACTION FOR LOSS OF SUPPORT

R-VALUE = 20
