# Geotechnical Engineering Pavement Thickness Design Report

Centennial Boulevard Reconstruction  
West Fillmore Street to Garden of the Gods Road  
Colorado Springs, Colorado

Terracon Project No. 23155014

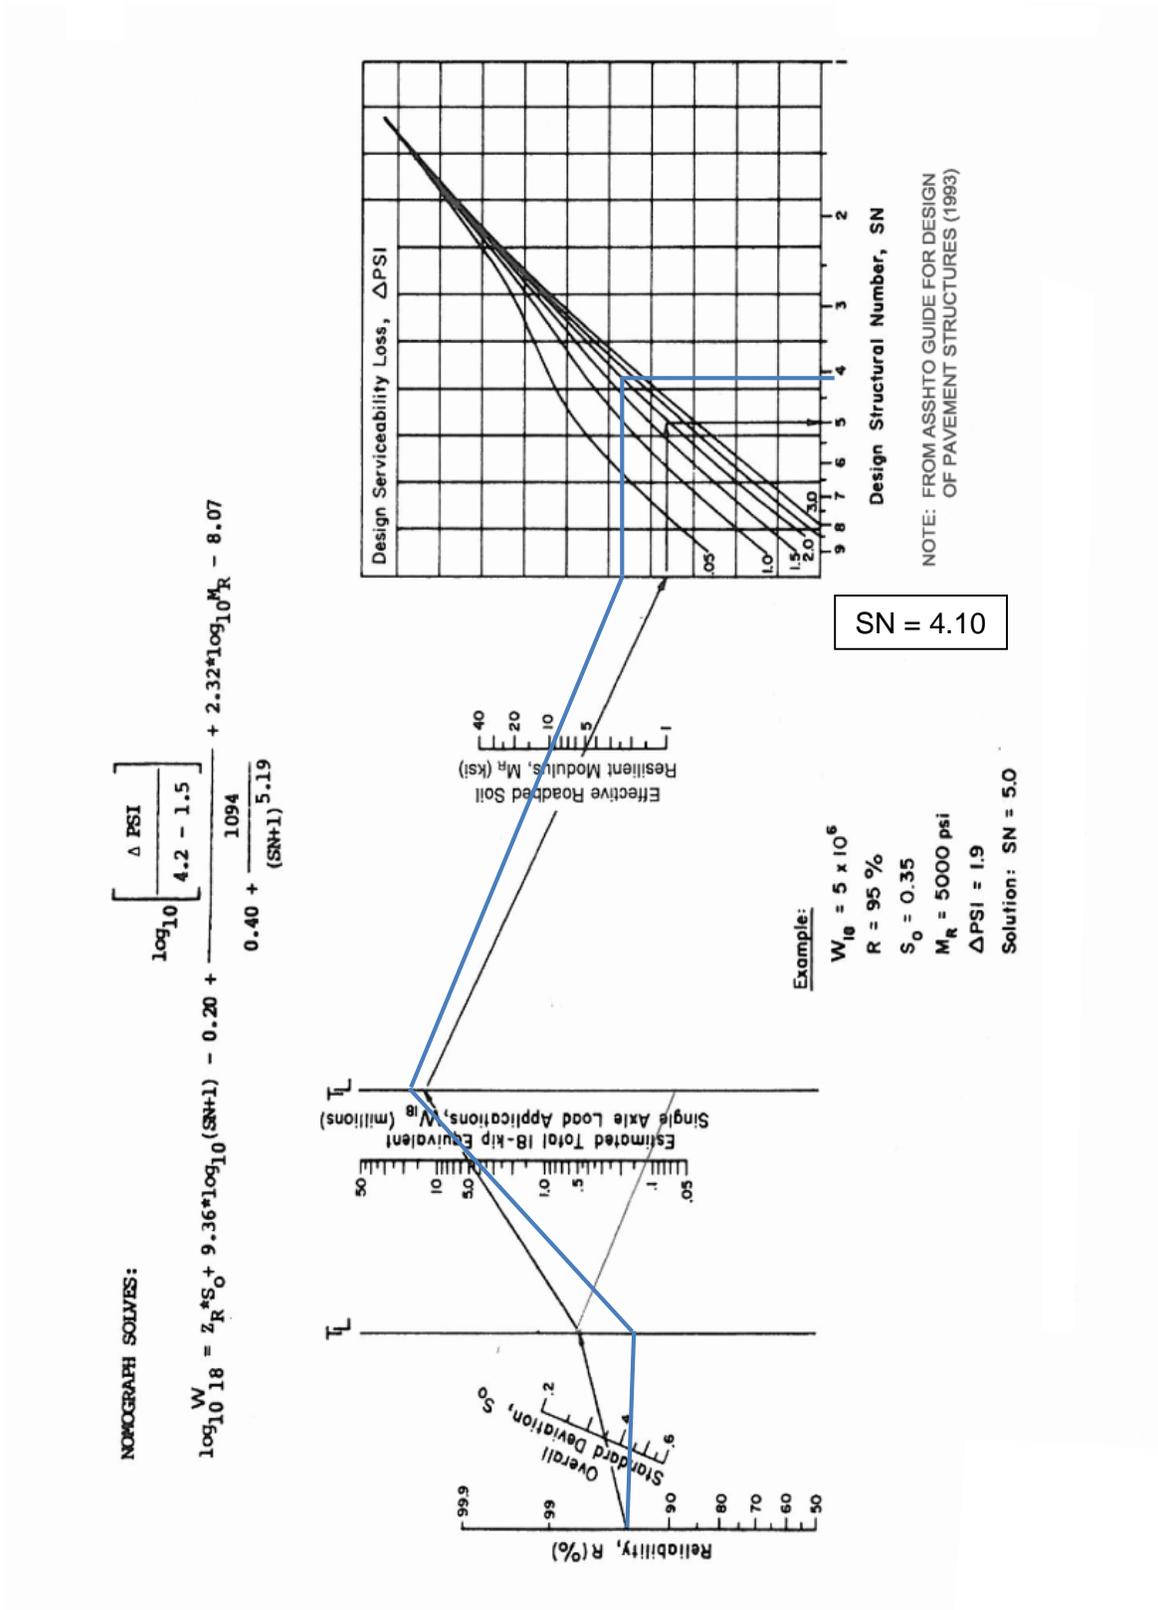
## Design chart for flexible pavements

R-value = 40

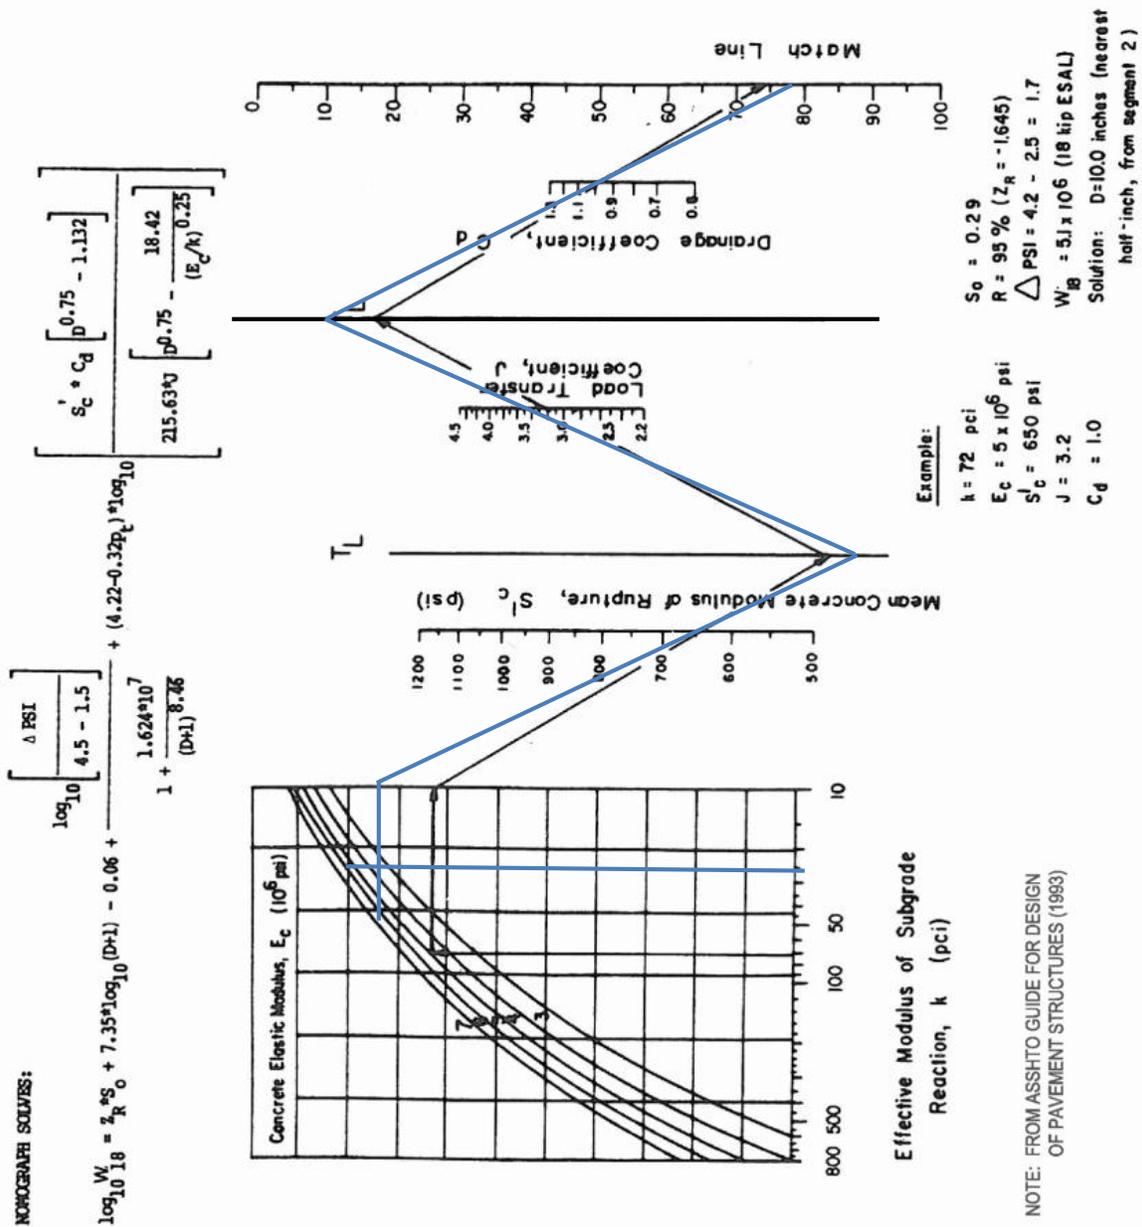
Design chart for rigid pavements  
 R-value = 40

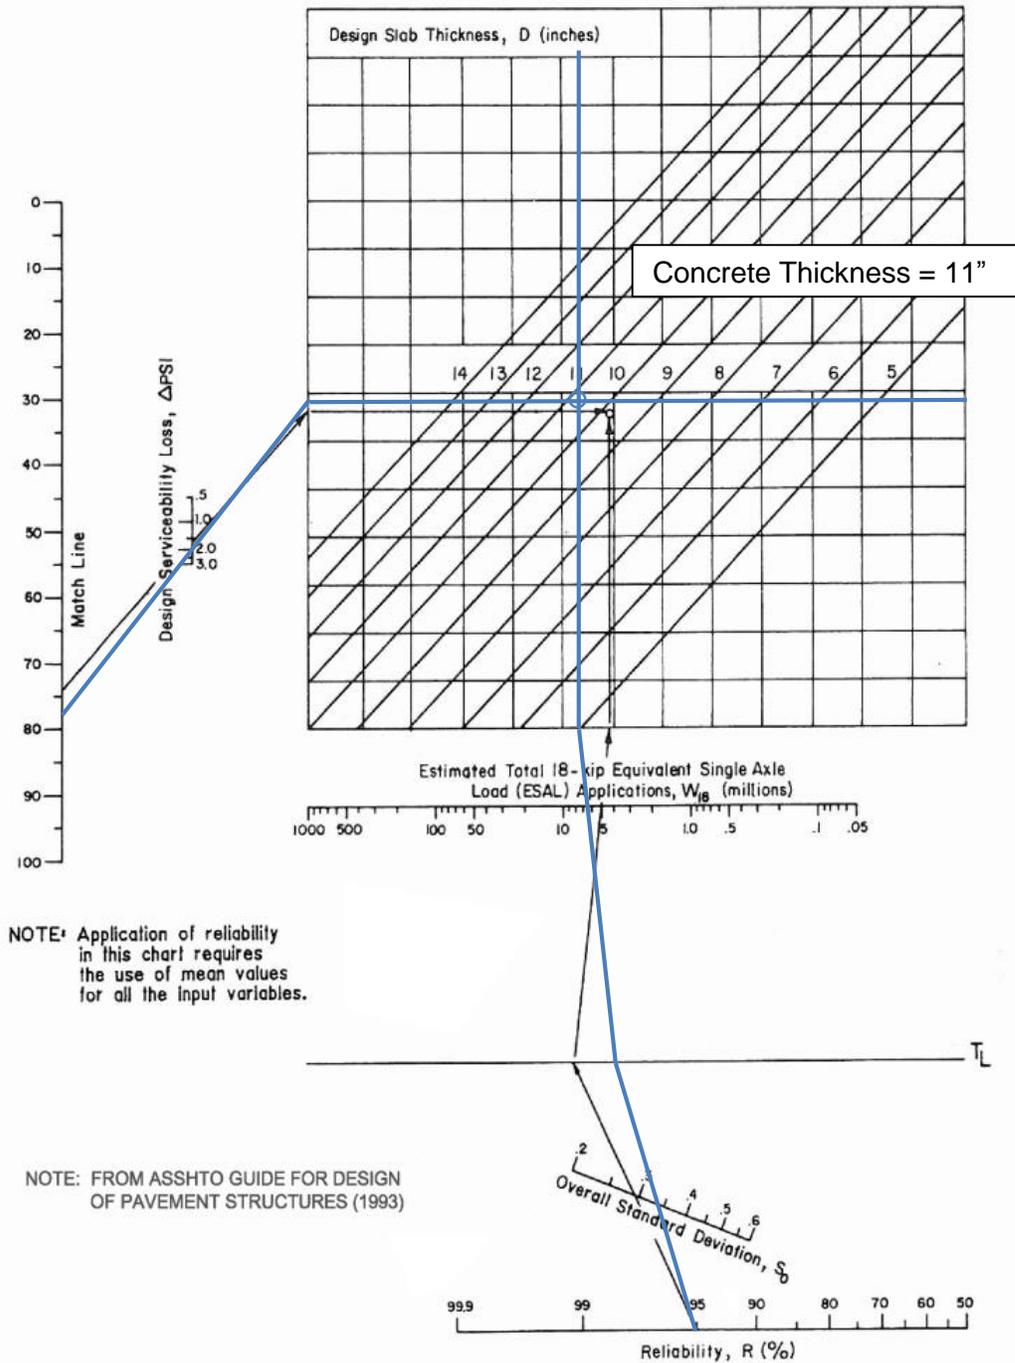
### Design chart for rigid pavements (Cont.)

R-value = 40

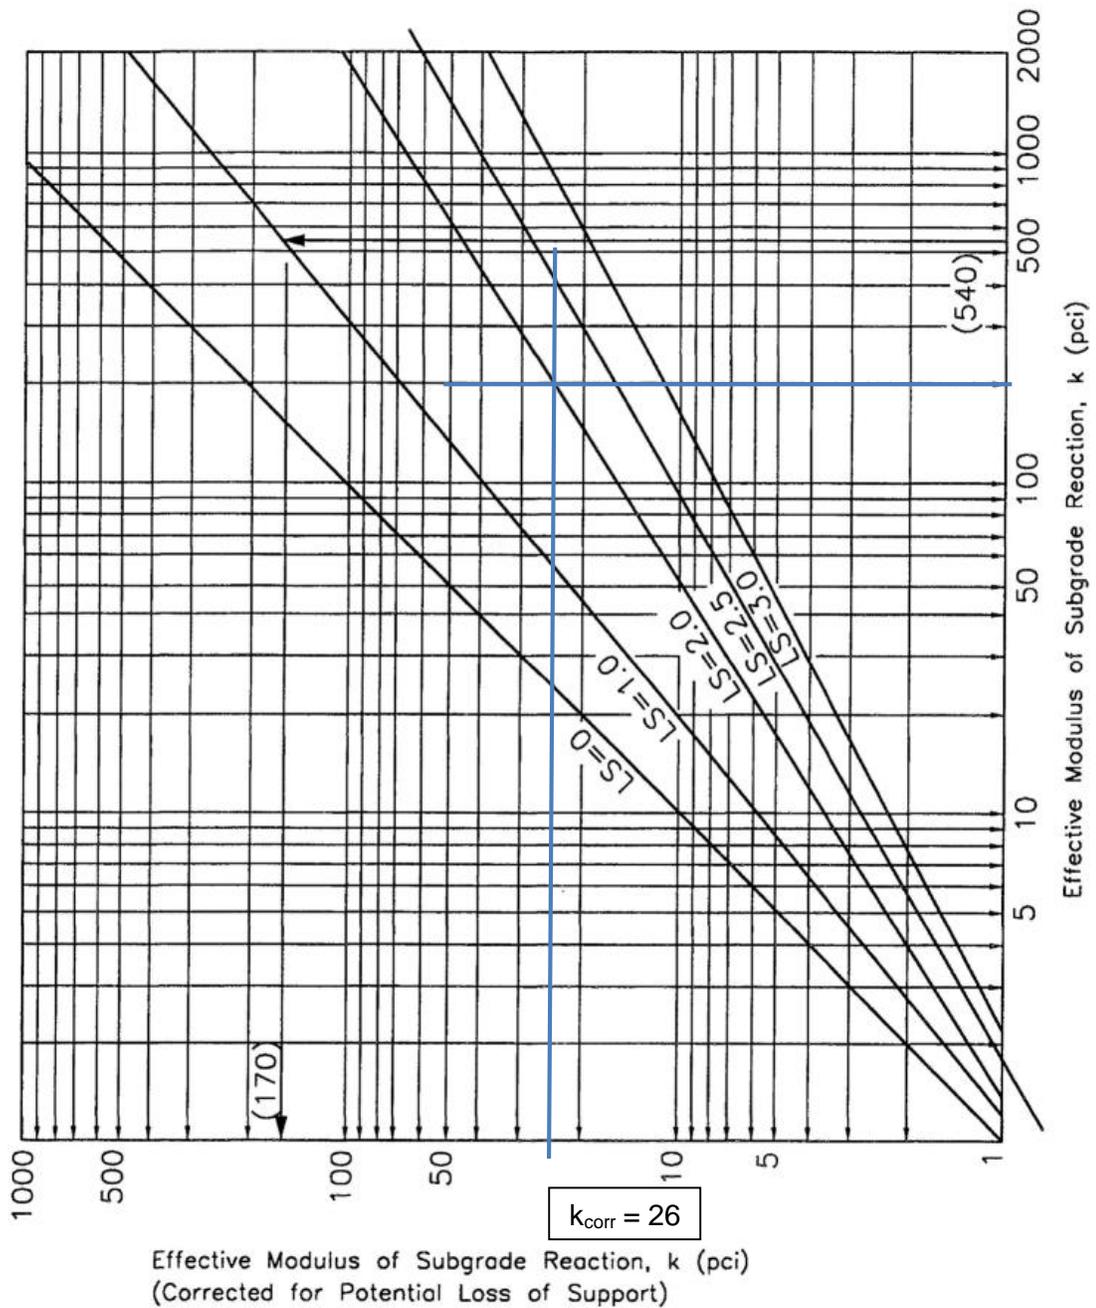
## CORRECTION OF EFFECTIVE MODULUS OF SUBGRADE REACTION FOR LOSS OF SUPPORT
